FINAL REPORT

**accident occurred
to the aircraft B737-8AS registration marks EI-DYG,
Ciampino Airport,
10th November 2008**

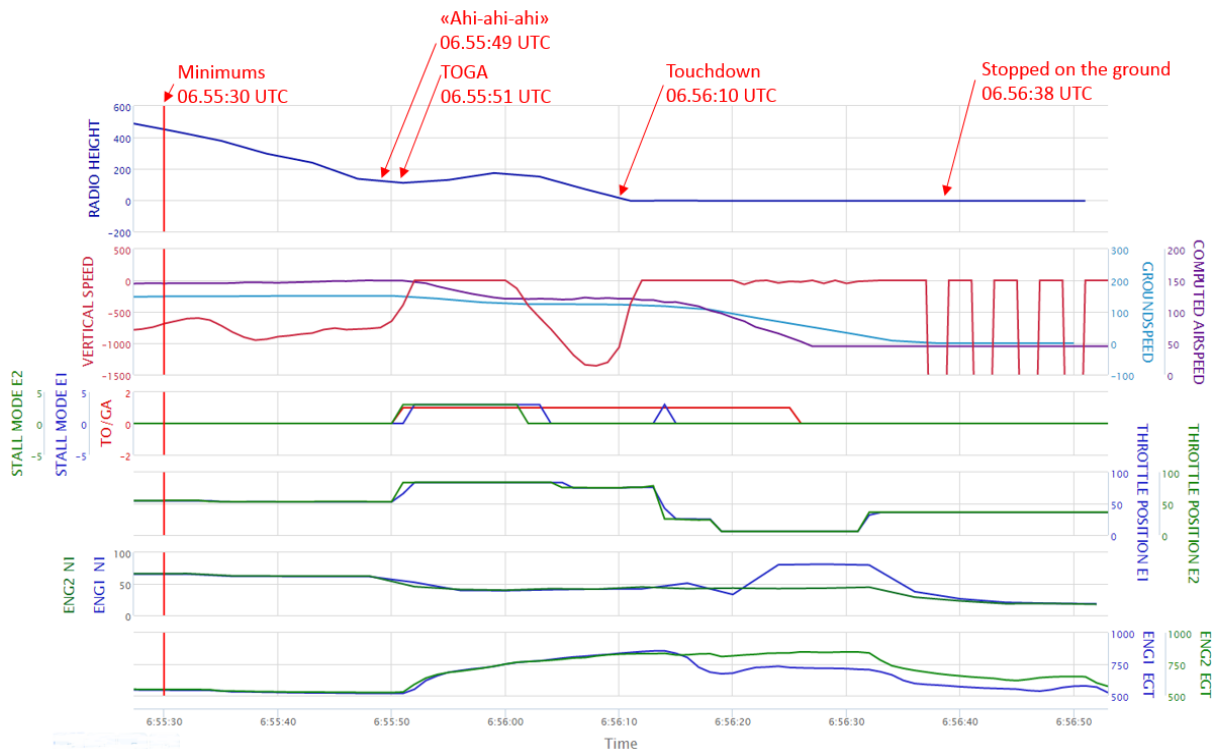
Figure 25: engines behaviour.

With regards to the behaviour of the two engines, both experienced a stall condition (state 3) when TO/GA was selected, the right hand engine at 06.55.51, the left 1 second later; the N1 RPM of both engines dropped from 66% to a value around 40%, where they remained until impact with the ground, after which the left engine increased RPM up to 81% through activation of the thrust reverse, whilst the right remained at values below 45%, until being shut down.

A sudden rise of the EGT of both engines was recorded coinciding with the reduction of the N1 rpm.

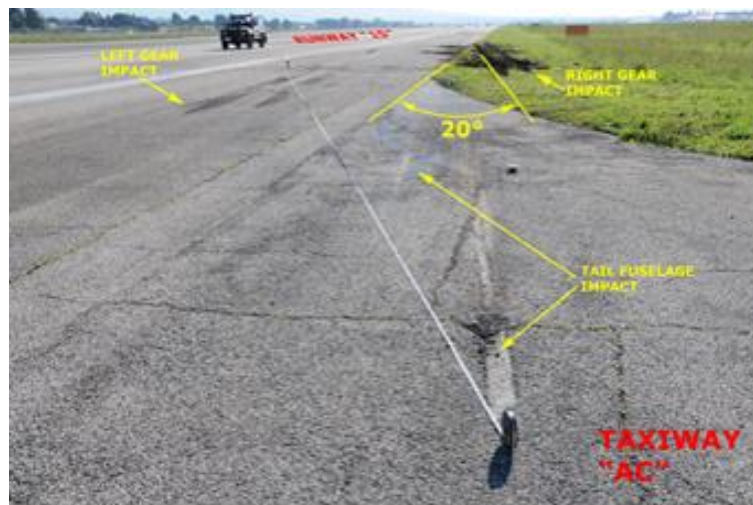
Photo 5: tracks of the landing gear and tail fuselage on the ground.

- marks of impact of the lower part of the tail fuselage with the asphalt surface of taxiway “AC”;
- marks of impact of left hand landing gear on the runway asphalt surface;
- marks of impact of the right hand landing gear on the grass adjacent to the right edge of the runway;
- continuous marks of left hand engine and left hand landing gear scraping from the first point of contact to the final resting point of the aircraft.

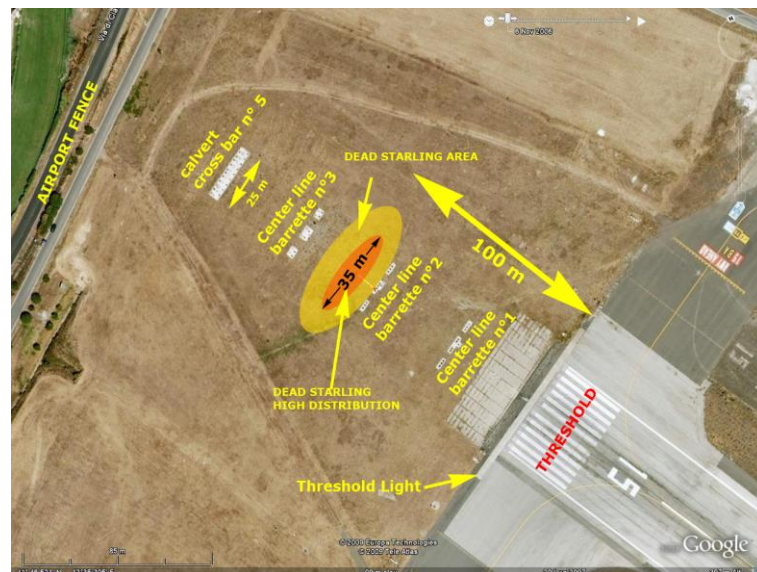
Photo 7: distribution of birds’ corpses.

The majority of the organic remains were concentrated inside an ellipsoidal area, closer to the “Center line barrette no. 2” pole, the larger axis of which was about 35 metres and the shorter one about 10 metres.

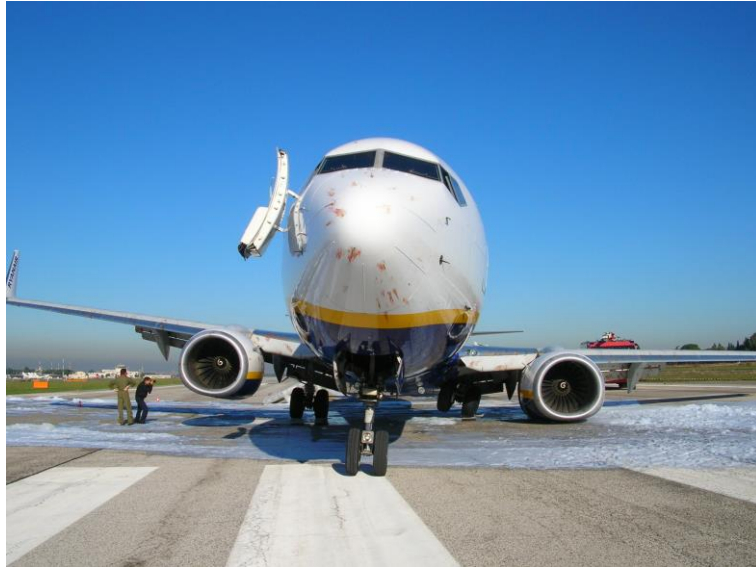
Photo 8: aircraft at rest on the runway.

The aircraft came to a stop close to RWY 33 threshold, resting on the main right landing gear, front landing gear and left engine nacelle.

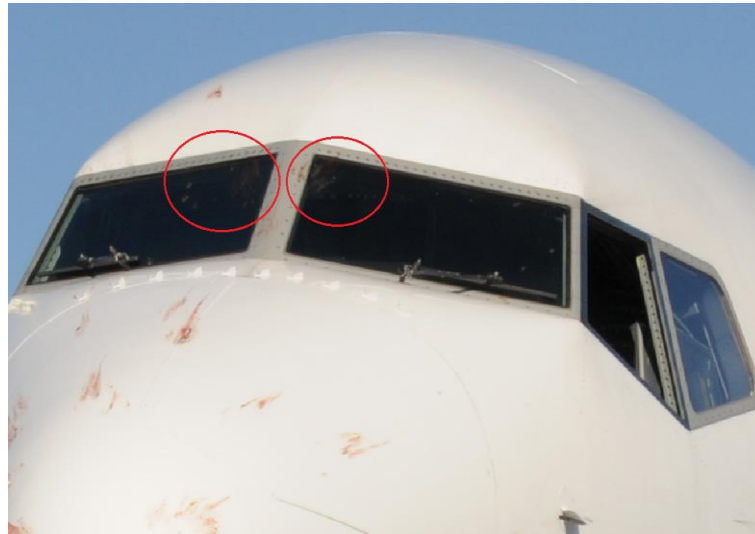
Photo 10: bird strikes on the windshield panels.

The fuselage shows multiple bird strikes (no less than 86), visible in the next images. The windshield panels show some bird strikes in their top central part.

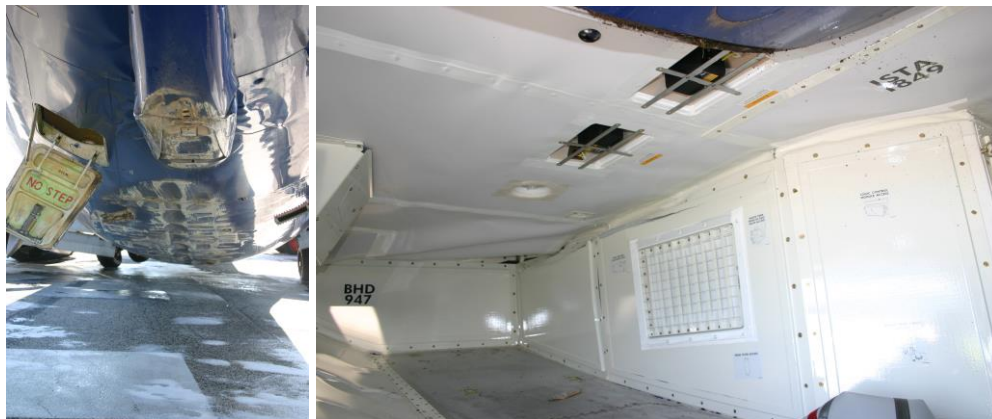
Photos 11 and 12: damage to the tail and passenger floor structure.

There are clear signs of damage caused by the impact and scraping along the asphalt runway on the lower tail part of the fuselage.

The lower part of the passenger cabin floor structure shows extended deformation.

The damage found on the aircraft confirmed that the tail of the aircraft came into contact with the runway, causing permanent deformation of the structure.

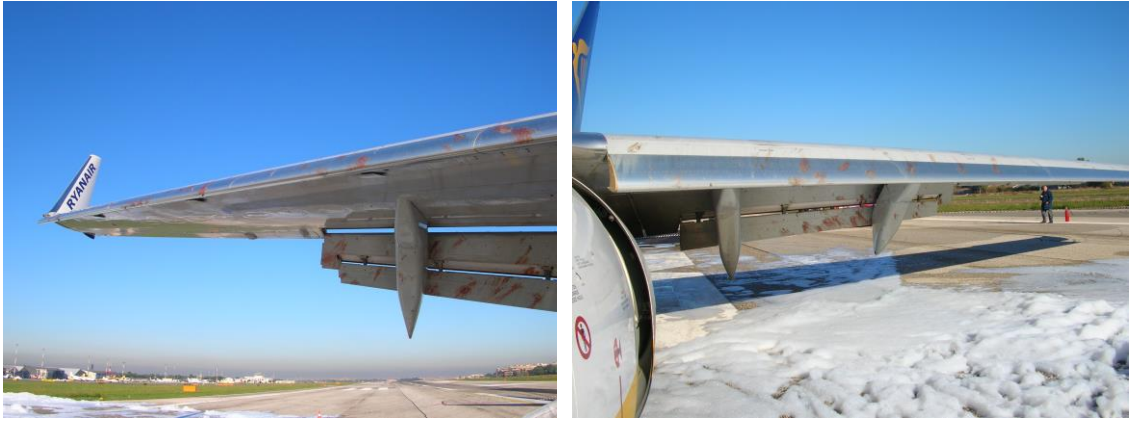
Photos 13 and 14: bird strikes on wings.

There are multiple damage points on the left hand wing and buckling on both the top surface and underside of the wing. The flaps showed some dents.

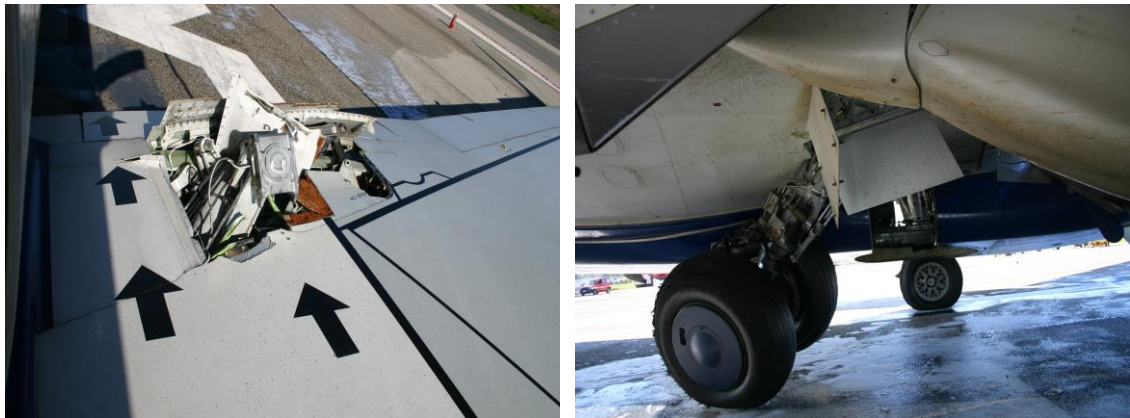
Photos 15 and 16: damage to the main left hand landing gear and wing.

The main left hand landing gear is seriously damaged, its shock absorber has gone back into the wing. The main left hand landing gear doors are heavily damaged.

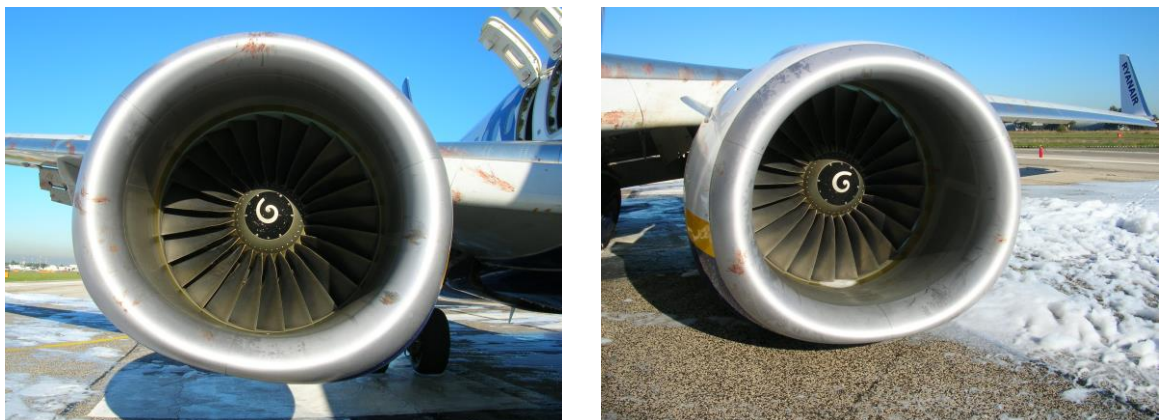
Photos 17 and 18: bird strikes on the engine air intakes.

Both engines show many bird strike points on their respective air intakes

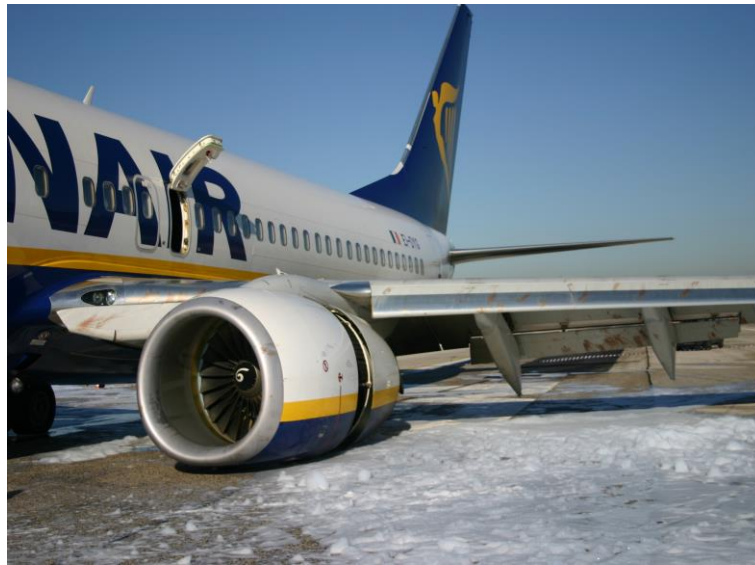
Photo 19: thrust reverse locked in partially open position.

The left hand engine nacelle shows damage from scraping along the asphalt; the thrust reverse doors are locked in a partially open position.

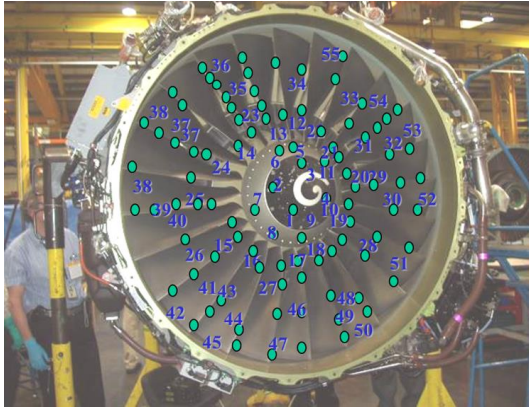
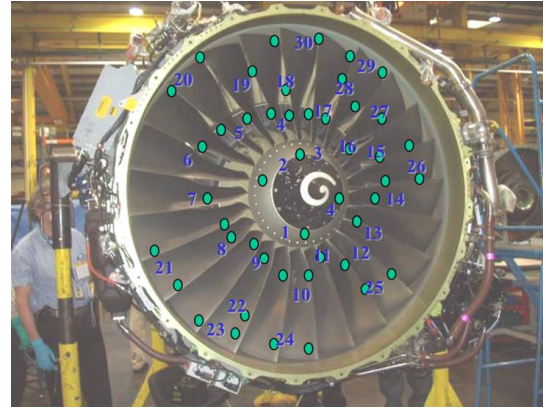
Photo 24: distribution of bird strike on fan, engine #1 Photo 25: distribution of bird strike on fan, engine #2.

The external visual inspection of the fans showed 55 impact points with birds on the left hand engine fan, 30 points on the right hand engine fan, both fans without apparent damage and deformation of the blades' aerodynamic profile, slight deformation of the *fan case* engine #1, due to the contact with and subsequent scraping of its nacelle along the runway¹.

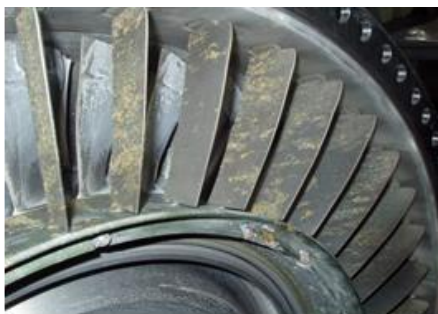
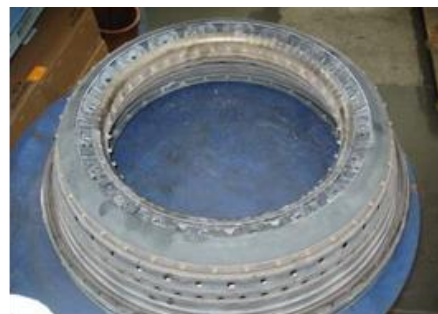
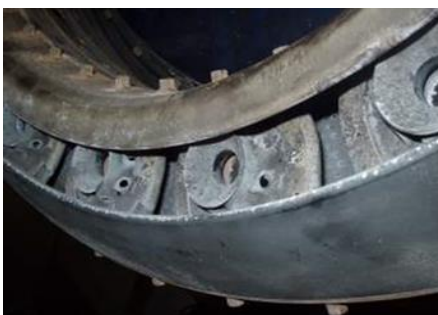
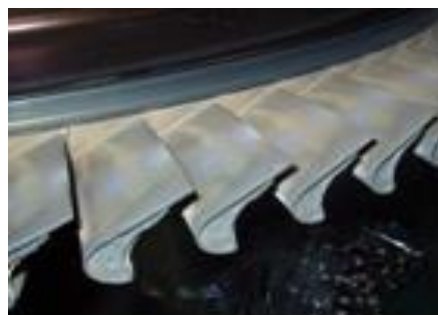
Photos 26, 27, 28 and 29: engine #1, modules conditions.

There was a considerable amount of organic material inside the fan, the compressor booster, the high pressure compressor and the combustion chambers of both engines, a greater quantity in #2 compared to engine #1, despite lesser traces of impact in its FAN. The organic residues found produced a severe alteration of the compressor blades' aerodynamic profiles and partial airflow disruption, affecting the various sensors, and inside the combustion chambers.

A limited presence of metal splatter was also identified on the hot parts of both engines, not such as to change the functional characteristics of the parts concerned. The accessories of both engines underwent specific inspections and functional tests, without any anomalies being found. No faults were found on both engines prior to the ingestion of the birds.
