**Air Accidents Investigation Branch**

**Report on the accident to  
Aerospatiale AS332L Super Puma, G-TIGK,  
in North Sea 6nm south-west of  
Brae Alpha Oil Production Platform  
on 19 January 1995**

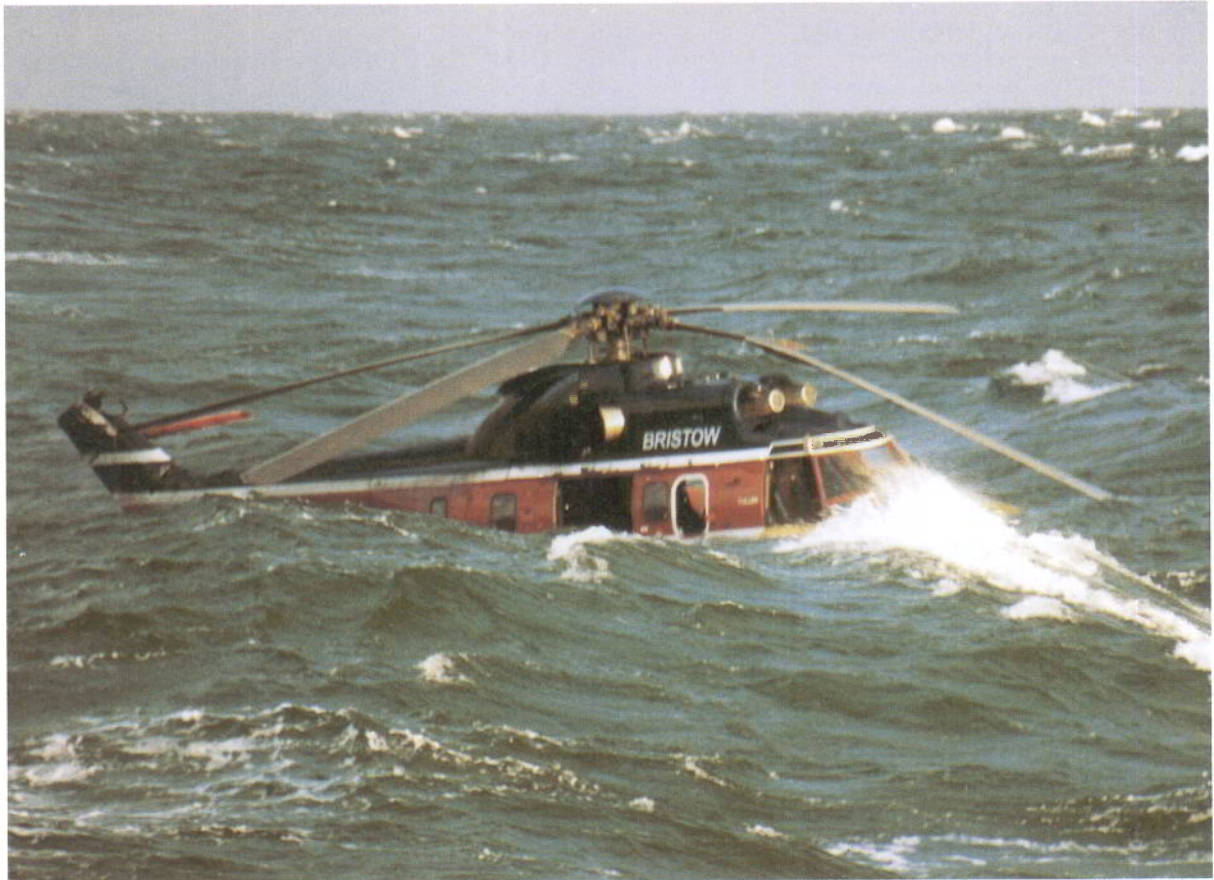
Showing G-TIGK drifting in heavy seas after ditching and evacuation of occupants, with tail rotor/gearbox missing and damaged main rotor blade.
