INTERSTATE AVIATION COMMITTEE
AIR ACCIDENT INVESTIGATION COMMISSION

FINAL REPORT
ON RESULTS OF INVESTIGATION OF ACCIDENT

Type of accident	Fatal accident
Type of aircraft	ATR72-201 aeroplane
Registration	VP-BYZ, Bermudas
Owner	BLF Limited
Operator	UTAir Aviation, JSC
Place of accident	1500 m from RWY 21 threshold; cross-track deviation about 400 m, Roschino aerodrome, Tyumen. Coordinates: N 57°09.440' E 065°16.000'
Date and time of accident	02.04.2012, 01:35 UTC (07:35 local time), day time

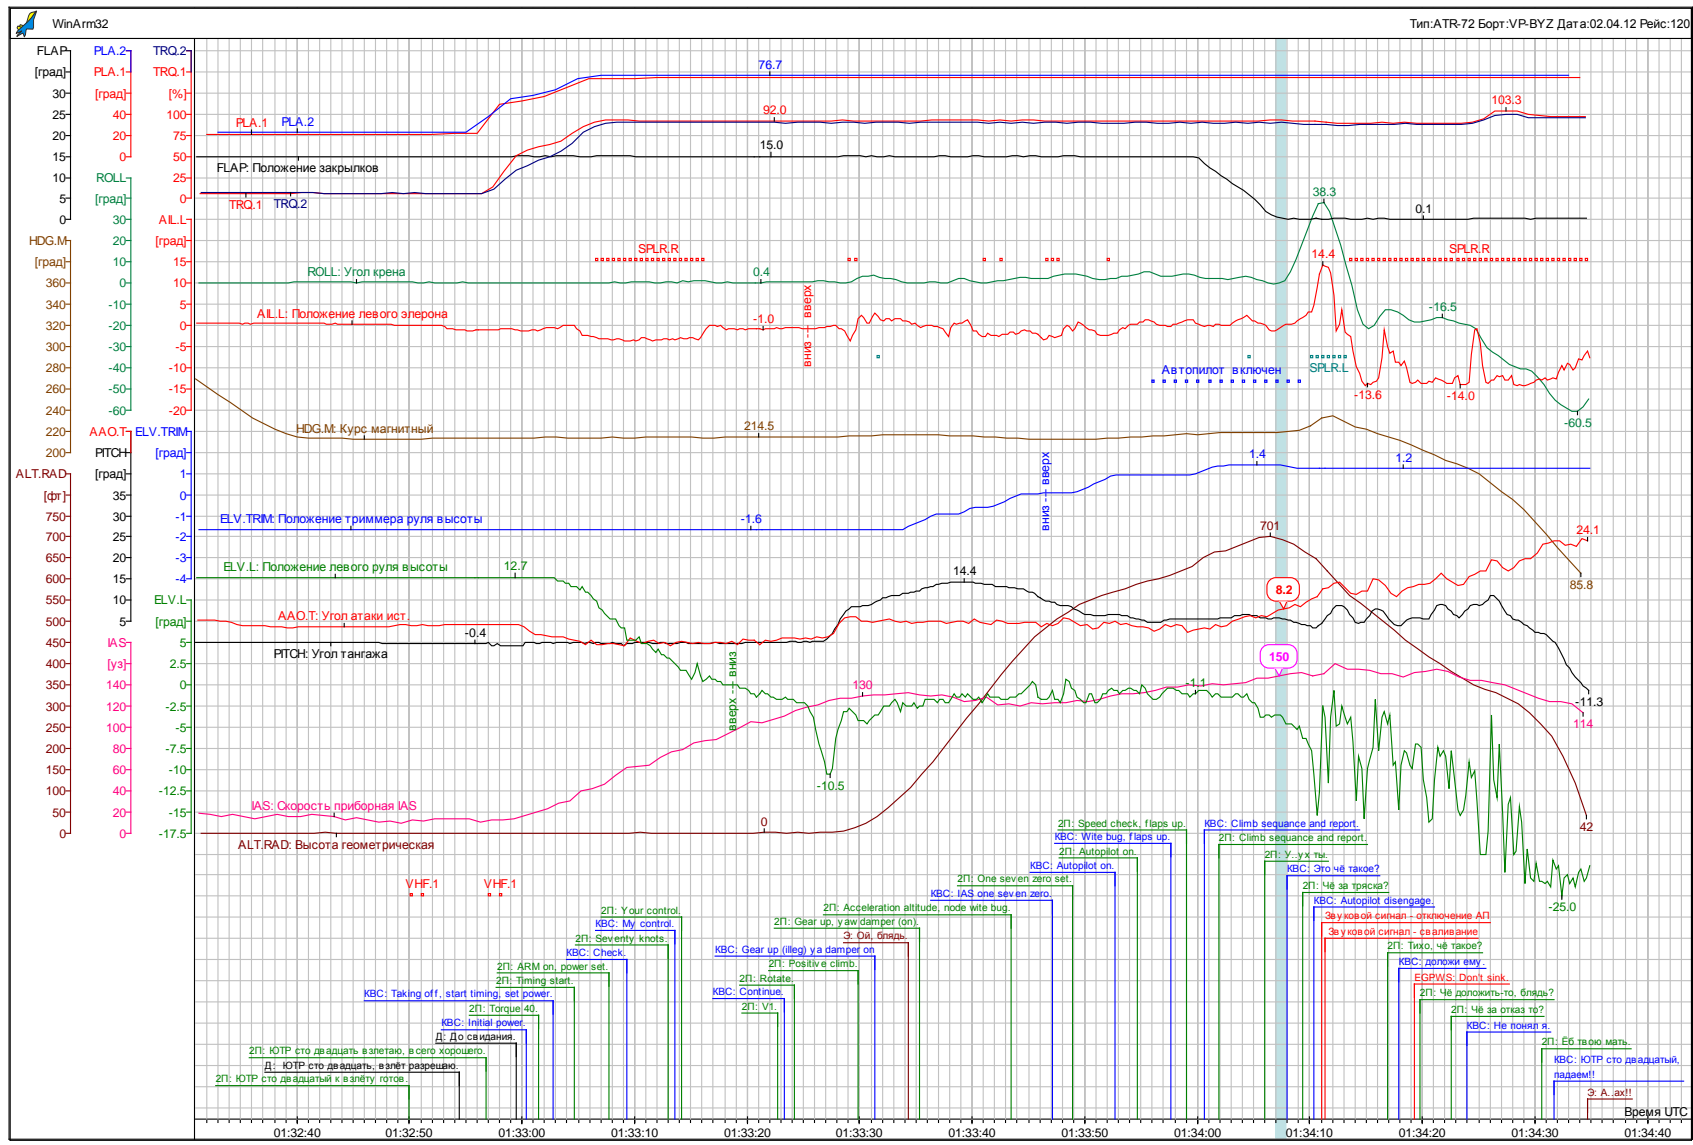
The FDR data revealed no engine or A/C system failures.

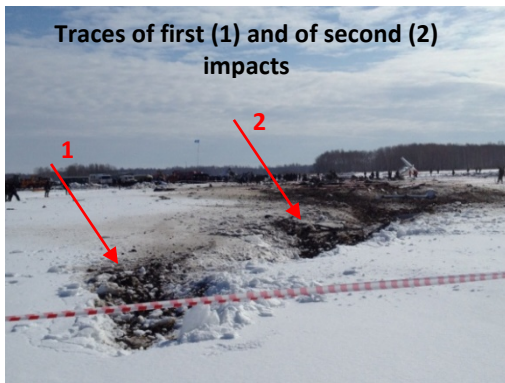
Figure 33

The initial ground impact was with the LH outer wing and resulted in the outer wing destruction. The initial impact “spot” dimension is 1.6 x 4 m.

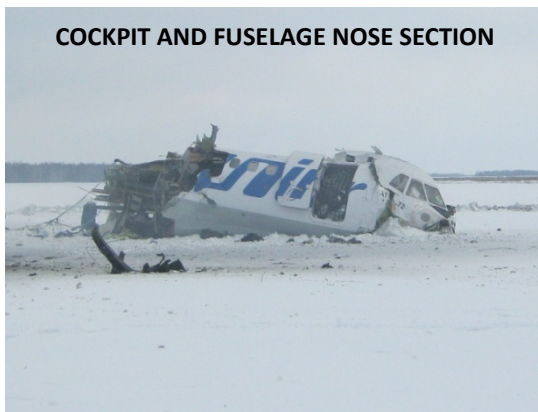
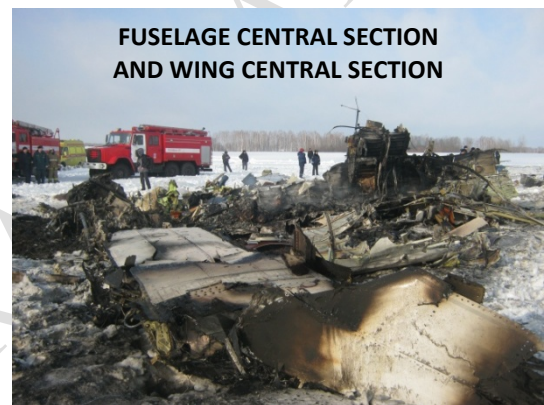
The second impact traces with dimensions 3 x 8.3 m showed further LH wing components destruction and contained some particles of the airplane paint-and-lacquer coating on the ground.

Cockpit with FNS was located at 134 m from the A/C initial impact point. The fuselage major damage, namely deformation, are along the fuselage LH side, and this evidences that the A/C collision first occurred with the fuselage left nose section. This is also evidenced by the absence of the left door that was found about 50 m before the FNS. The FNS did not show any evidence of fire.

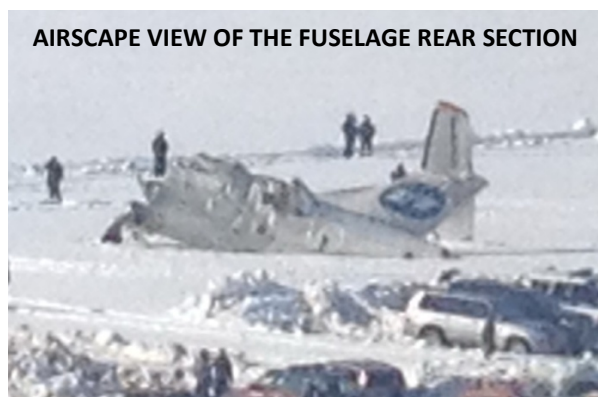
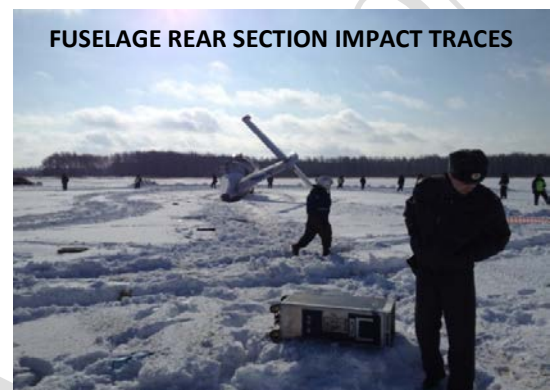
Figure 36

The FRS, as the result of significant A/C ground impact, separated from the FCS near the LH fr. 32 and the RH fr. 31 up to fr. 48.

Approximately 25 m after the initial ground impact point a trace of RH elevator horn ground impact can be seen (coordinates: N 57°09.411' E 65°16.075'); further the FRS continued its in-air traveling heading $MH\approx 110^\circ$ followed by ground collision. The FRS was located 173 m from the A/C initial ground impact point and 39 m to the right from the general direction of the A/C fragments traveling.

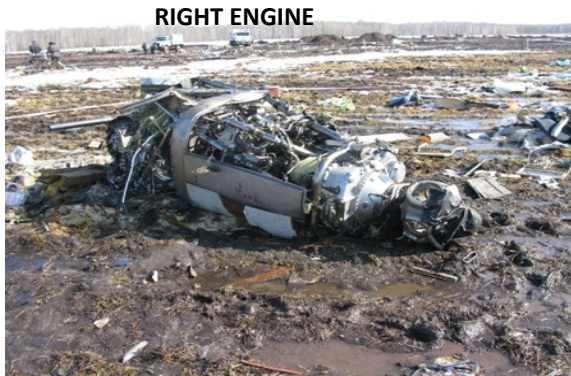
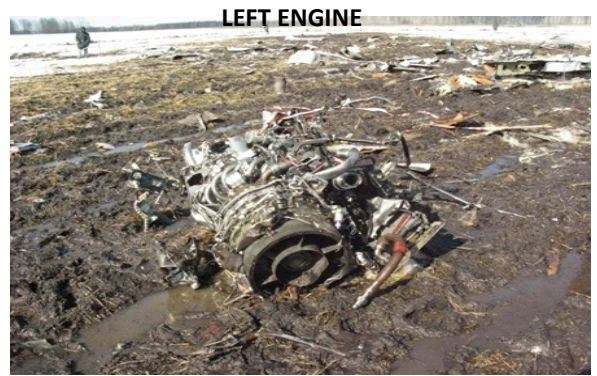
Figure 38

During A/C destruction and its' fragments on ground movement, the engines were torn off their mounting places. The LH engine was located 93 m from the A/C initial ground impact point along the trajectory and 10 m to the right from the general direction of the A/C fragments traveling. The RH engine was located 79 m from the A/C initial ground impact point along the trajectory and 15 m to the right from the general direction of the A/C fragments traveling. The A/C rotor blades showed the deformation and destruction that is representative for the engines being in operation.

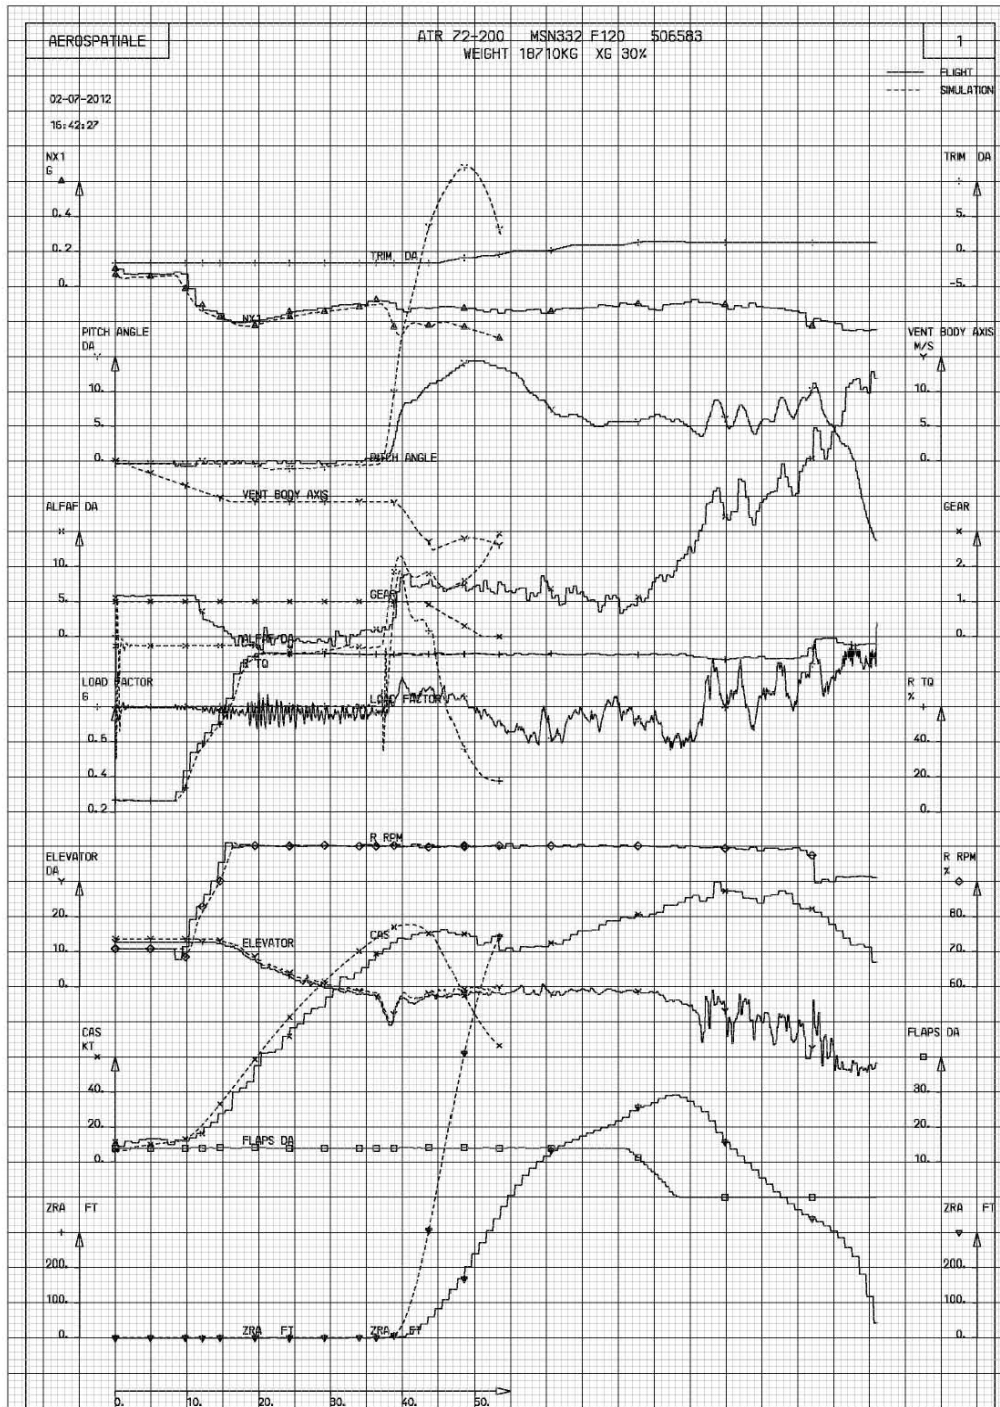
The accident flight simulation (Flight UTA-120) showed that with the actually realized deflection of the flight control surfaces, engine thrust and the aerodynamic data basis, the simulation did not match the DFDR parameters (Figure 44).

Figure 424. Simulation compared to FDR Flight UTA-119 – with "normal" aerodynamic factors

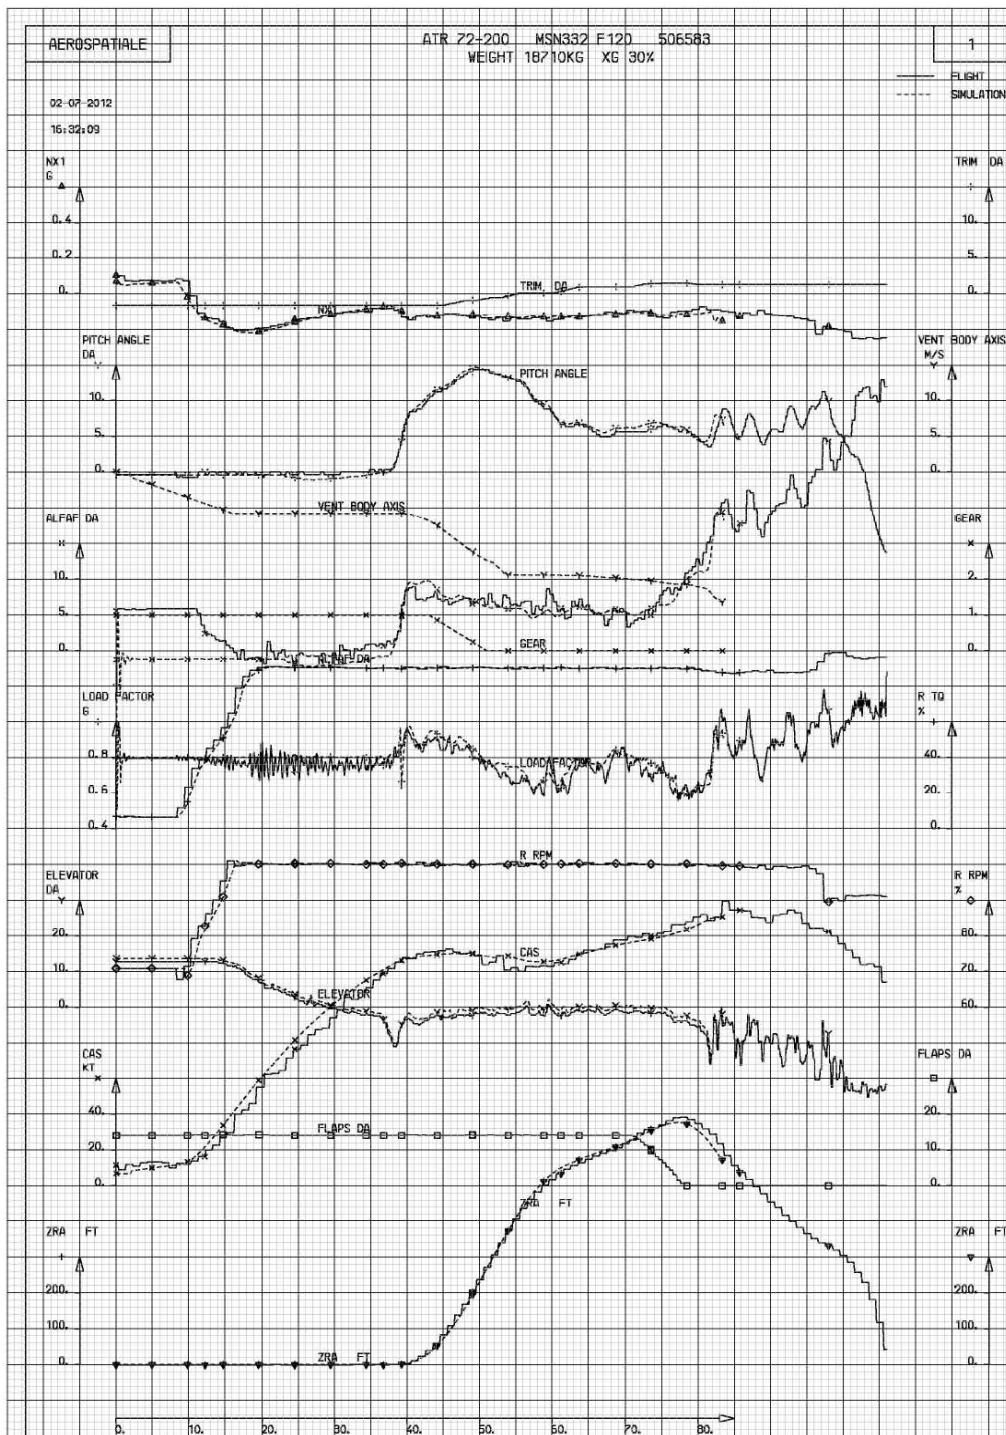
At the next stage of the simulation the lift and drag factors were modified to make the simulation match the DFDR data taking into account the actual flight control inputs and thrust (Figure 45).

Figure 435. Simulation compared to FDR Flight UTA-119 – with extra drag and lift

The simulation revealed that during the takeoff run at angle of attack near 0° , a loss of lift and an increase of drag were $\Delta CL_0 = -0.23$ and $\Delta CD_0 = 0.05$ (Figure 46). The graph analysis shows that at that phase of flight CL was reduced by approximately 25%, while drag was doubled. Further after the landing gear retraction the loss of lift remained more or less constant, while the drag increased with angle of attack, providing a $\Delta CD_0 = 0.064$ (Figure 46). After the flaps retraction the loss of lift still remained almost constant, while the drag increasing was $\Delta CD_0 = 0.05$ (Figure 47).

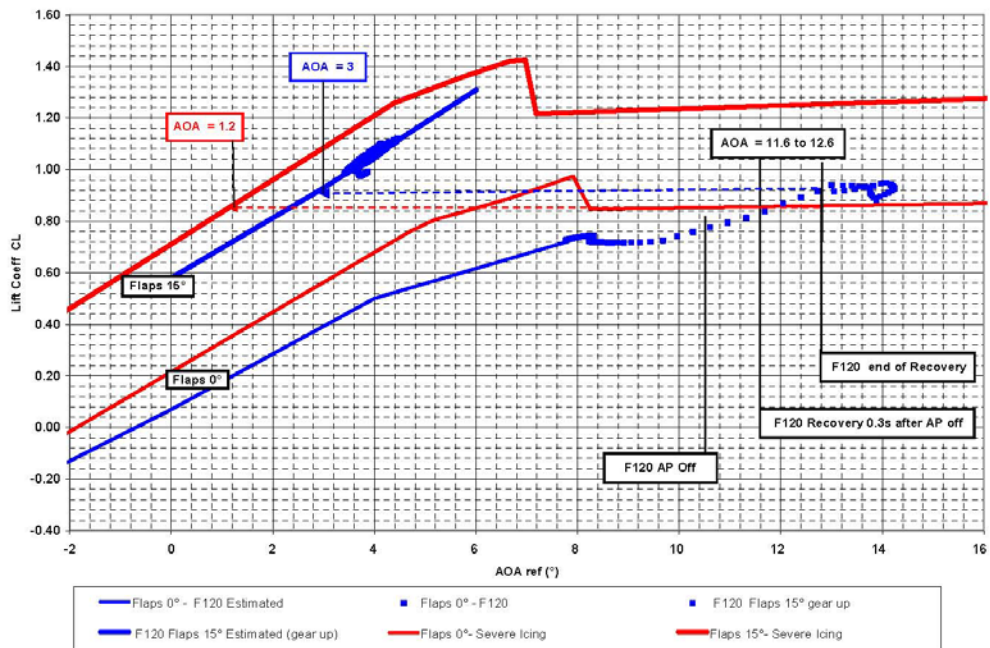
The analysis of drag and lift plots introduced in the FFS for severe icing conditions, and their comparison with the engineering simulation data (Figure 50) revealed that behavior of curves of CL versus alpha (AOA) in the FFS database and in the accident flight is almost similar (in linear range). They differ in absolute values (the curves are parallel) due to a difference in CL_0 . The loss of lift after reaching the critical AOA as per the FFS database is more significant than in the accident flight. The effect of the flaps extension (in the way it reduces the required angle of attack to reach the same CL) is comparable. Thus, the FFS test findings can be used to assess the possibility to recover the aircraft performance after the stall in the accident flight.

Figure 50. FFS (severe icing) and FDR performance compared

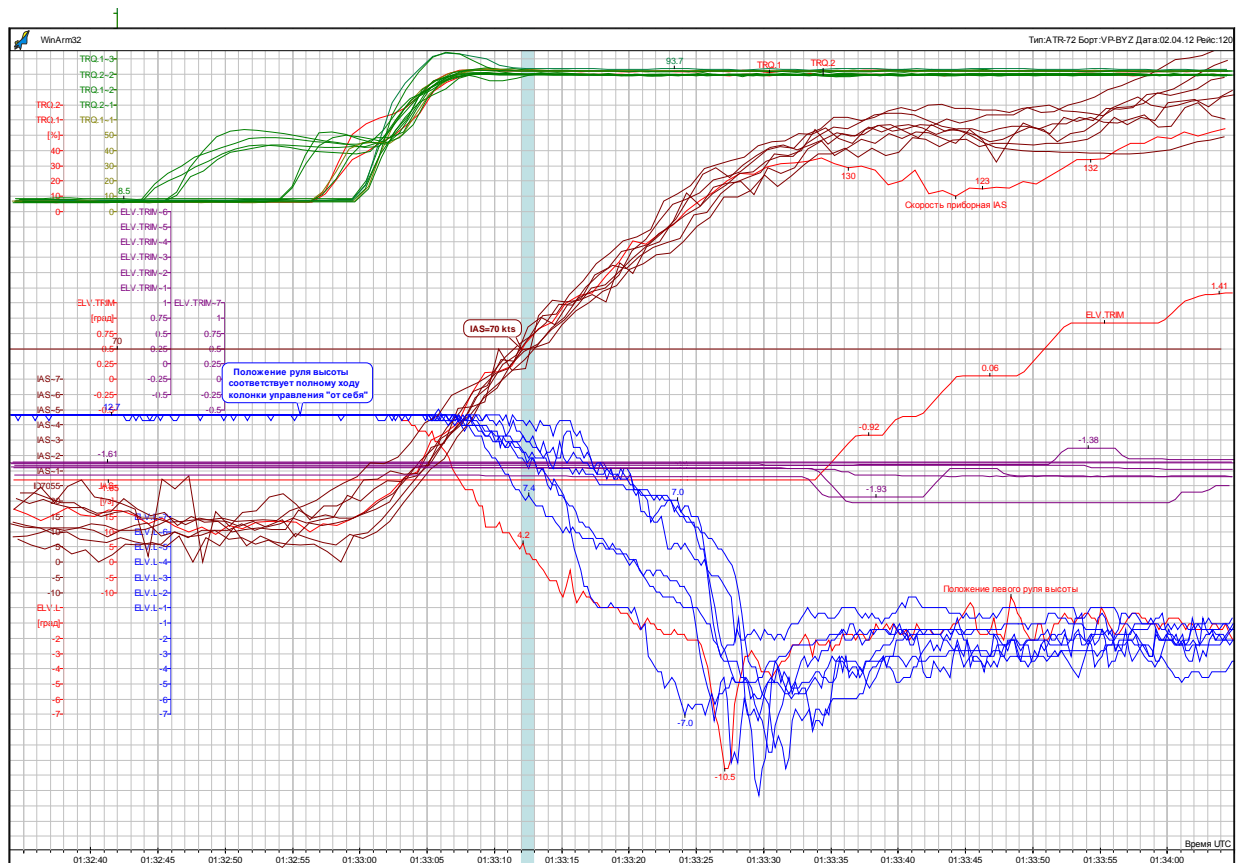
Figure 55 shows the changes in the elevator position in some flights with the elevator trim $\approx -1.65^\circ$ nose up. As it can be concluded from the graph, at the initial phase of the takeoff run (up to the speed of 70-80 knots, when pilots hardly apply any forces on control column in pitch, that is the elevator is deflected under the effect of hinge moment) the way the elevator position was changing in the accident flight with the speed (hinge moment) increase is significantly different from the other flights, which confirms the difference in the air flow over the stabilizer and the elevator.

Figure 55. The comparison of the elevator deflection at the takeoff run with the elevator trim position $\approx -1.65^\circ$
