An investigation into a dropped fuel element incident at Chapelcross Nuclear Power Station

A report by HM Nuclear Installations Inspectorate

*Published by the Health and Safety Executive
February 2002*

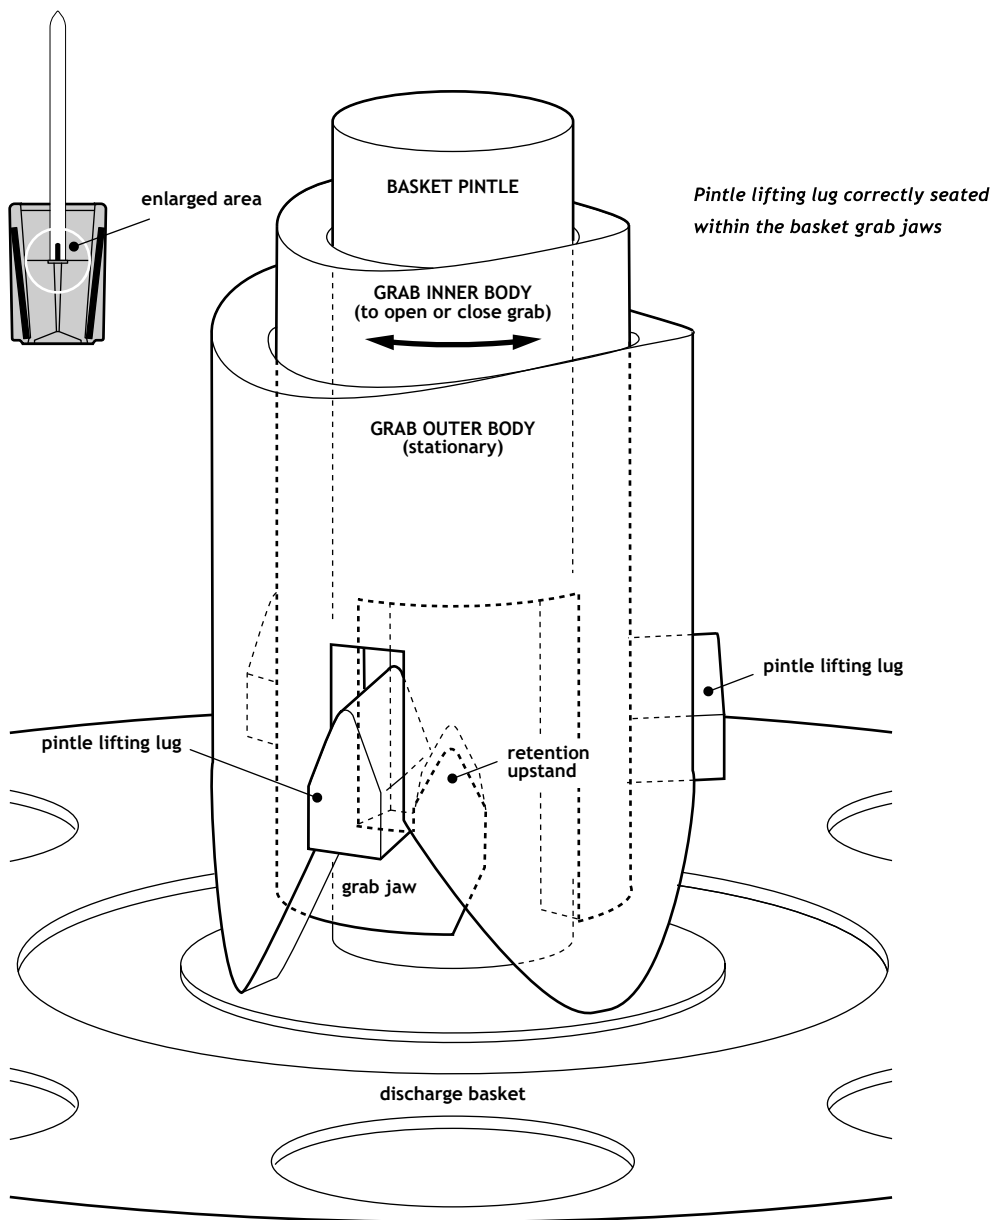
Figure 3: Grab jaws

17. Subsequent tests carried out by BNFL have shown that during closure of the grab, "spring back" can occur which can result in the jaws not being fully closed. These tests have shown that if there is only 25-50% relative movement between the inner and outer cylinders the discharge basket can still be lifted without the jaws being fully closed. The tests have also shown that there is a critical position where the jaws can spring open under the weight of the discharge basket. It is possible

that if the jaws of the grab had not been fully closed and were close to this critical position a jolt could cause them to spring open and allow the basket to drop.

21. Our investigation concluded that safety would be improved by the installation of additional cameras within the discharge chamber to enable the operator to check and confirm that the basket grab is correctly latched before attempting to raise the basket up the discharge well.

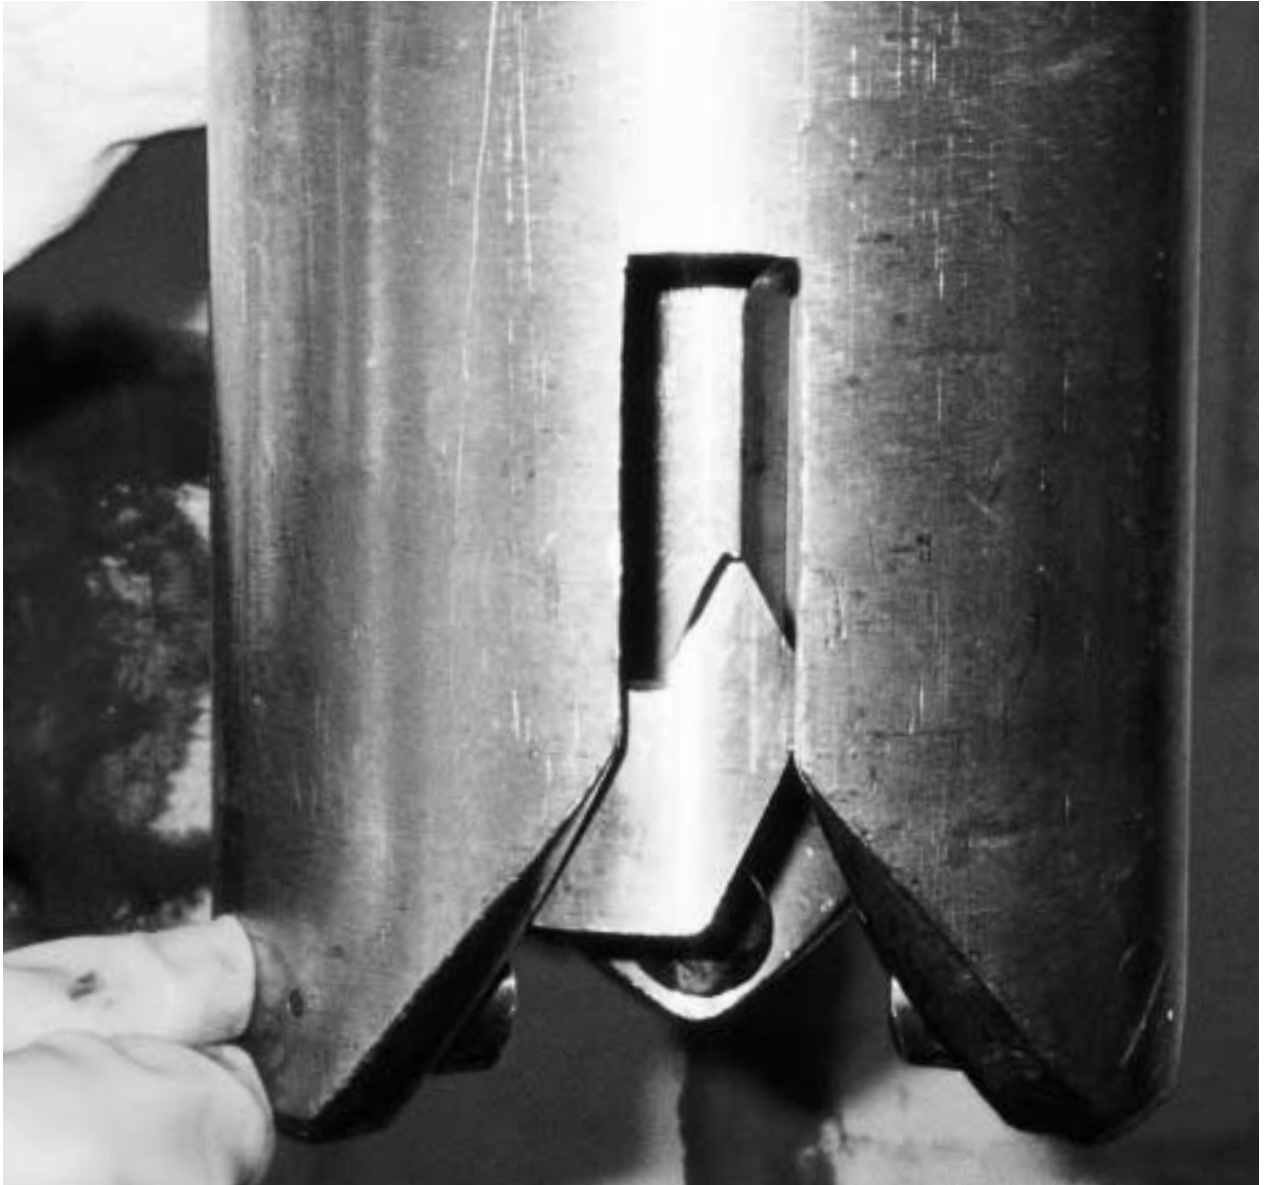
Figure 4: Jaws of the basket grab in partially closed position

26. Once the operator has fitted the discharge machine door he moves the discharge machine from the traverser onto the pile cap. In order to load fuel elements into the discharge basket each of the basket’s twenty-four fuel element pockets are sequentially rotated to align with the fuel element grab. The indexing system used to rotate the basket through 360° imposes a jolt that is capable of causing relative movement between the inner and outer cylinders of the basket grab assembly and hence potential for the grab jaws to open. Under normal circumstances retention up-stands on the end of each grab jaw prevent this occurring because they locate against the discharge basket pintle lifting lugs (Figures 3, 4 and 6).

35. Our investigation team judged that the jolt imposed on the basket during the final alignment movement would have been sufficient to make it fall from the grab if the jaws were sufficiently open to allow the discharge basket pintle lugs to topple off the retention up-stands of the grab jaws. Consequently, we concluded that the most probable cause of the basket becoming detached was due to this jolt being coincident with the jaws either gradually opening during defuelling until they reached the critical position where they could spring open (see paragraphs 17 and 26) or for the basket to have been manoeuvred without the jaws being fully closed at the time of initial latching (see paragraphs 16 and 17). The basket must then have fallen onto a partially open hoist well door.

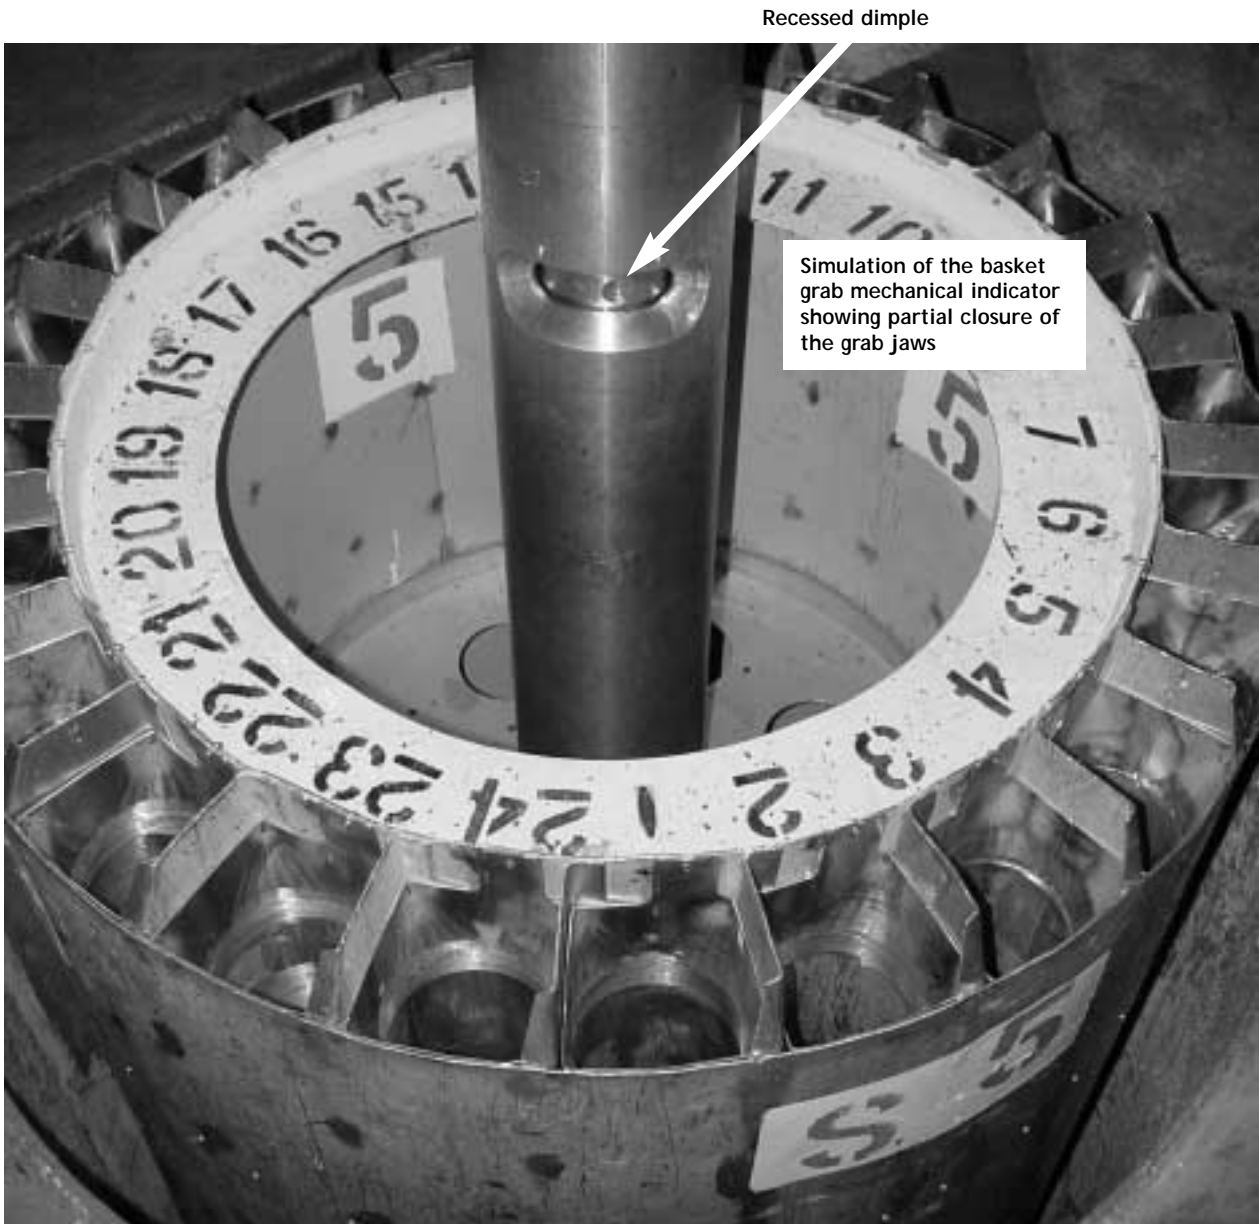
Figure 5: Basket grab mechanical position indicator

18. A mechanical indicator on the basket grab shows the relative position of the two concentric cylinders. The indication is provided by a slot cut into the outer cylinder and a recessed dimple in the surface of the inner cylinder. When the dimple is at one end of the slot the grab jaws are fully open and at the other end they are fully closed (Figure 5).

19. Our investigation found that it is only possible for the operator to attempt to confirm the position of the dimple within the slot, if it is aligned with either a camera mounted inside the discharge chamber (which has very limited capability), or an introscope which again has only a limited field of vision. This alignment with the camera does not routinely happen because the grab assembly is suspended on a long cable and freely rotates as it is raised and lowered. Interlocks prevent the operators entering the discharge chamber and visually confirming that the grab assembly had been correctly connected to the basket.

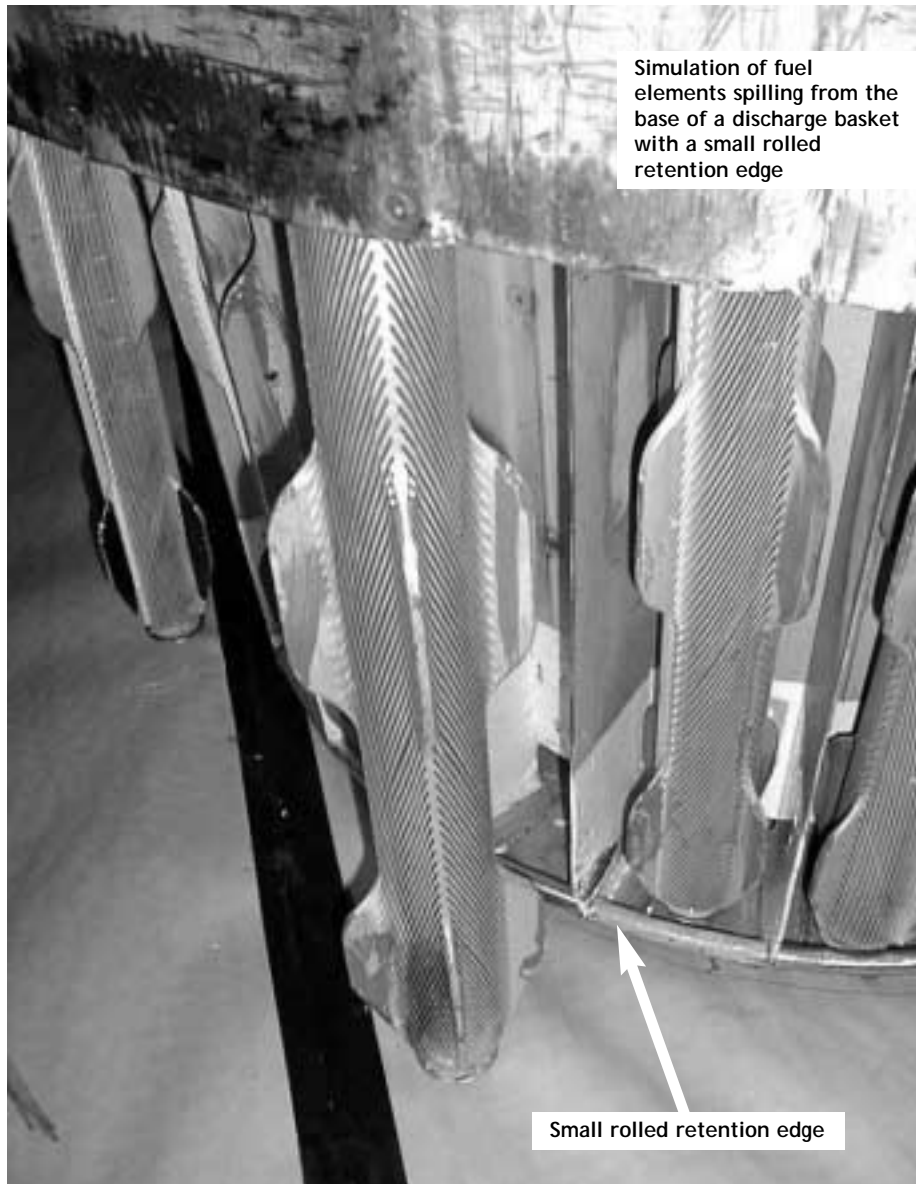
Figure 7: Fuel elements inside discharge basket

33. Our investigation also found that the discharge basket being used at the time of the incident only had a small rolled edge at its base which provided limited retention capability (Figure 7). This would not have been sufficient to prevent fuel

elements from jumping out of their recess as a result of the impact load from the basket striking the door of the hoist well. We conclude that this type of discharge basket should be withdrawn from service.
