PB91-910404  
NTSB/AAR-91/04

## AIRCRAFT ACCIDENT REPORT

AVIANCA, THE AIRLINE OF COLUMBIA  
BOEING 707-321B, HK 2016  
FUEL EXHAUSTION  
COVE NECK, NEW YORK  
JANUARY 25, 1990

**ADOPTED: APRIL 30, 1991  
NOTATION: 52558**

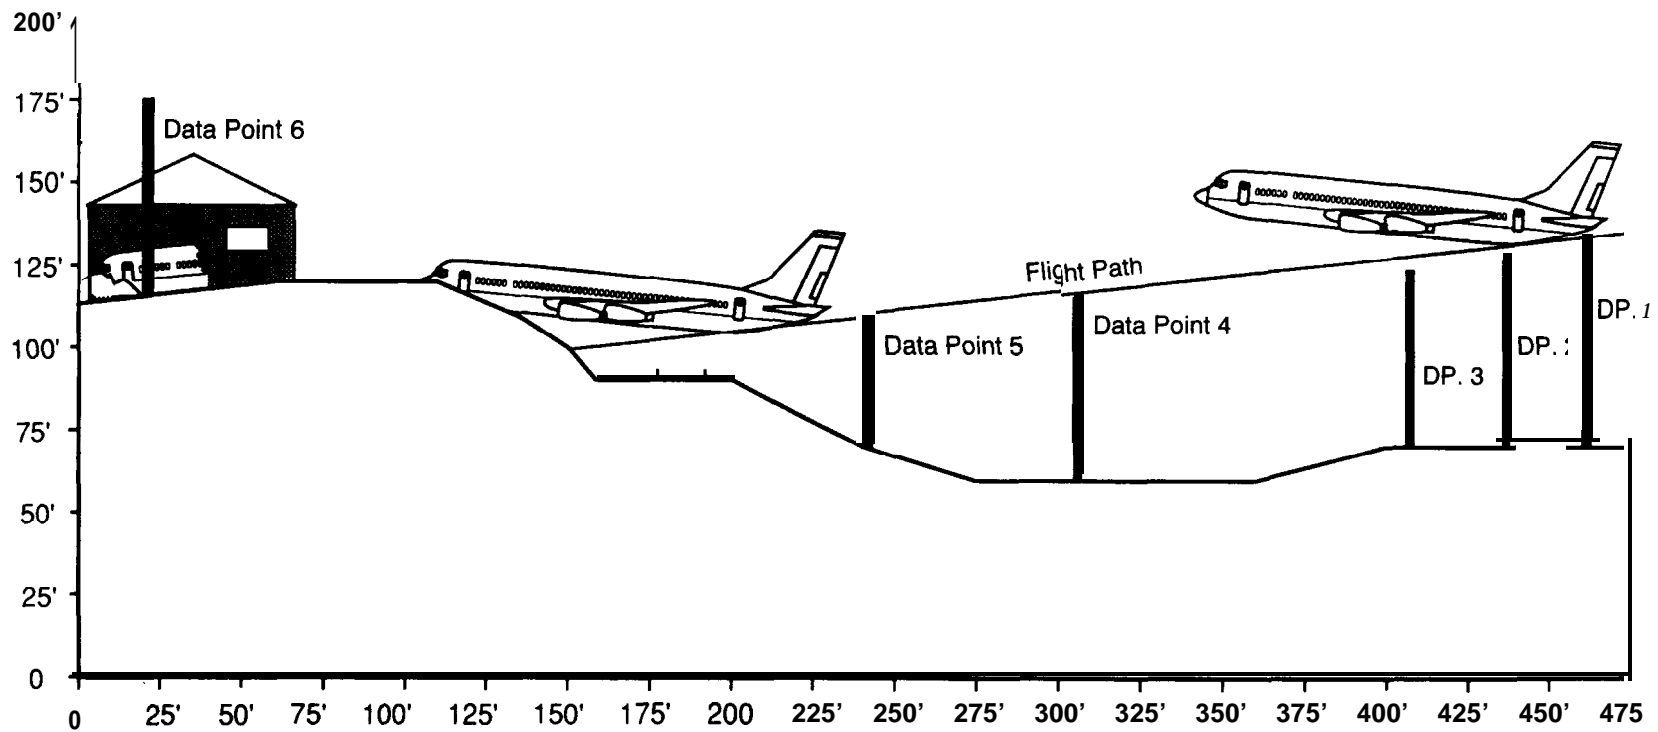
Figure 5. --Terrain impact, AVA052.

<b>Data Point</b>	<b>Description</b>	<b>Approx. Base Elev.</b>	<b>Approx. Measurement</b>	<b>Approx. Top Elev.</b>	<b>Misc. Notes</b>
1	Sheared 17' Hickory Tree	72'	61'	-133'	Measured
2	Sheared 18" Tulip Tree	66'	-61'	-127'	
3	Sheared 10" Unk. Tree	79'	-45'	-124'	
4	Sheared 8" Maple Tree	72'	-36'	-106'	
5	Sheared Telephone Pole	87'	-16'	-103'	
6	24" Oak Tree

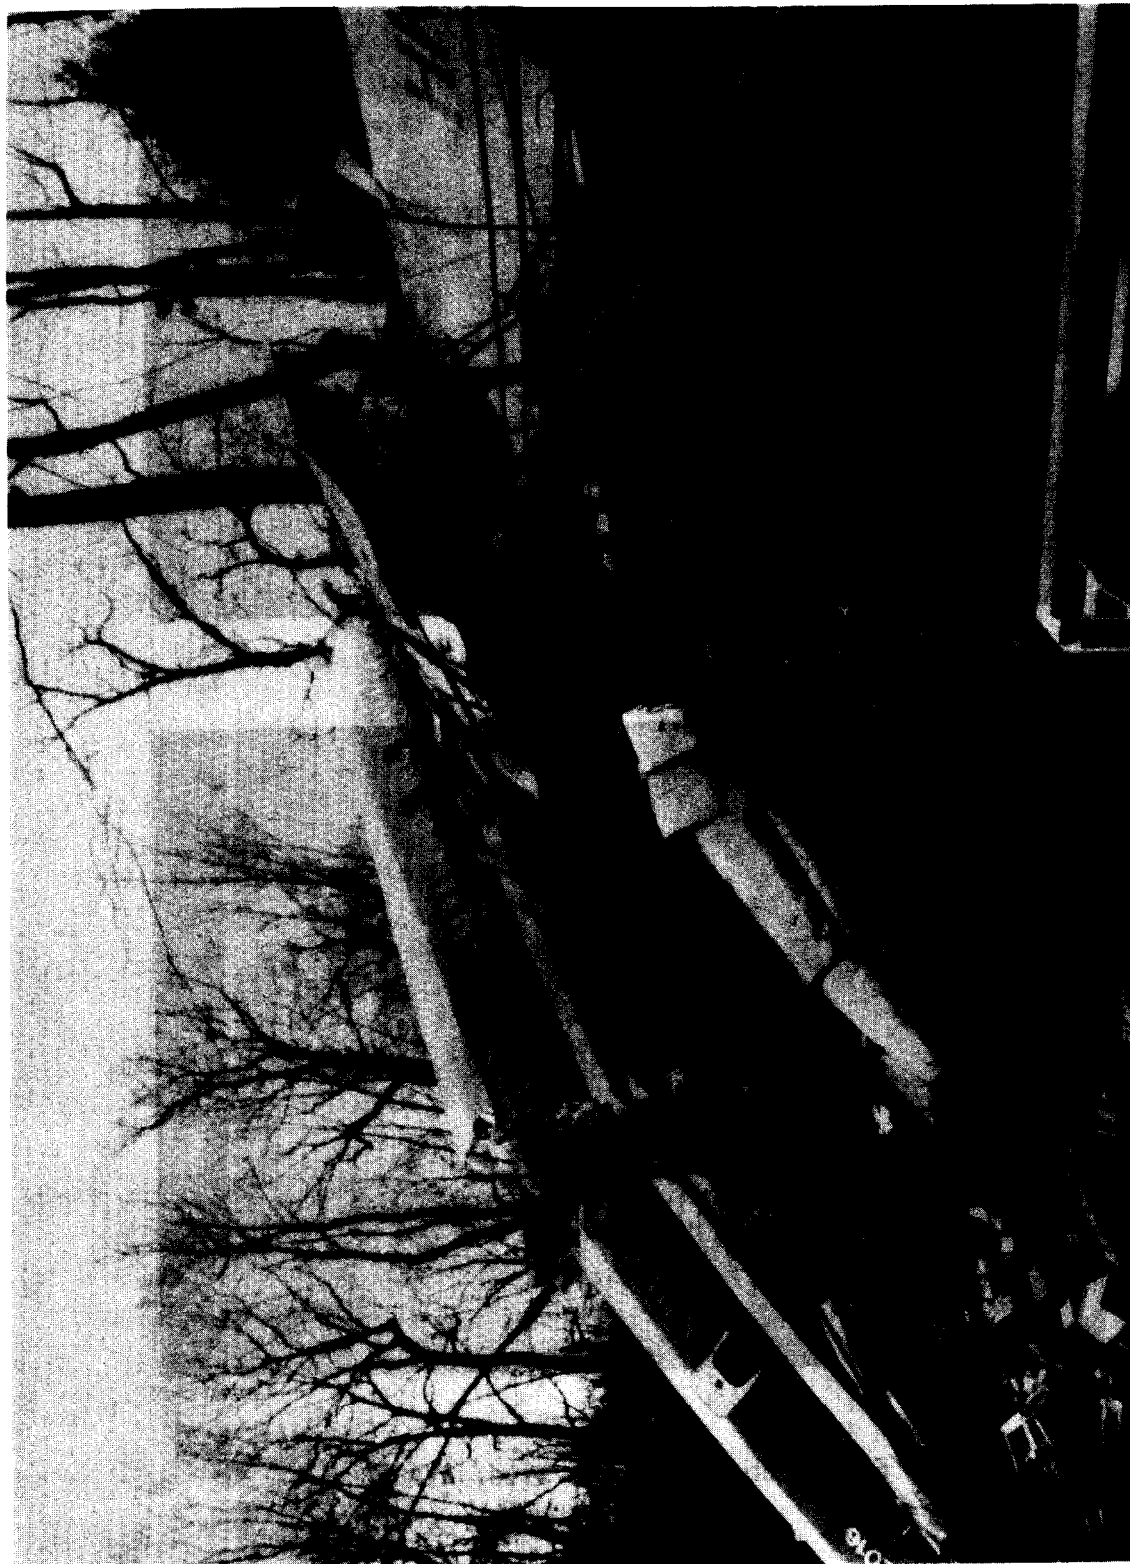
Figure 6.--Wreckage site, AVA052.

The fuselage was found partially separated into three sections. The cockpit and forward cabin had broken away from the rest of the fuselage at the time of terrain impact and had continued to move over the crest of the slope, coming to rest about 90 feet forward of the main wreckage. This section was significantly damaged, with seats and other cabin components lying on the ground, extending back to the main wreckage.
