# NATIONAL TRANSPORTATION SAFETY BOARD

## AIRCRAFT ACCIDENT REPORT

SKY TRAIN AIR, INC.  
GATES LEARJET 24, N44CJ  
FELT, OKLAHOMA  
OCTOBER 1, 1981

NTSB-AAR-82-4

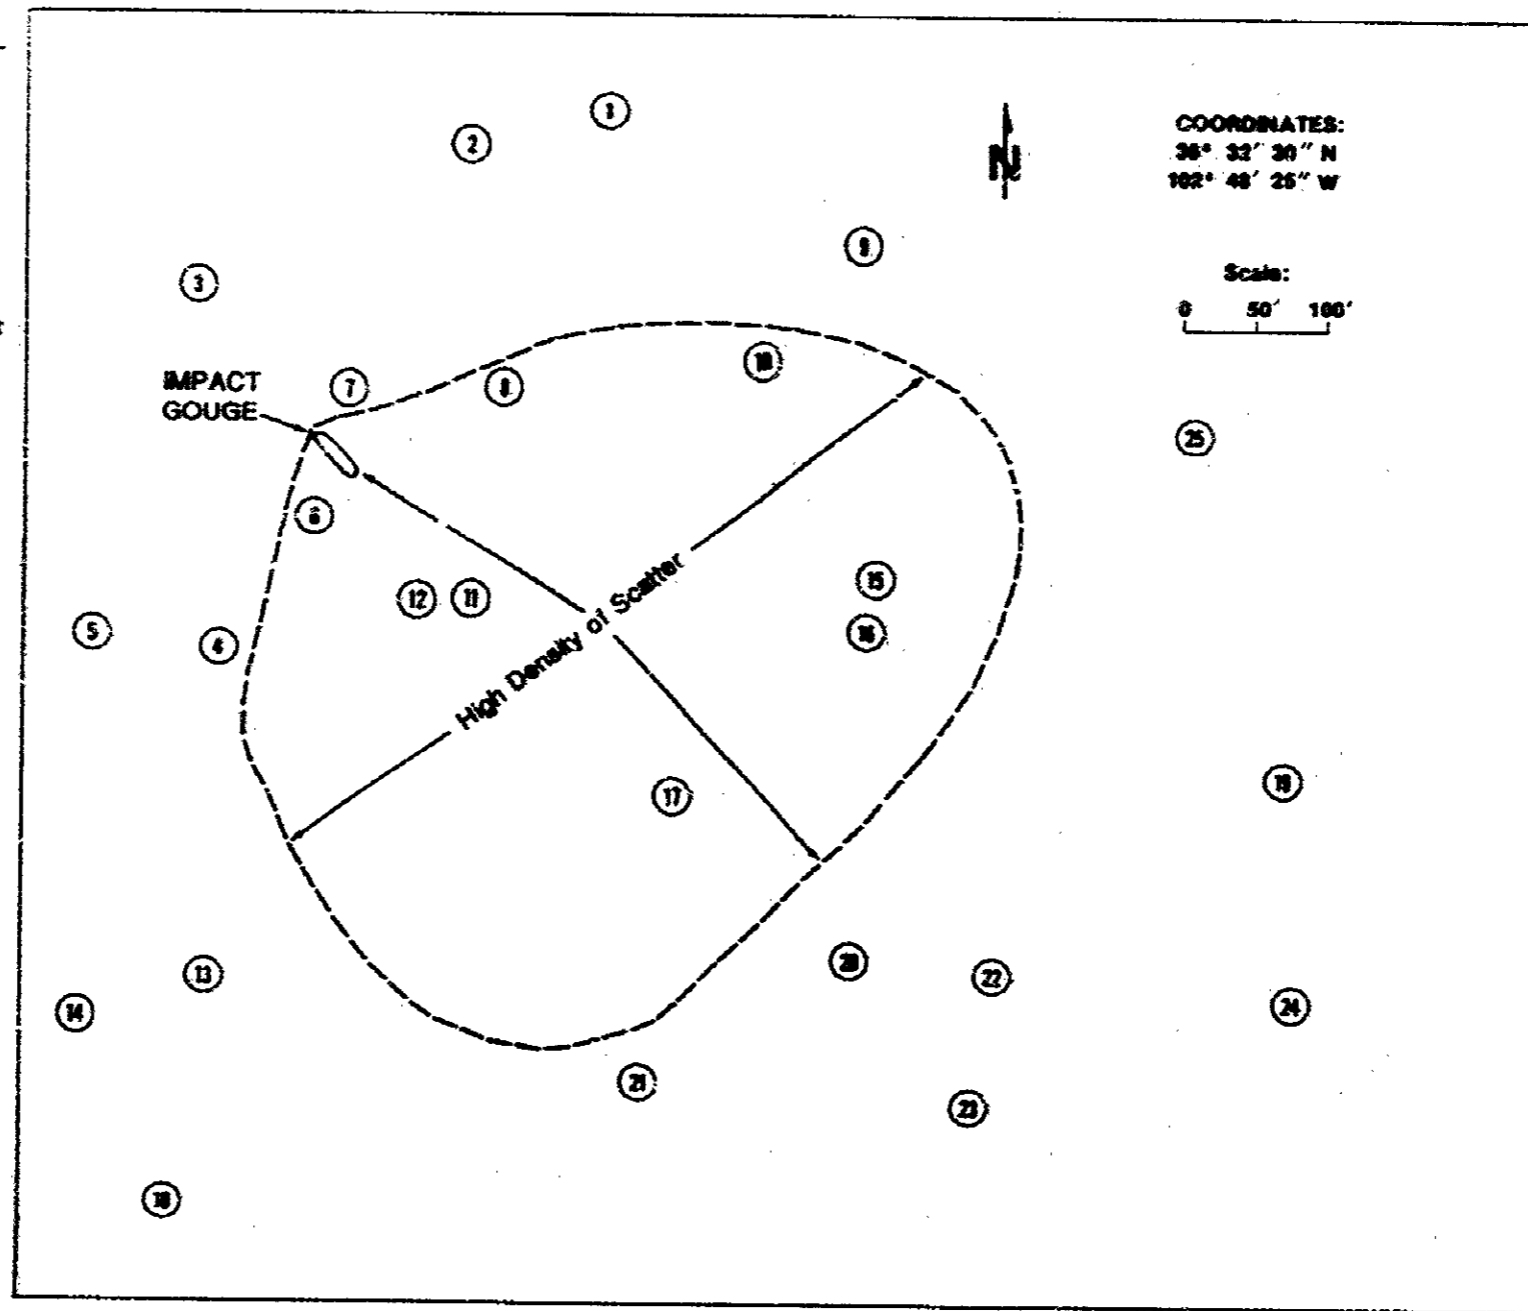
**APPENDIX 7**  
**WRECKAGE DISTRIBUTION CHART**

1. Piece of Cabin Window Frame
2. Seat Cushion
3. Piece of Wing Skin
4. Piece of Nose Tire
5. Access Panel
6. Piece of Left Aileron
7. Horizontal Stab. Pivot Casting
8. Piece of Elevator
9. Piece of Cabin Floor with Seat Belt
10. Piece of Horizontal Stab.
11. Drag Chute
12. Piece of Tip Tank
13. Piece of Fuselage Skin
14. Piece of Wing Skin
15. Piece of Right Elevator
16. Piece of Horizontal Stab.
17. Rudder
18. Cockpit Blower Motor
19. Right Engine
20. Nose Gear Trunnion
21. Main Gear Trunnion
22. Piece of Right Aileron
23. Left Engine
24. Gyro
25. Piece of Crew Seat Frame
