Report

Accident on **9 August 2007**
off **the coast of Moorea (French Polynesia)**
to the **DHC6-300**
registered **F-OIQI**
operated by **Air Moorea**

BEA

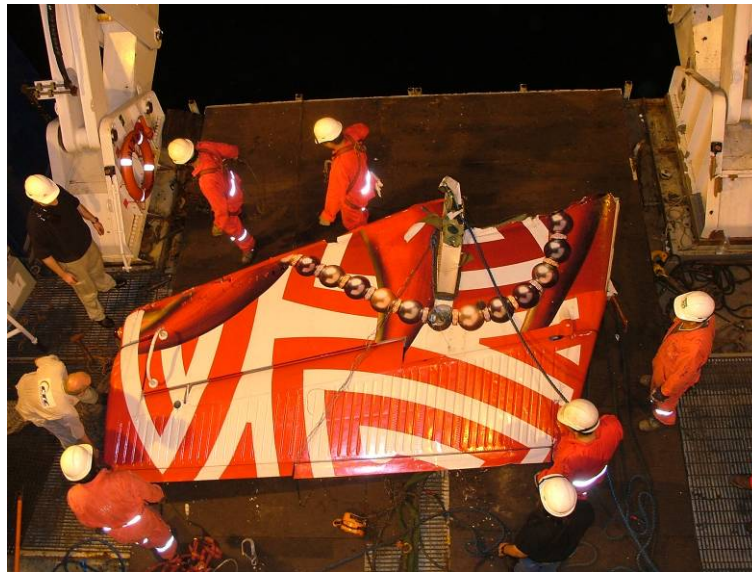
Fin after raising

The two rudder cables and the two elevator control cables were broken: three were about the same length but the fourth, the pitch-up cable, was about 2.5 metres long. On visual examination, one of the failures of this last cable had a different appearance from the others. It was thus decided to examine these parts as a priority.

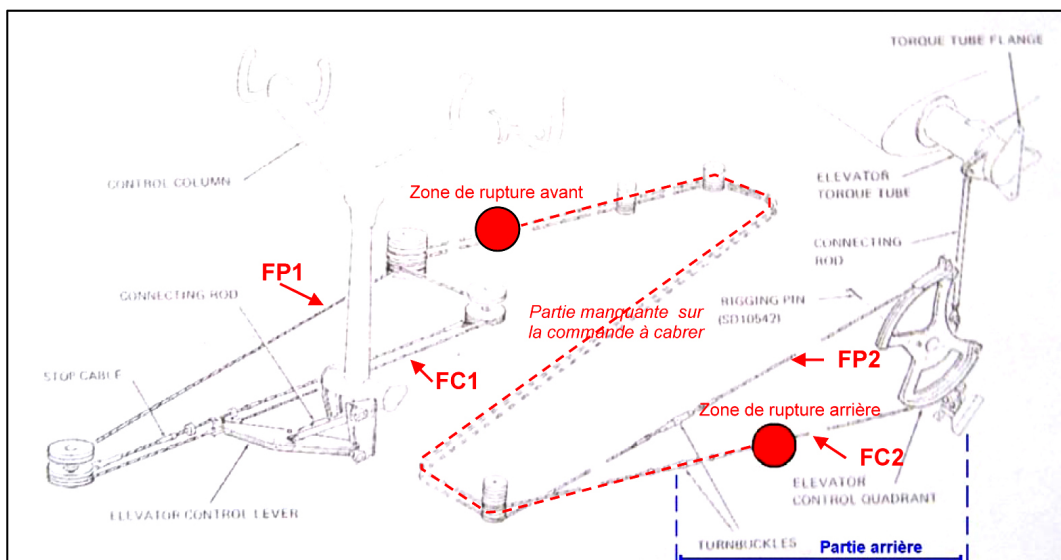
The two elevator control cables and the two rudder control cables broke off in a zone situated in the forward part of the aeroplane. The pitch-up control cable showed a second failure in the aft part of the aeroplane, with a different appearance to the other failures, and an 8.8-metre long piece of this cable was missing. All of the pitch-down elevator cable was recovered.

- FP1 : Fragment of pitch-up cable attached to control column, length 1.55 metres
- FP2 : Fragment of pitch-up cable attached to elevator, length 11.25 metres
- FC1 : Fragment of pitch-down cable attached to control column, length 0.75 metres
- FC2 : Fragment of pitch-down cable attached to elevator, length 2.60 metres
- Total length of pitch-up cable = 12.80 metres
- Total length of pitch-down cable = 12.15 metres

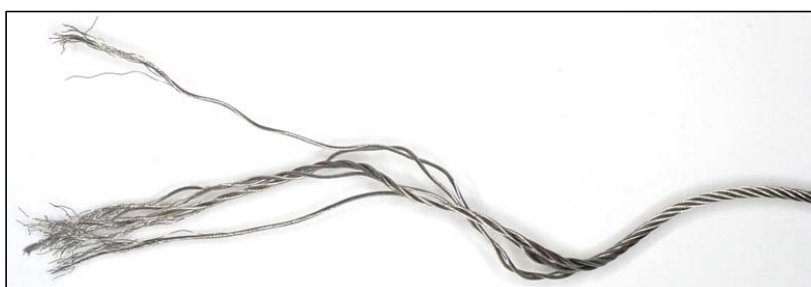
Typical failure of a cable broken off in the forward zone (scale 1:2)

All the failures that occurred in the forward zone were identical, the strands had separated (untwisting) over several centimetres. They were typical of overload failures. No deposit, traces of corrosion or signs of wear were observed in line with the failed areas.

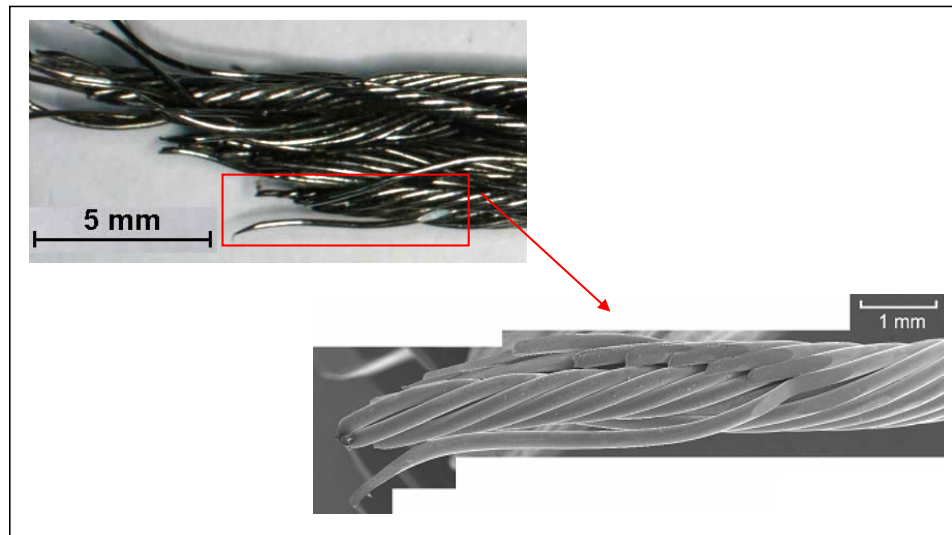
Profile of wear on the outer wires in the failure area

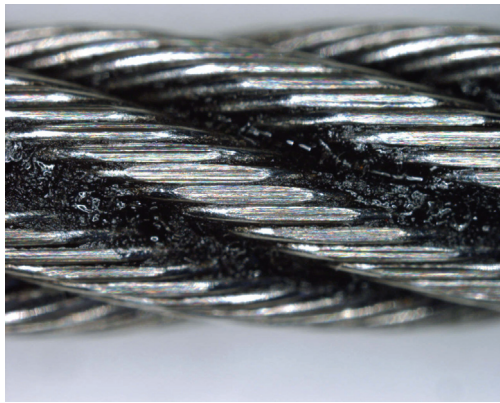
A range of wear appeared on the stainless steel cable whereas no wear was detectable on the carbon steel cable. These tests confirmed what had been noticed in operation (see 1.18.1). They did not, however, allow a possible cable wear law to be established, if only because calculating the rate of wear by counting wires implied cutting the cable. Because of this, and even if it seemed likely, it was not possible to say if the rhythm of wear accelerated at the same time.

Binocular view of the wear area
on a stainless steel cable
after 150,000 cycles

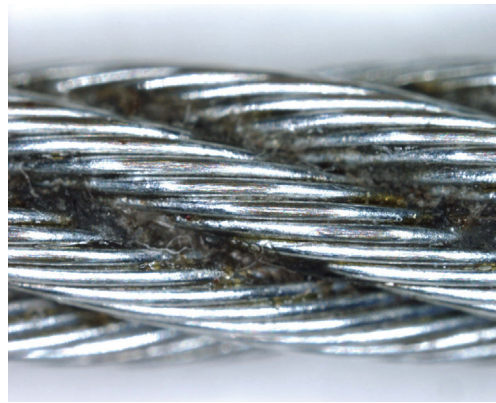
Binocular view of the wear area
on a carbon steel cable
after 150,000 cycles

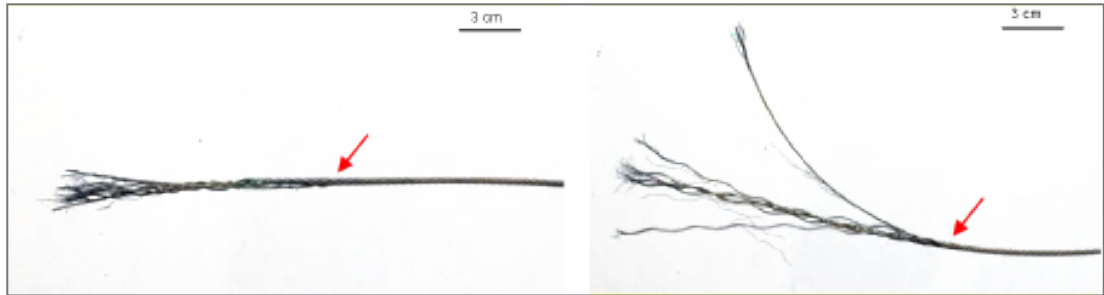
Failure occurred after 58,000 cycles, on the worn spot, with a strong untwisting as far as the fixation zone marked below by red arrows.

Appearance of the failed cable ends after fatigue test

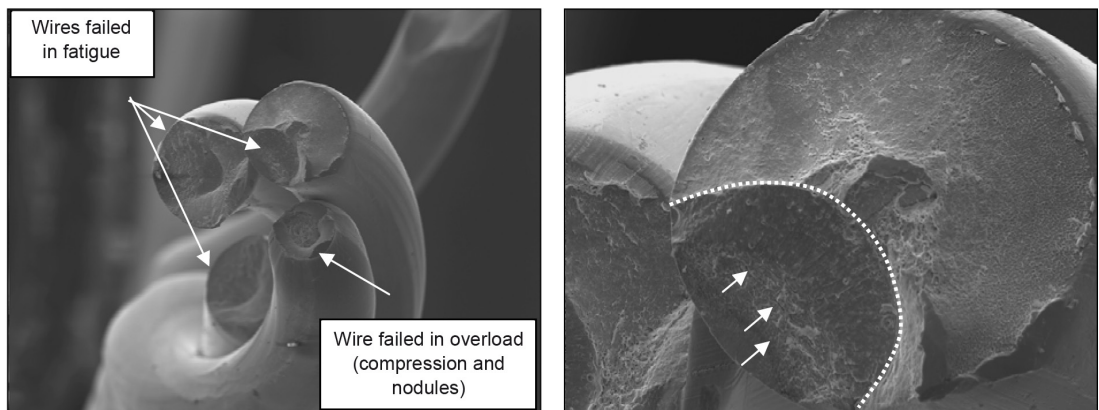
Several of the outer and central strand wires showed signs of fatigue (see photo below), unlike the F-OIQI's pitch-up cable wires.

Fatigue failures of wires

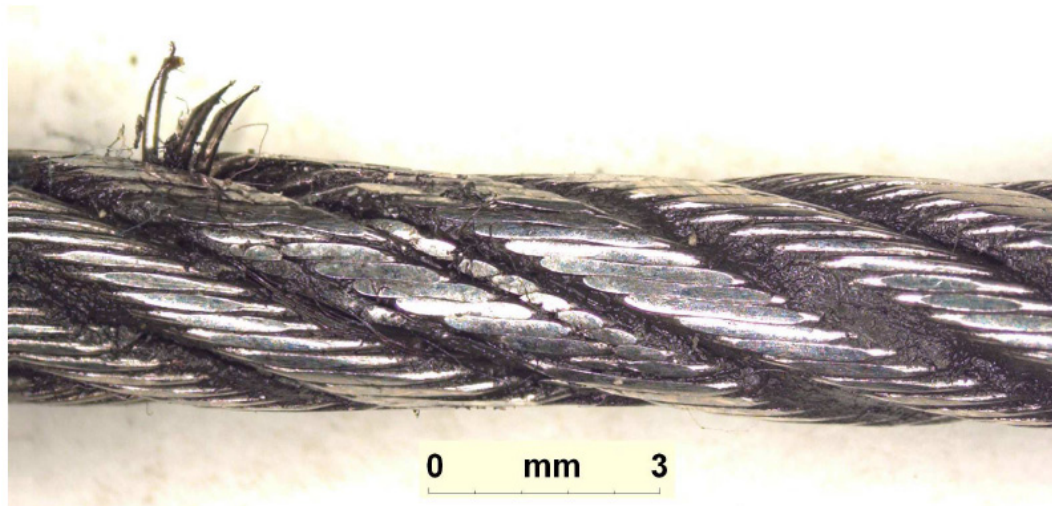
The wear noted on the lower and upper cables was located exactly the same distance from the stops and had the same appearance.

Cliché 6 : Zone d'usure E sur le câble inférieur
