1. Report No. NTSB/AAR-88/10		2. Government Accession No. PB88-910412		3. Recipient's Catalog No.	
4. Title and Subtitle <i>Aircraft Accident Report--A VAir Inc. Flight 3378, Fairchild Metro III, SA227 AC, N622AV, Cary, North Carolina, February 19, 1988</i>				5. Report Date December 13, 1988

14. Sponsoring Agency Code	
15. Supplementary Notes					
16. Abstract On February 19, 1988, an AVAir Inc. Fairchild Metro III, N622AV, operating as Air Virginia (AVAir) flight 3378, crashed in Cary, North Carolina, shortly after it departed runway 23R at Raleigh Durham International Airport (RDU), Morrisville, North Carolina, with 2 flightcrew members and 10 passengers on board. The airplane struck water within 100 feet of the shoreline of a reservoir, about 5,100 feet west of the midpoint of runway 23R. The airplane was destroyed and all 12 persons on board were killed. The National Transportation Safety Board determines that the probable cause of this accident was the failure of the flightcrew to maintain a proper flightpath because of the first officer's inappropriate instrument scan, the captain's inadequate monitoring of the flight, and the flightcrew's response to a perceived fault in t

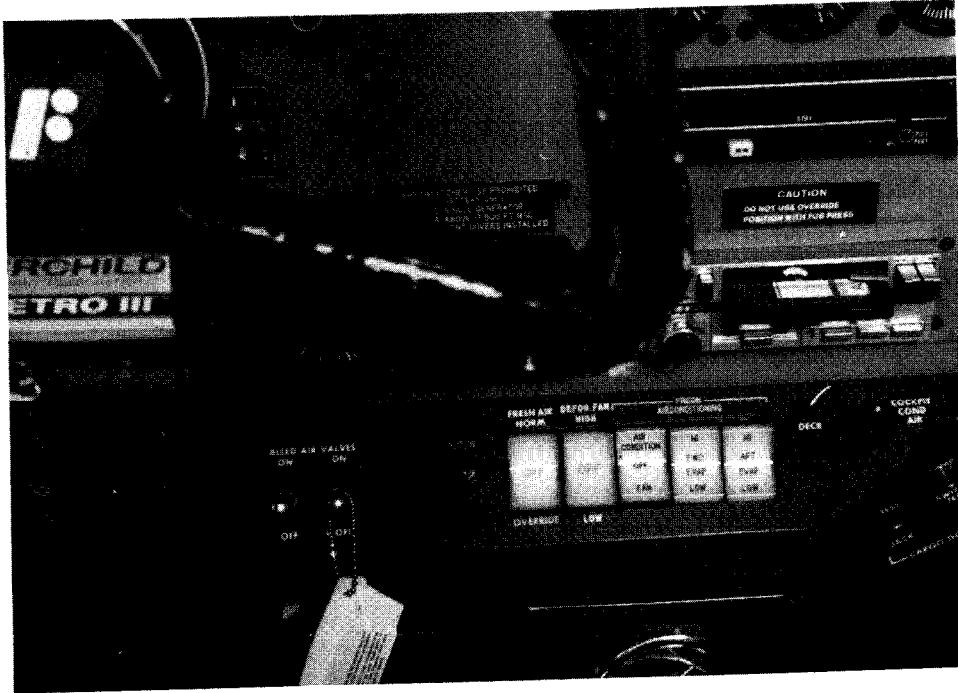
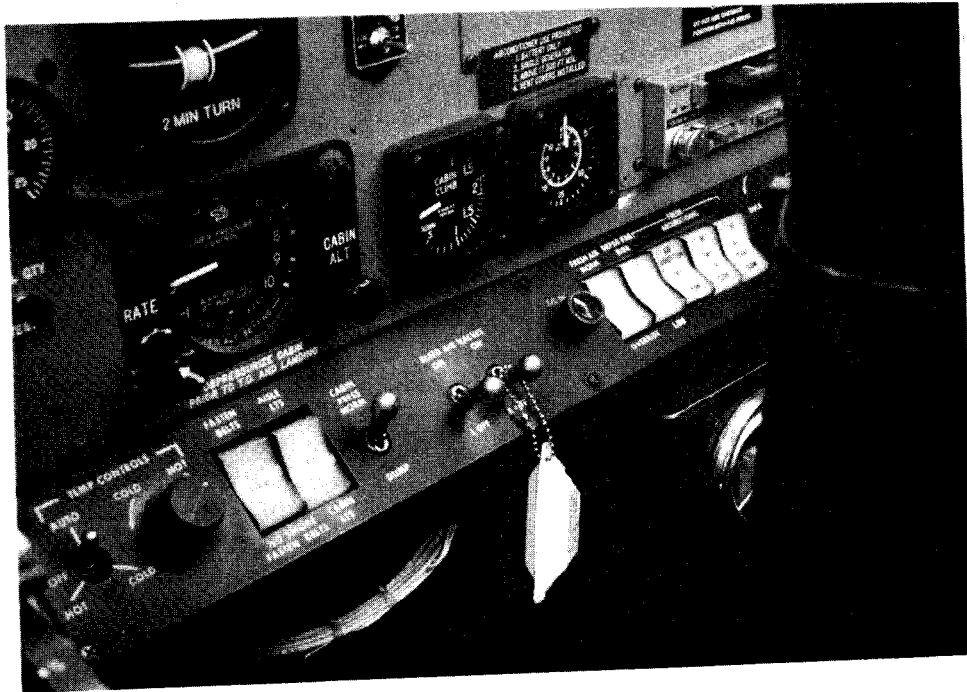
Figure 1.--Bleed air switches as viewed from the captain's control column

(View from right side)

(View from left side)

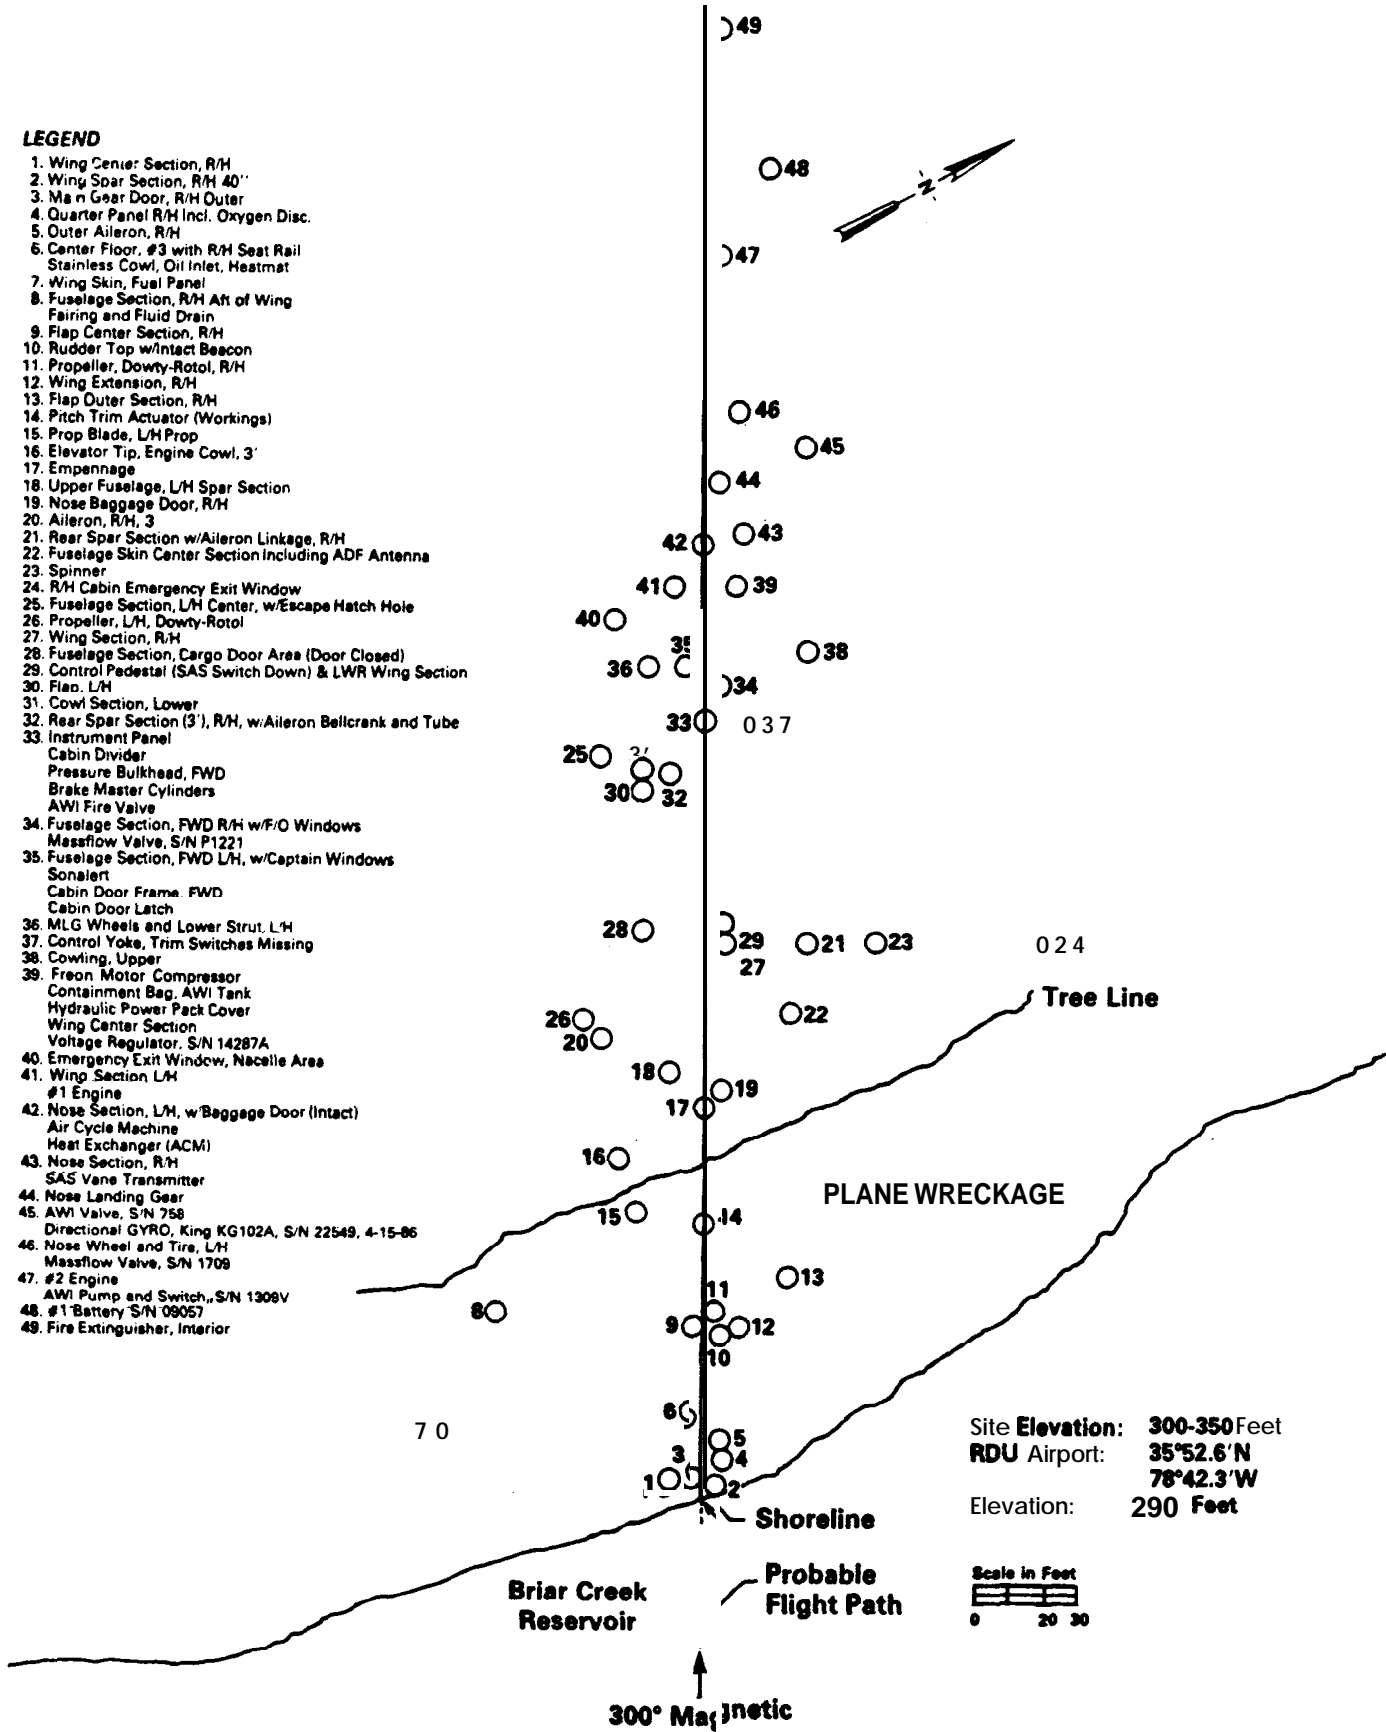
The airplane was extensively damaged and fragmented from its initial impact with the water and its more than 100-foot path through a wooded area beyond the shore of the reservoir. The wreckage path extended about 425 feet from the shoreline on a magnetic heading of about 300". (See figure 3.)

The fuselage from the nose to the empennage was extensively fragmented. The tail cone, which had separated with the aft pressure bulkhead, was found intact and with minimal damage. The vertical stabilizer and horizontal stabilizers were attached to the empennage.

The left wing was extensively damaged along its entire span. Spanwise compression for most of the length of the leading edge extended 5 feet from the root to 6 feet from the tip, where there was downward bending about 10" with extensive leading edge compression. Compression buckling was found along the lower surface of the flap, and tension on the upper surface, both spanwise. The damage to the flaps indicates that the flaps were at the 1/4, or 9" position. Evidence of postcrash fire was observed on the No. 1 engine and nacelle and the areas alongside the nacelle. The No. 1 engine had separated from the firewall about 6 feet forward of the wing facing aft.

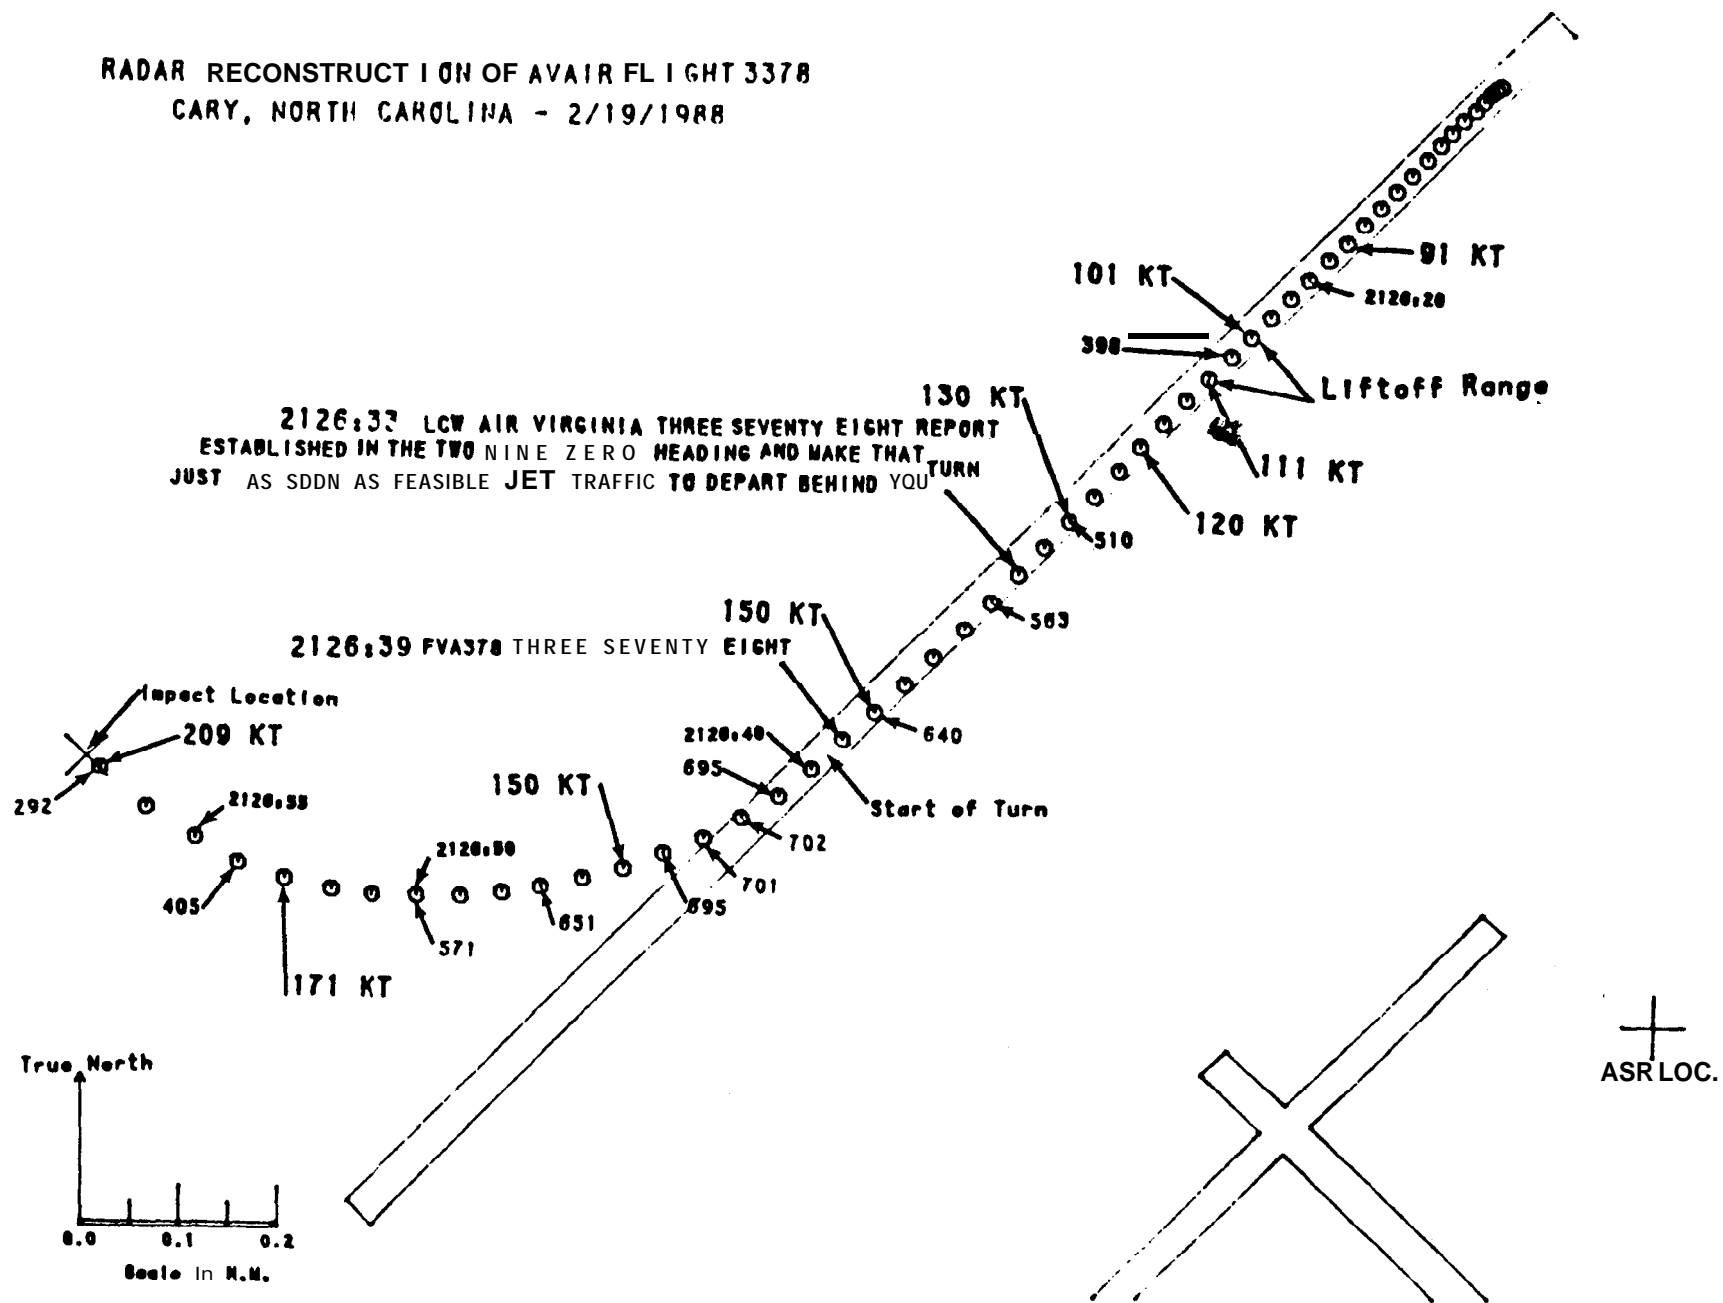
Figure 4.--Overhead view of flight of AVAIR 3378
Data not identified refers to mean sea level altitude, in feet.

The Safety Board applied data from the Metro III Type Inspection Report concerning the pitch trim at various airspeeds, power settings, CG conditions, and flap positions to the obtained pitch setting on AVAir 3378. Given a mid-range CG, the pitch trim position found on AVAir 3378 corresponded to an approximate 157-knot airspeed.
