AIRCRAFT ACCIDENT REPORT

MARKAIR, INC.
BOEING 737-2X6C, N670MA
CONTROLLED FLIGHT INTO TERRAIN
UNALAKLEET, ALASKA
JUNE 2, 1990

NTSB Report No.: NTSB/AAR-9 1/02
NTIS No.: PB91-910402
Report Date: January 23, 1991
Notation No.: 535BA

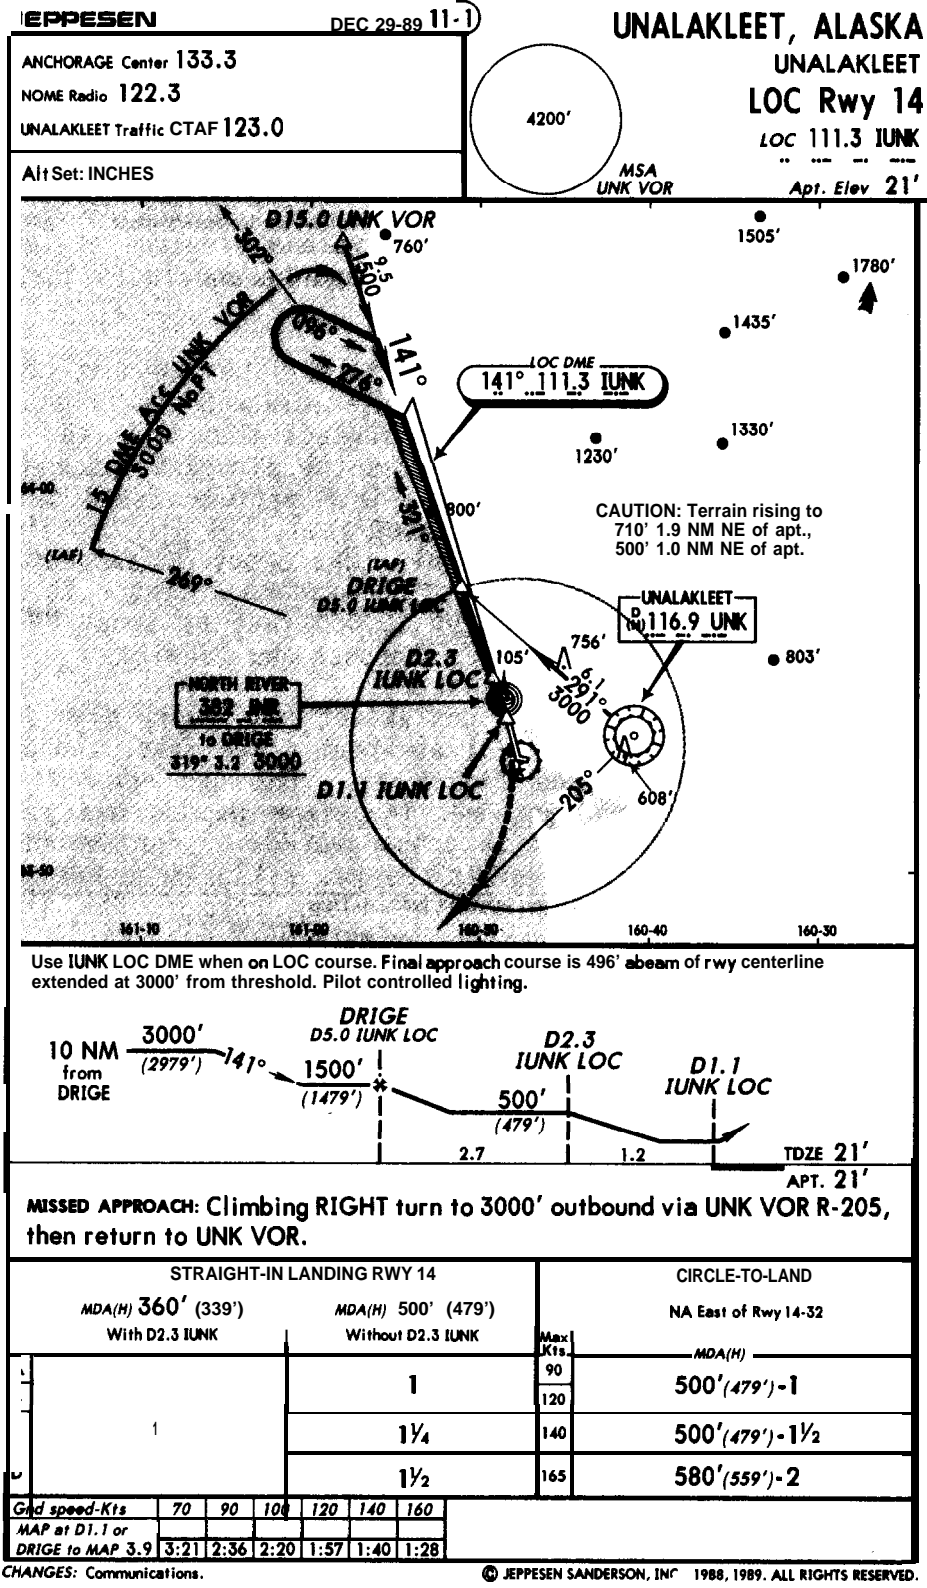
Figure 1. --UNK LOC Rwy 14 Instrument Approach.

These conditions were above minimums for the localizer runway 14 (LOC Rwy 14) instrument approach to be flown by the captain. (See figure 1).

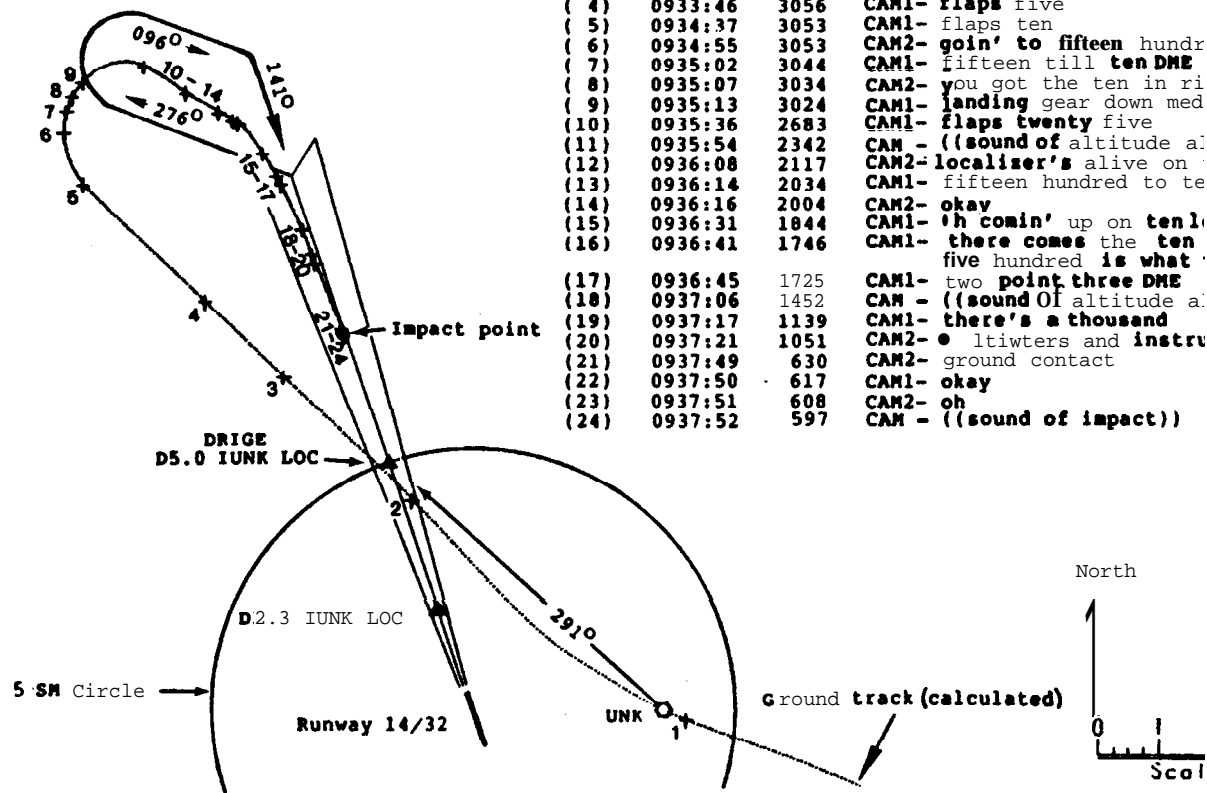
Figure 2. --UNK LOC Rwy 14 planview overlaid with MarkAir flight calculated ground track, selected altitudes, and CVR commen

At 0936:41, the captain stated, "There comes the 10 to 1,500--500 feet is what we're headed for [lapse of 3 seconds] 2.3 DME." A conversation then ensued about turning the bleed switches off (to aid in avoiding gravel foreign object damage to the engines upon landing) and turning the engine anti-ice system off. This conversation began as the airplane was descending through about 1,700 feet.

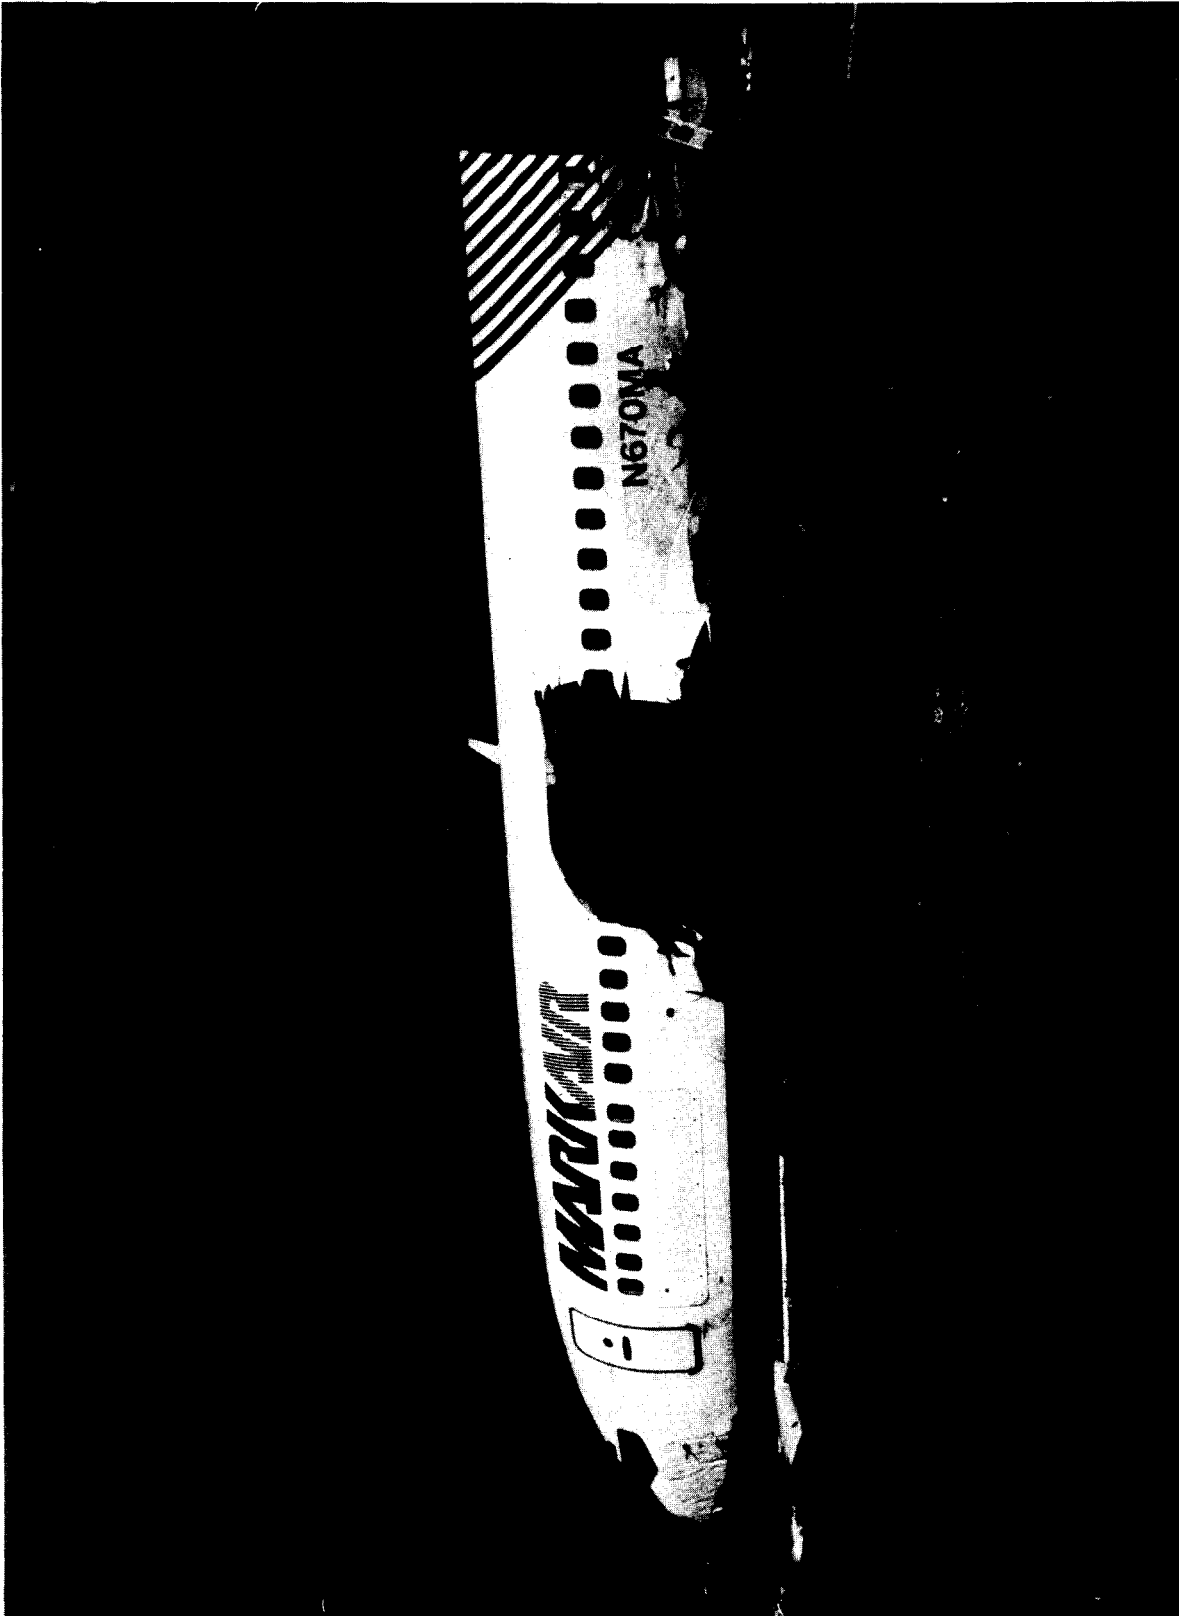
Figure 4.--Flight 3087 fuselage.

Most of the fuselage below the floor level from the nose of the airplane to the wing center section was destroyed during impact and the slide up the hill. The fuselage had rotated clockwise about 165° before coming to rest on the hill. The nose wheel well/nose landing gear assembly was dislodged from the fuselage and was found about 20 feet away from the nose of the airplane. The right forward side of the fuselage was cracked and partially separated behind the cockpit, but this separation was only about half the circumference of the fuselage.

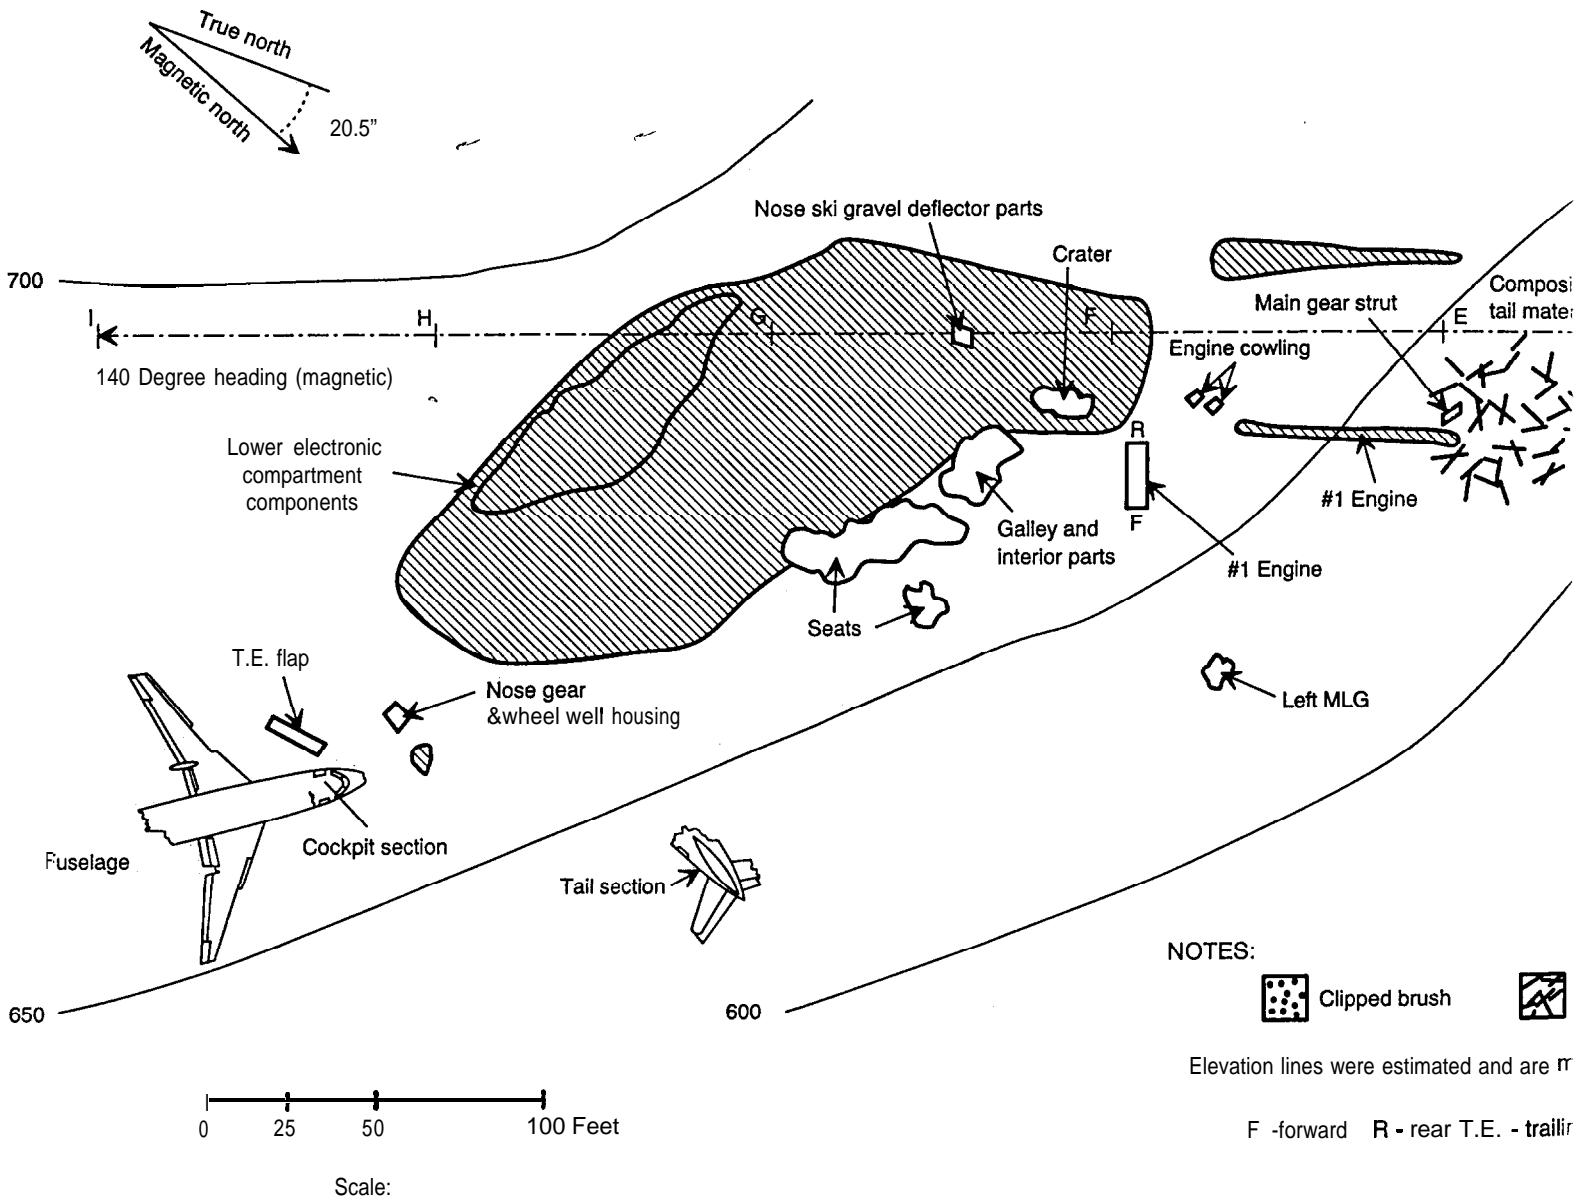
Figure 5.-- Wreckage Dis

The airplane impacted the ground on a small level area about 530 feet up the northeast slope of Blueberry Hill. The top of Blueberry Hill is about 700 feet. The first indications of impending terrain contact were broken branches on several alder bushes located about 30 feet prior to the first impact mark on the ground. The aircraft began breaking apart upon ground contact and the wreckage scatter pattern extended about 800 feet up the hill on an average magnetic heading of 140° degrees. The width of the wreckage debris field was about 125 feet. The landscape along the wreckage path was typical tundra, small bushes of various kinds, grass, scattered rocks and shale.

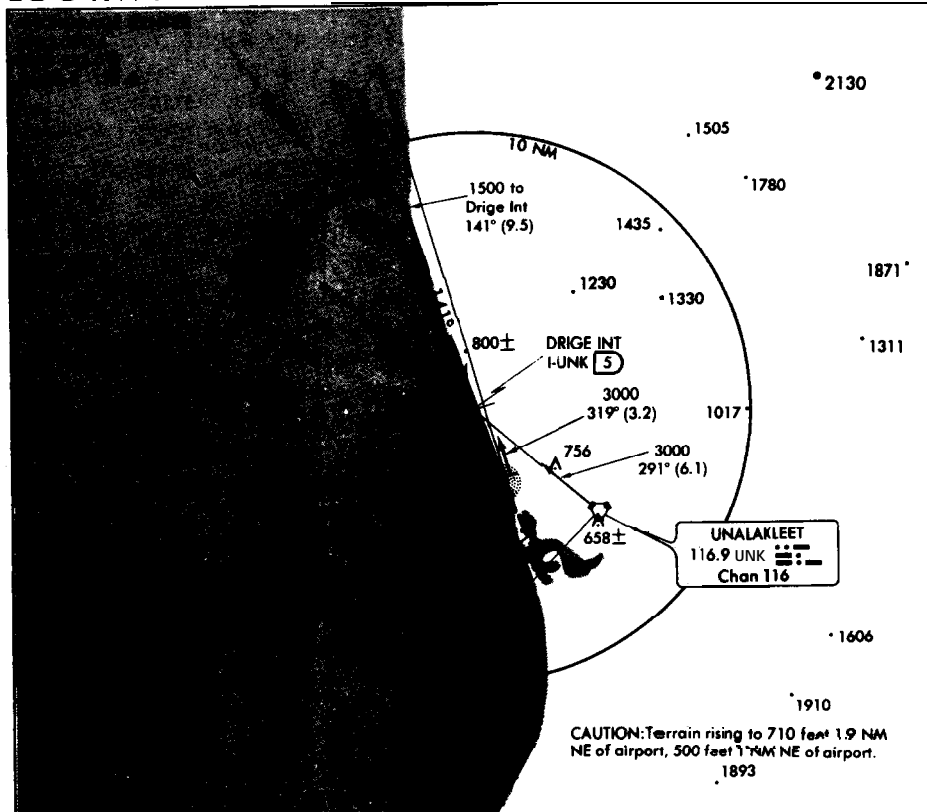
Also, on Jeppesen approach plates, "airport reference circles" with radii of 5 statute miles (SM) are shown around the airport to depict airport traffic areas (if applicable) and otherwise to draw the plate reader's attention to the airfield location. The diameter of the circles are noted in the "Approach Chart Legend" section of the introduction to the Jeppesen Airway Manual but not on the actual plates. On NOS low-altitude approach plates, these circles are called "distance rings" and have varying radii, most of which are 10 NM. They indicate that everything within the ring is to cartographic scale. The words "10 NM" appear near the ring circumferences of the plates with 10 NM distance rings. Rings of other radii have the radii annotated in a similar manner. This 10 NM ring and other distance rings on NOS plates may be offset from the airfield. (See figure 6).
