Turkish Airlines DC-10 TC-JAV
Report on the accident in the
Ermenonville Forest, France
on 3 March 1974

**ACCIDENT TO
TURKISH AIRLINES DC-10 TC-JAV
IN THE ERMENONVILLE FOREST
ON 3 MARCH 1974**

FINAL REPORT

February 1976

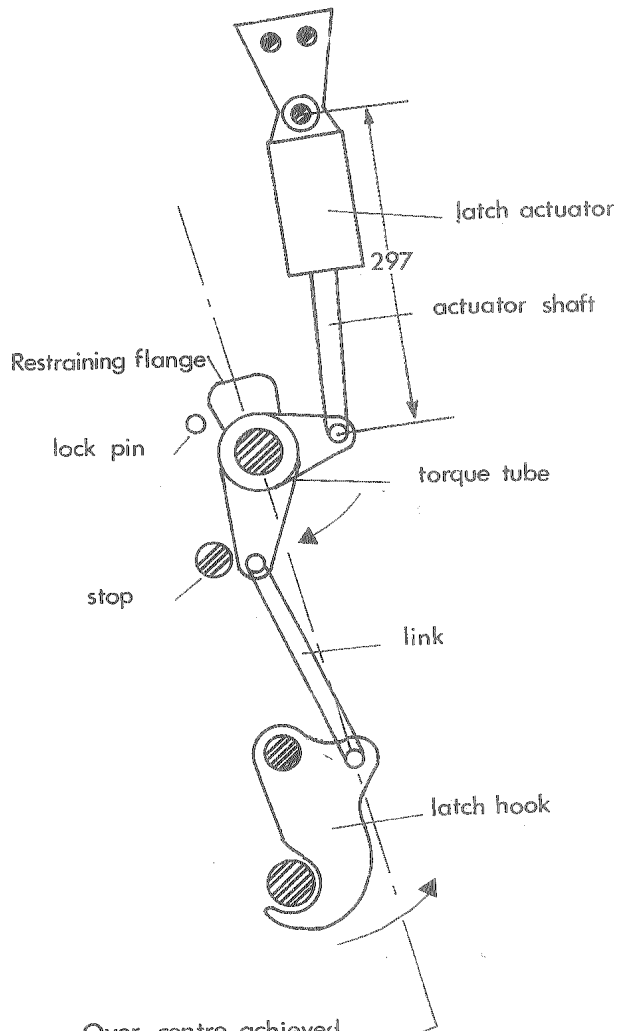
Fig. 1

Over-centre achieved
System irreversible
Correct closure

Under these conditions, the chain of operation between actuator and latches is not irreversible: any force exerted on the latches is re-transmitted to the actuator instead of being absorbed by the 4 stops provided for that purpose (fig 1).

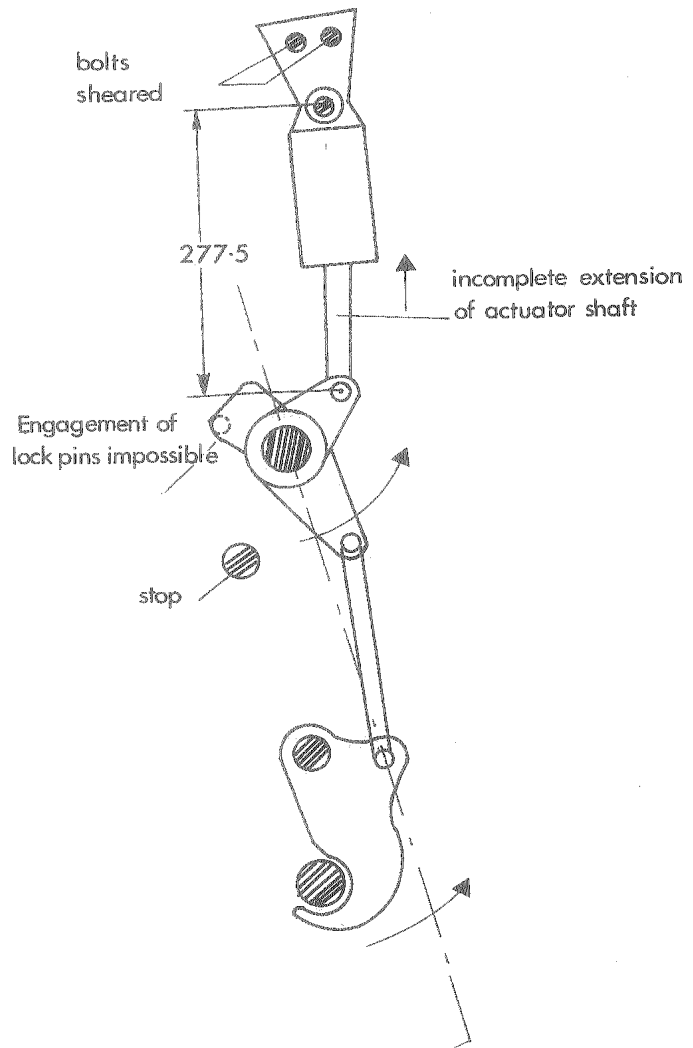
Fig 2

Over-centre not achieved
System reversible
Incorrect closure

Expert examination of the wreckage of the door, of which the closing system (latches, latch actuator and operating mechanism) was found in good condition, has revealed various deficiencies. The latter were such that the aircraft's take-off was undertaken with the latches very near to their correct position when closed, but at the same time the links which control the latches had not achieved over-centre (fig 2) and as a natural consequence the lock pins could not have been engaged.

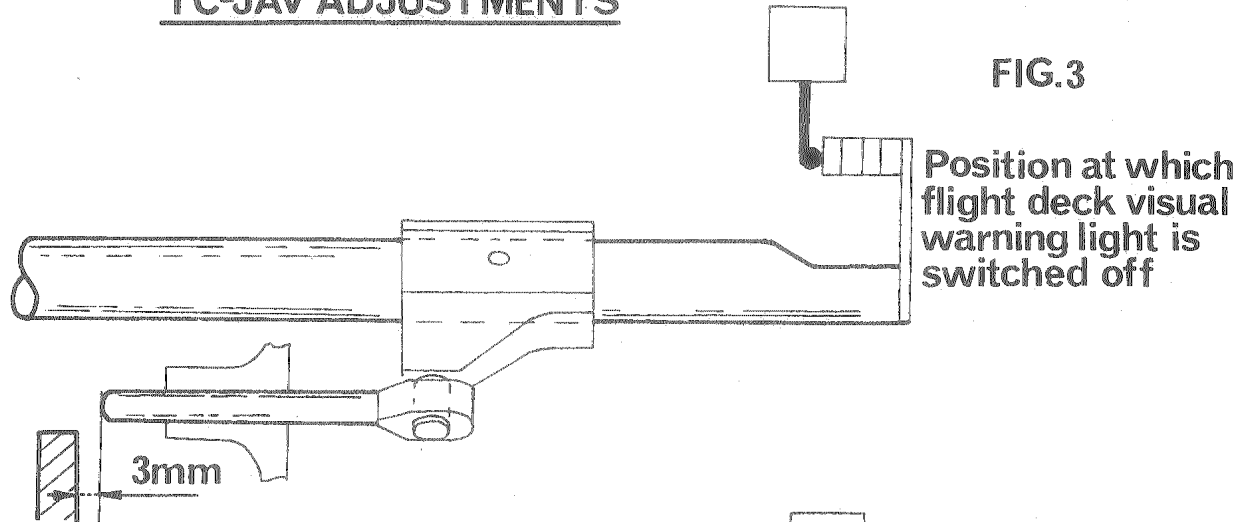
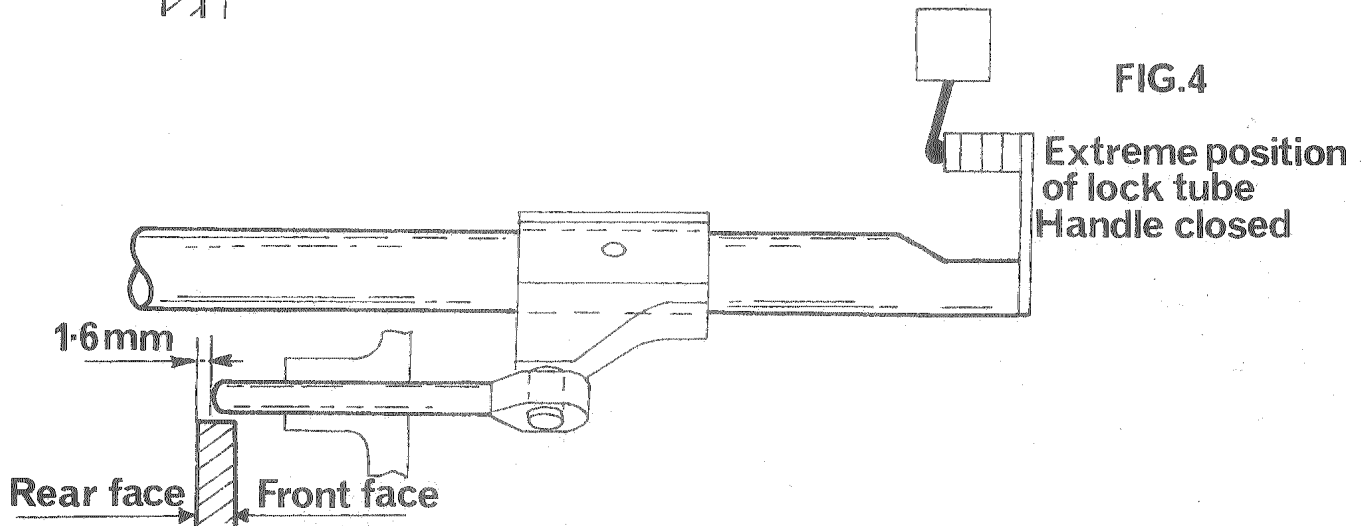
TC-JAV ADJUSTMENTS

- When the lock tube was pushed towards the locked position, the switch switched off the flight deck warning light, although the ends of the lock pins were still 3 millimetres away from the restraining flanges (fig 3). It should be noted, moreover, that according to the Maintenance Manual, the ends of the lock pins in the unlocked position must not be more than 2 mm away from the flanges.

In conclusion, the adjustment of the lock limit warning switch was defective and caused the flight deck warning light to go out when the latches were not necessarily closed.

The thickness of the striker shims made any correct adjustment of the lock pins impossible; any attempt to bring the ends of the lock pins to the correct distance of 6.35 mm beyond the rear face of the flanges inevitably led to damage to the lock limit warning switch. The incorrect adjustment of this switch caused the flight deck warning light to go out when the door was still unlocked.

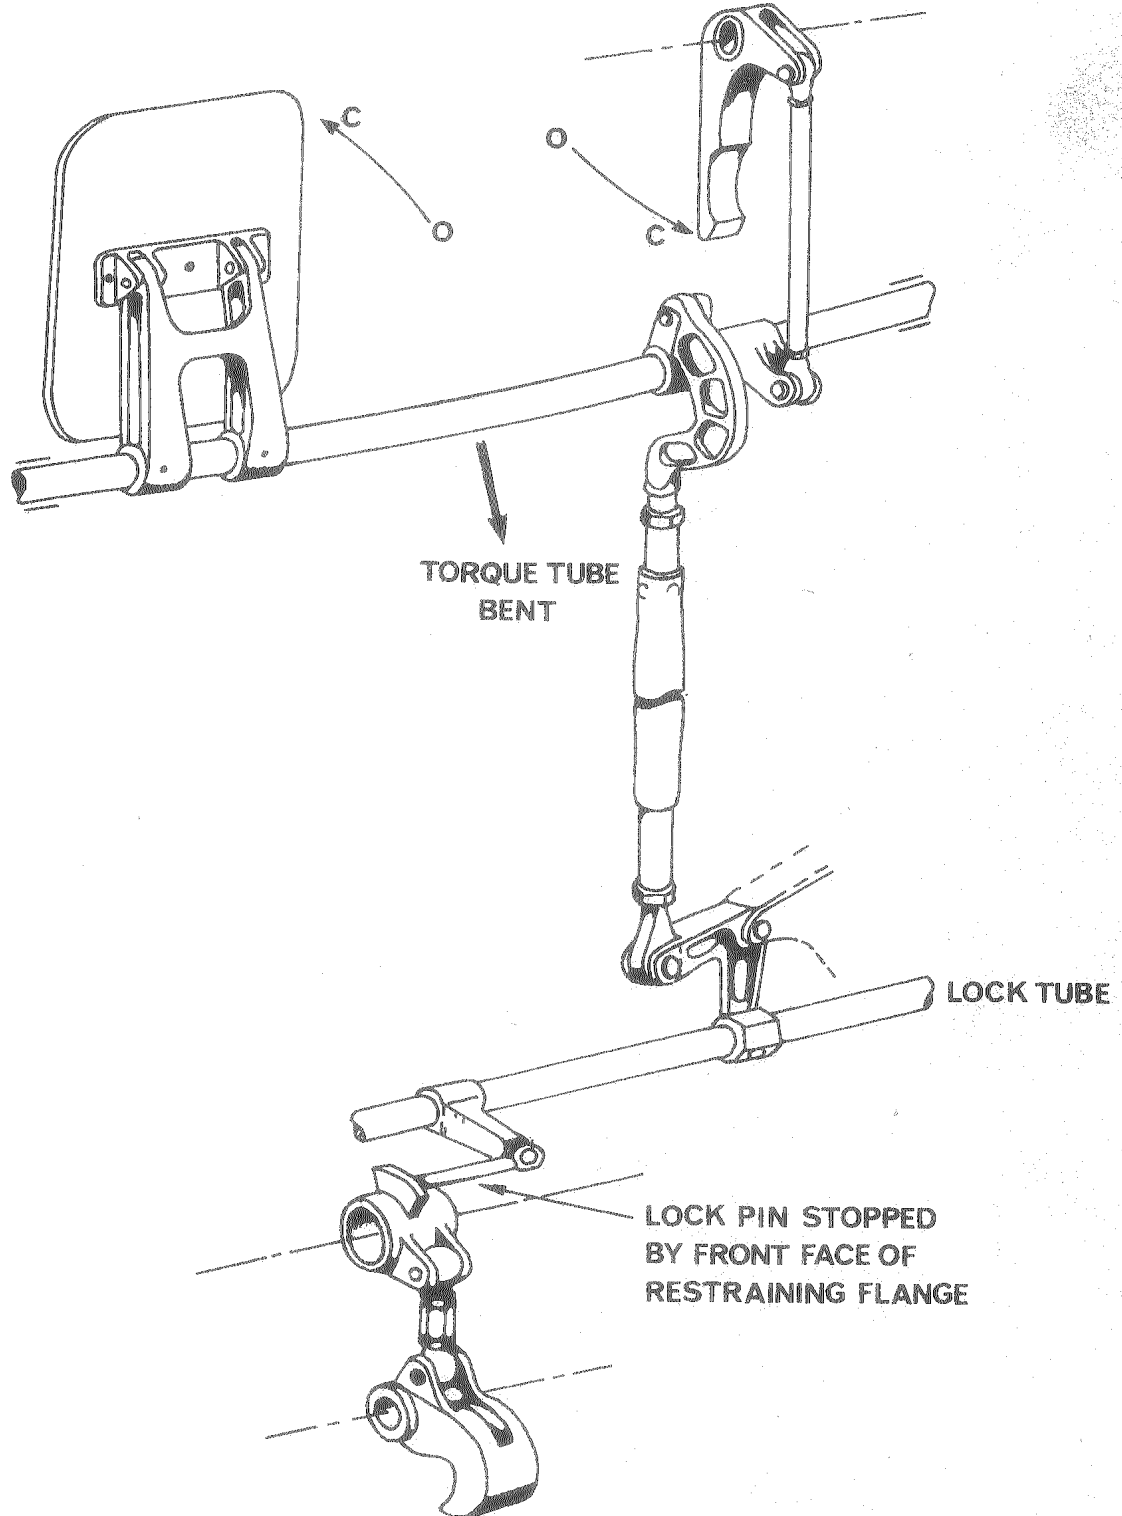
FIG. 6

Because of the defective adjustment of the extreme positions of the lock tube, the handle could be closed without excessive force, although the latches were not completely closed.

FORCED CLOSURE

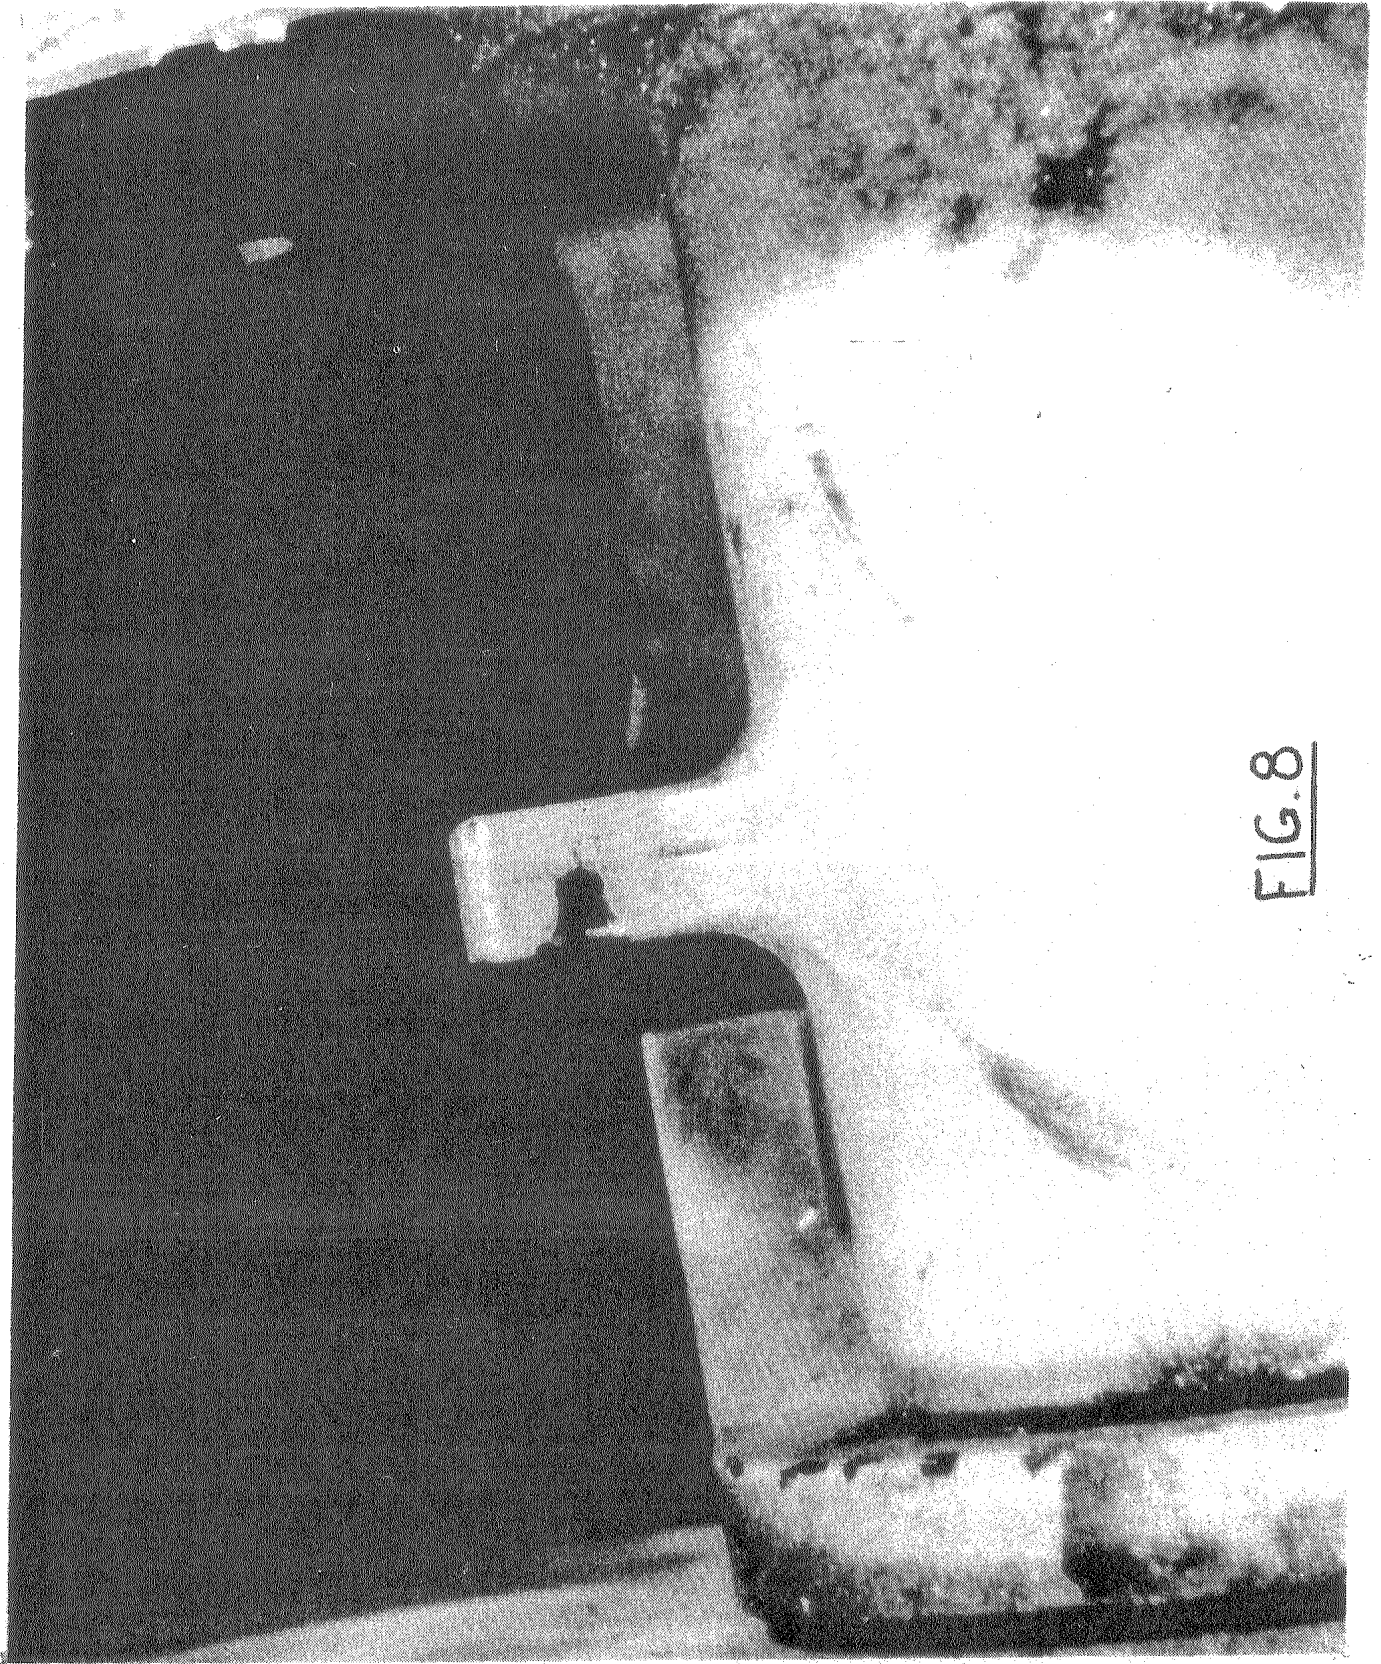
FIG. 8

It should be noted that the edges of the restraining flanges of the 4 latch cranks showed heavy marks (detachment of paint and metal) made by the lock pins (fig 8). These marks were not produced during the last flight, for in that case the latches would have been engaged. They show that in earlier circumstances the operation whereby over-centre is achieved was incomplete, for the pins must pass freely without any friction (figs 1 and 5).

It should be noted that the partial engagement of the lock pins as reproduced on the new door corresponds to the friction marks which they made on the edges of the flanges of the door of TC-JAV, which occurred only on the leading half of the edges (fig 8).
