Rail Accident Investigation Branch

Rail Accident Report

**Passenger door open on a moving train
near Desborough
10 June 2006**

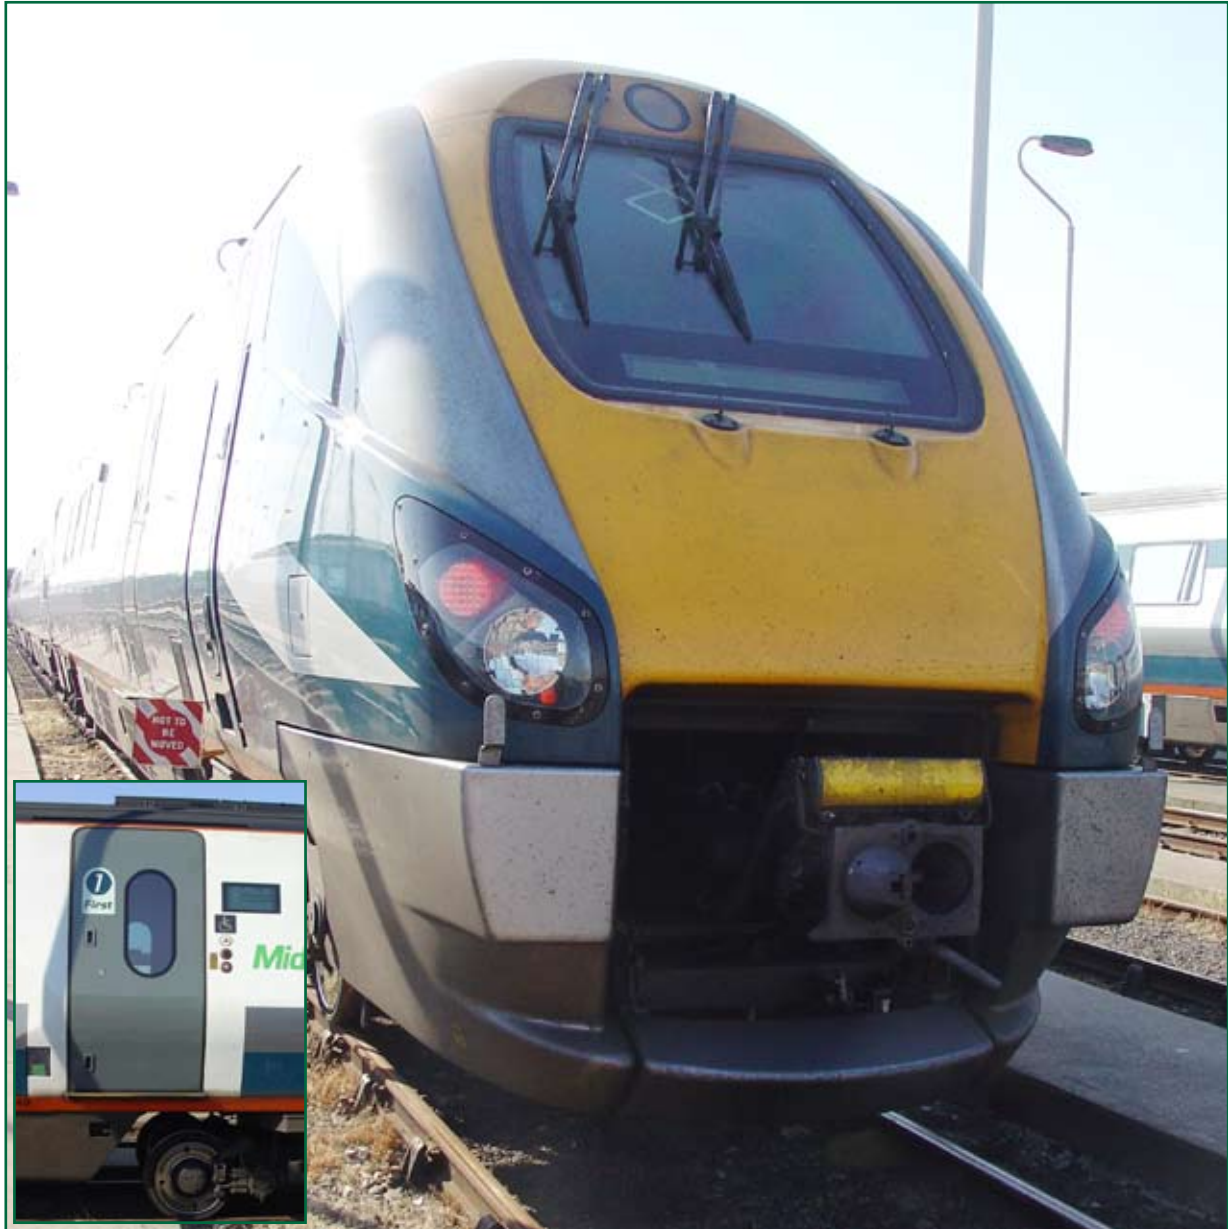
Figure 2: The train and (inset) door involved in the incident

- 17 The door became unlocked and able to open as result of a locking fault which occurred at 10:52 hrs when the train stopped at Luton station (30 miles 19 chains). The door came open at 11:31 hrs, two minutes after departing from Kettering station (72 miles 1 chain) while the train was travelling at 79 mph (127 km/h).
- 18 There was no obvious indication – such as a visual or audible alarm – to the on-board staff of the locking fault at the station stop at Luton or afterwards. To the driver, the indications in the cab, when the door opened north of Kettering, were ambiguous.

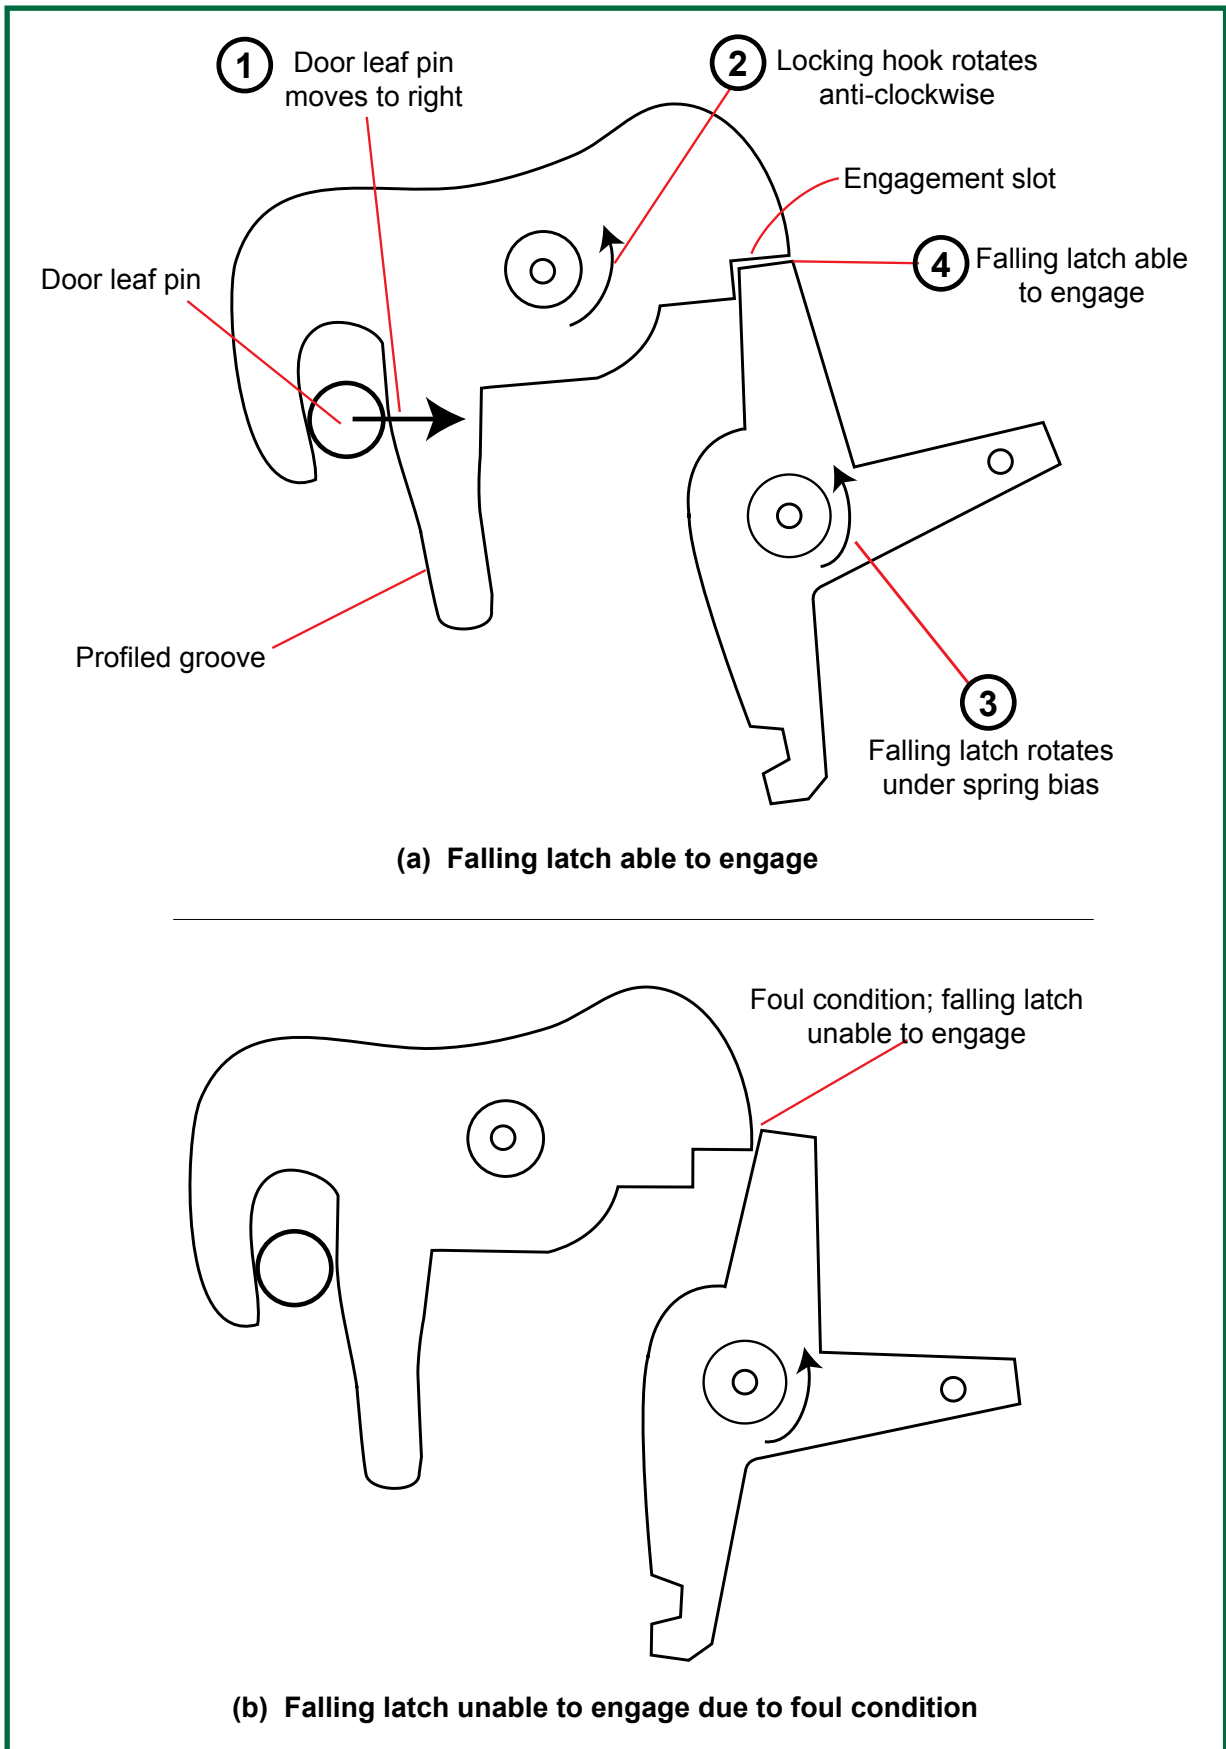
Figure 12: Relationship between the locking hook and the falling latch - annotation in diagram refers to description given in paragraph 163

- 163 Figure 12 shows the relationship between the falling latch and the locking hook. With reference to Figure 12(a), to ensure engagement of the falling latch in the locking hook, the door leaf pin must move in towards the carbody – to the right (1). This rotates the hook anti-clockwise (2), in order that the engagement slot is aligned so that the falling latch, rotating under spring bias (3), can enter (4). If the pin does not move sufficiently far enough, a foul condition results and the falling latch cannot engage, Figure 12(b).

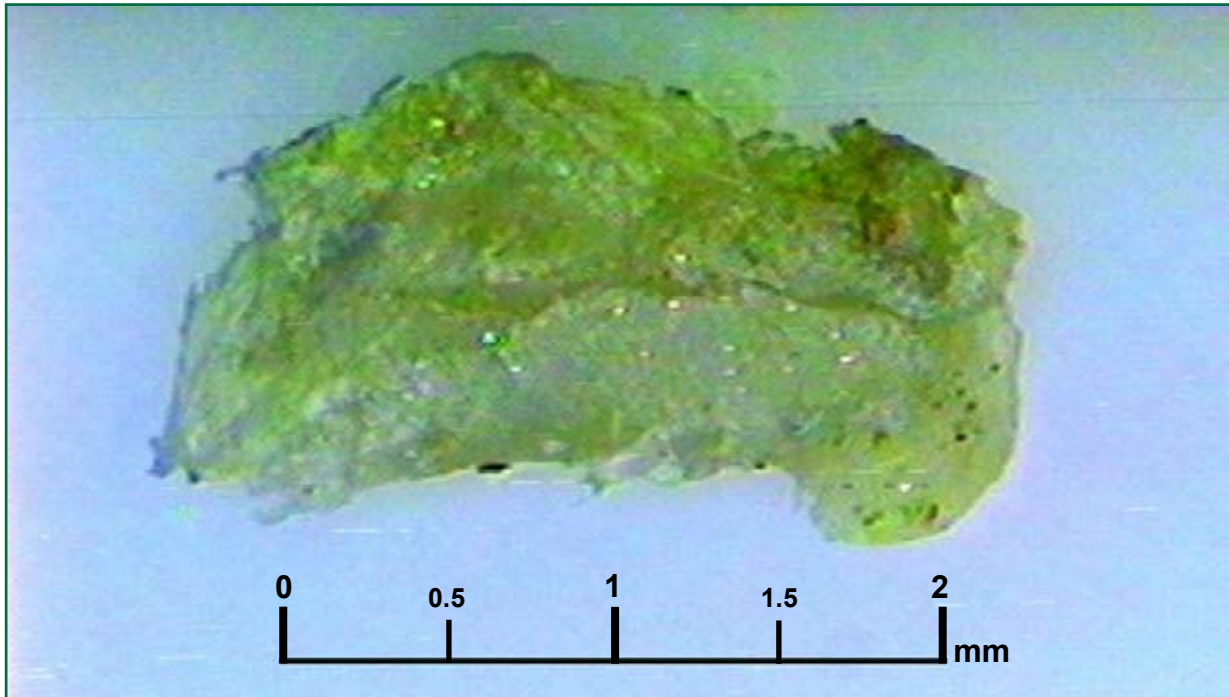
Figure 13: Particle found in the DLS

- 117 The DLS was then removed from the DLA and a small foreign body (particle) was observed to be inside the switch. The DLS was dismantled and the particle removed. Chemical analysis showed the particle and the switch to be of different materials.

- 118 Inspection showed that the particle was too large to have got into the DLS after assembly. Locations were identified within the DLS where the particle, if located, could cause the microswitch to jam.

179 Upon close examination, a small and mobile particle was found in the DLS. After dismantling the switch, the particle was examined chemically and physically. On microscopic examination the particle appeared to be of a plastic material, approximately 2.5 mm long and 1.2 mm wide, Figure 13. Its thickness, at its narrowest dimension, was 0.4 mm.

180 Chemical analysis showed the particle core to be of a different material to that of any of the switch components. However, surface analysis indicated chemical agents which are present elsewhere in the switch, notably the switch plunger.

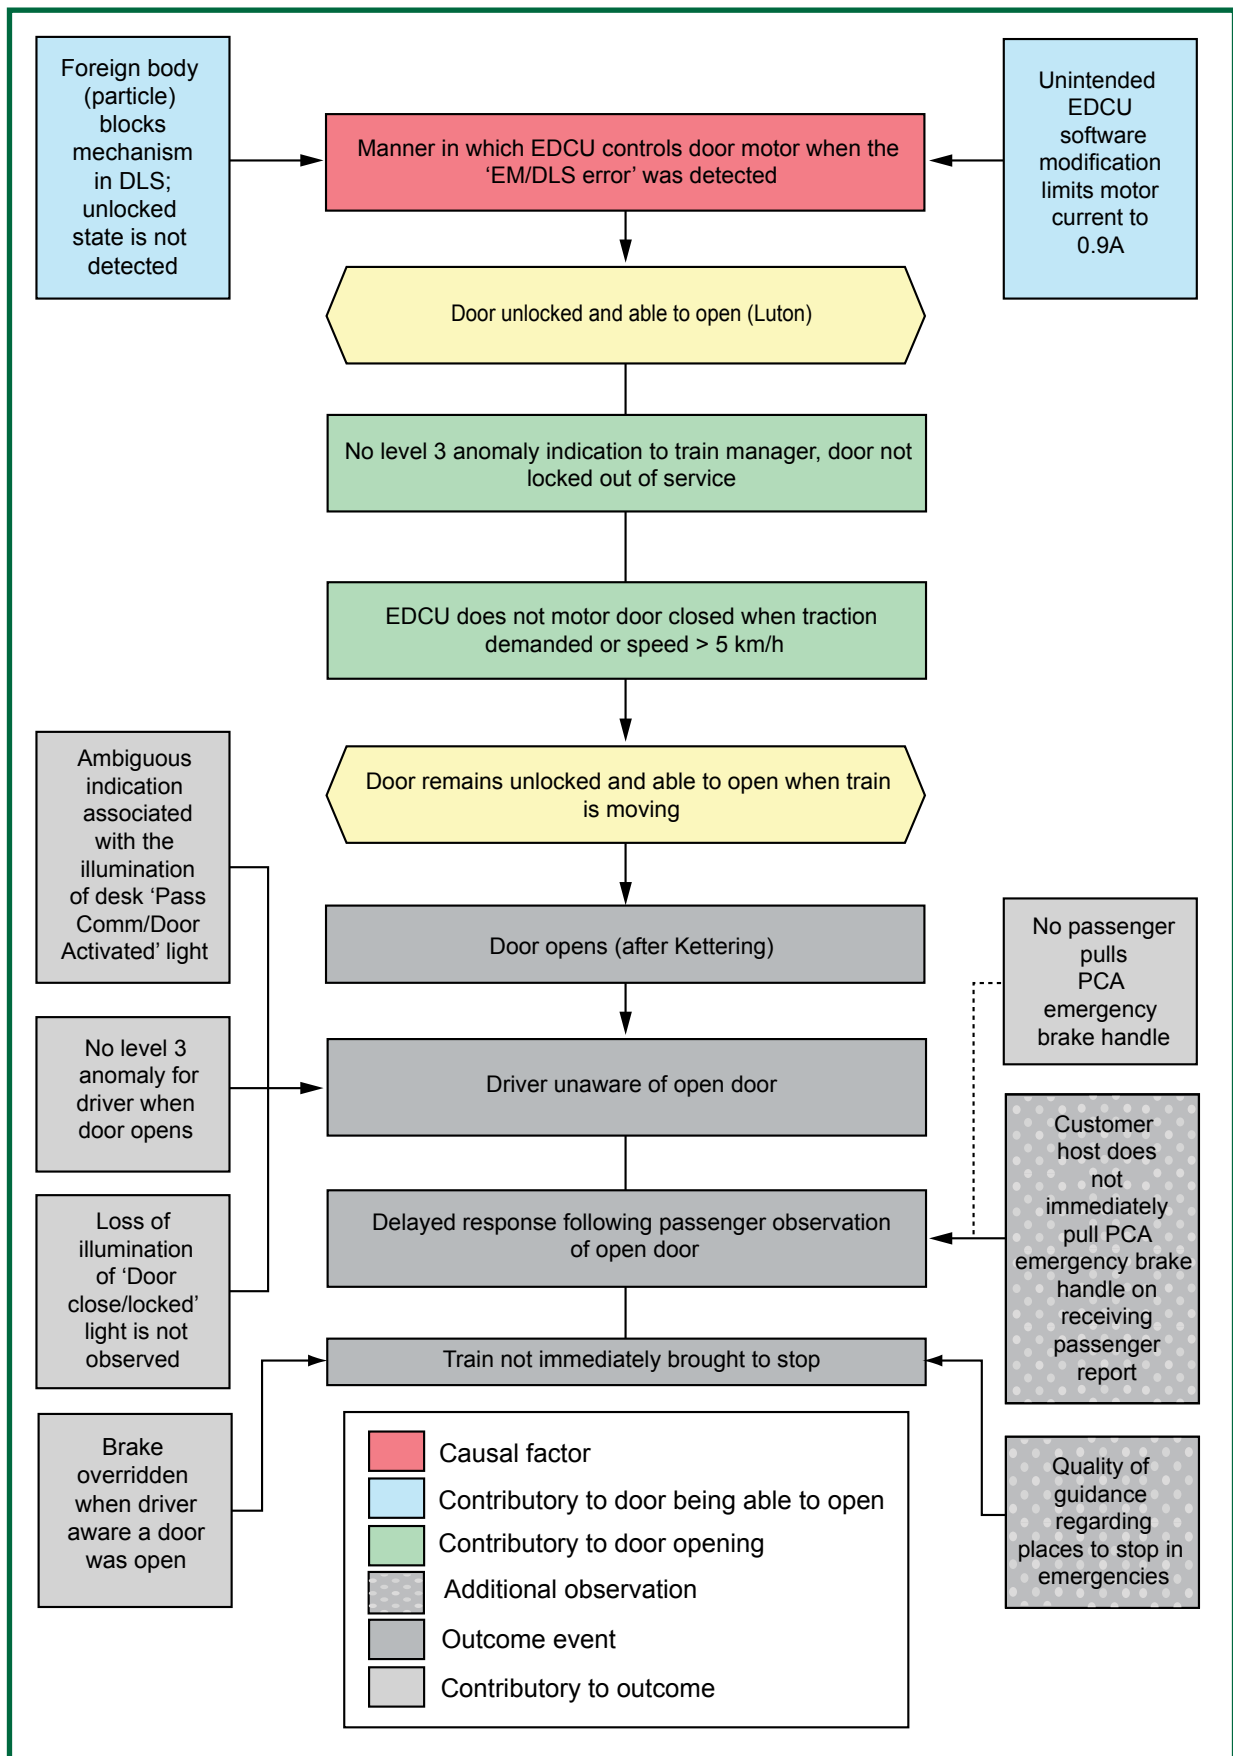
Figure 14: Overview of the identified causal factors

219 Figure 14 is an overview of the most likely identified causal and contributory factors, showing their relationship to the incident and its outcome. It does not show possible causes which have been discounted as part of the investigation (paragraph 159).
