Remedial works for the Iron Bridge

by J. A. WILLIAMS, FICE, FStructE, Sandford Fawcett, Wilton and Bell

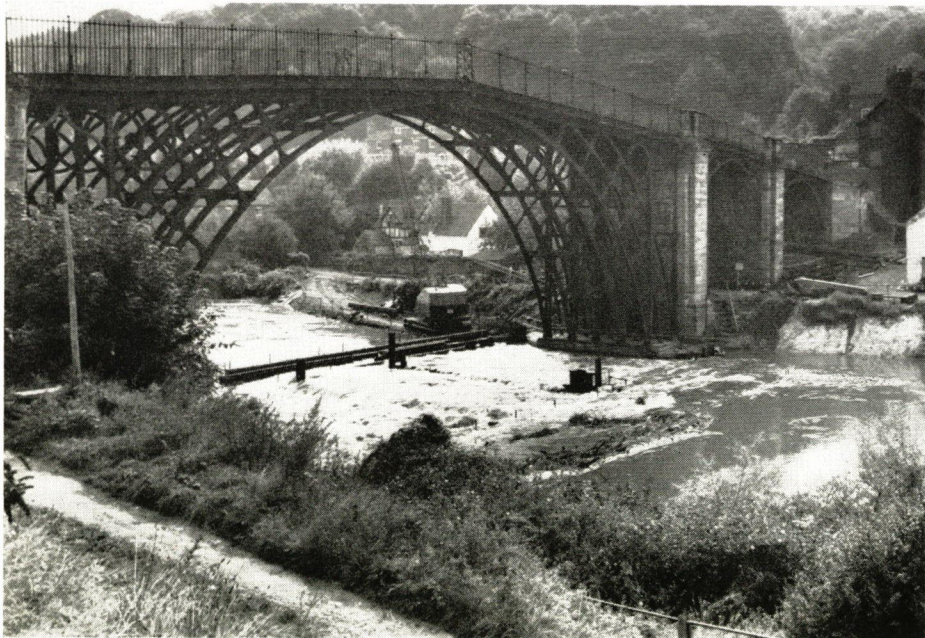
Left—The Iron Bridge remedial works subjected to Severn River flood

During the April-October working season the cofferdams were overtopped on six occasions involving some 25 days delay. During one of these the river rose to "the highest level for a summer flood during living memory"—some 1.5 m (5 ft) above arch springing level. On one or two of these occasions the temporary gantries suffered comparatively minor damage, but by and large, the Temporary Works proved adequate to resist both the flood flows and the inevitable pile-up of debris. The contract provided for such flooding so at least the "paper work" did not give rise to any problems.

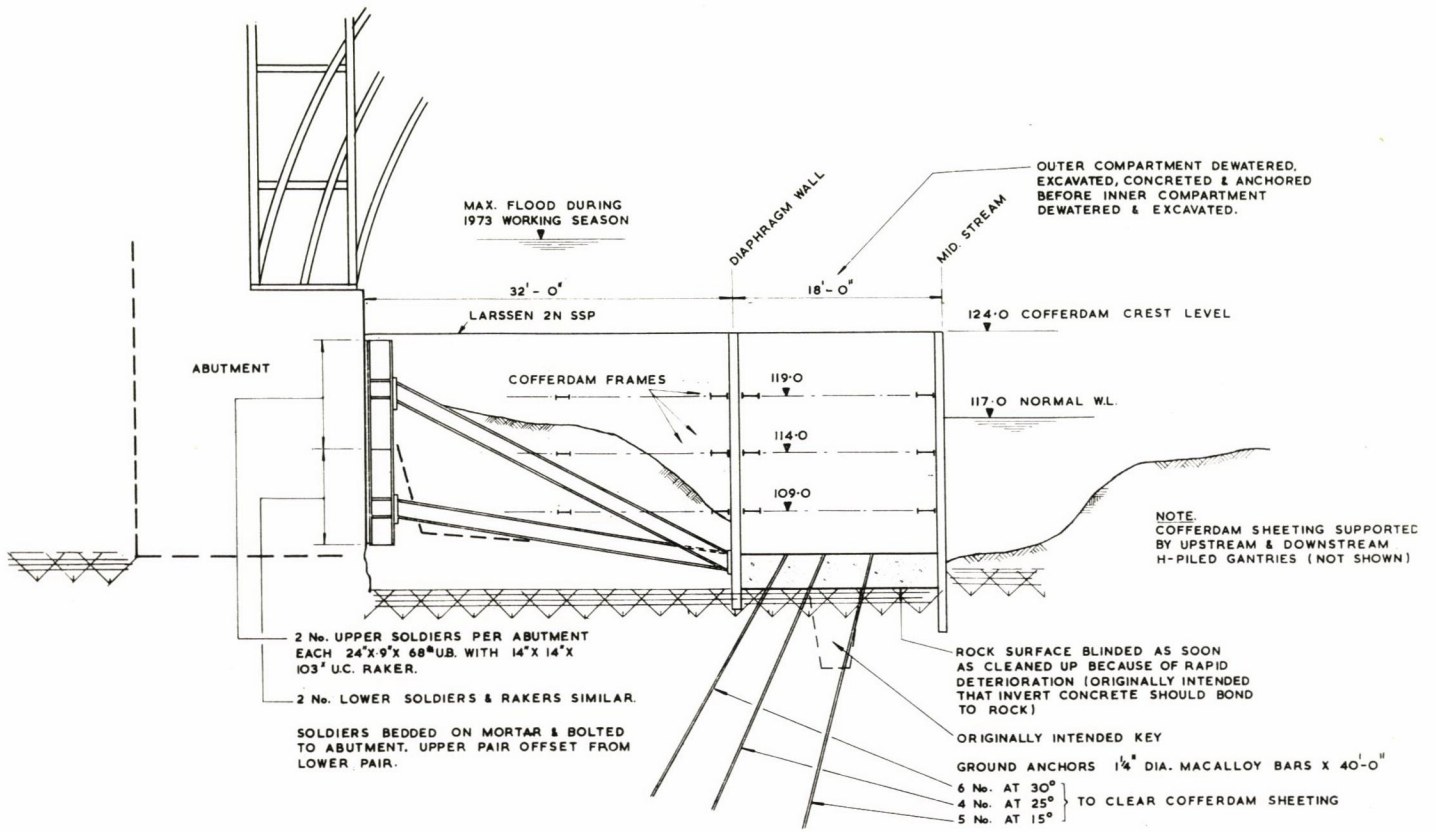
Above—Stage 2 temporary works revealing use of ground anchors

Turning now to the temporary support of the abutment, it was mentioned earlier that the intention was to take the reaction of the temporary raking struts by keying a section of permanent invert slab into the rock. In the event, despite the hard pile driving and excavation conditions, the mudstone deteriorated quickly on exposure to the atmosphere. The value of the key thus became most suspect and in view of the possibly vital role to be played by the temporary support system, the decision was made to abandon the proposed key and to substitute a system of ground anchors (see sketch). This decision was reinforced by the unwelcome fact that, at this time, it was clear that the original target—to complete the contract in one working season—was no longer practicable. Thus as virtually the whole of any remaining cofferdam, temporary strutting, etc. have to be taken out of the river during the "close season", the ground anchor installation would ensure adequate support of the south abutment through the winter, pending final "closure" of the invert slab next season.

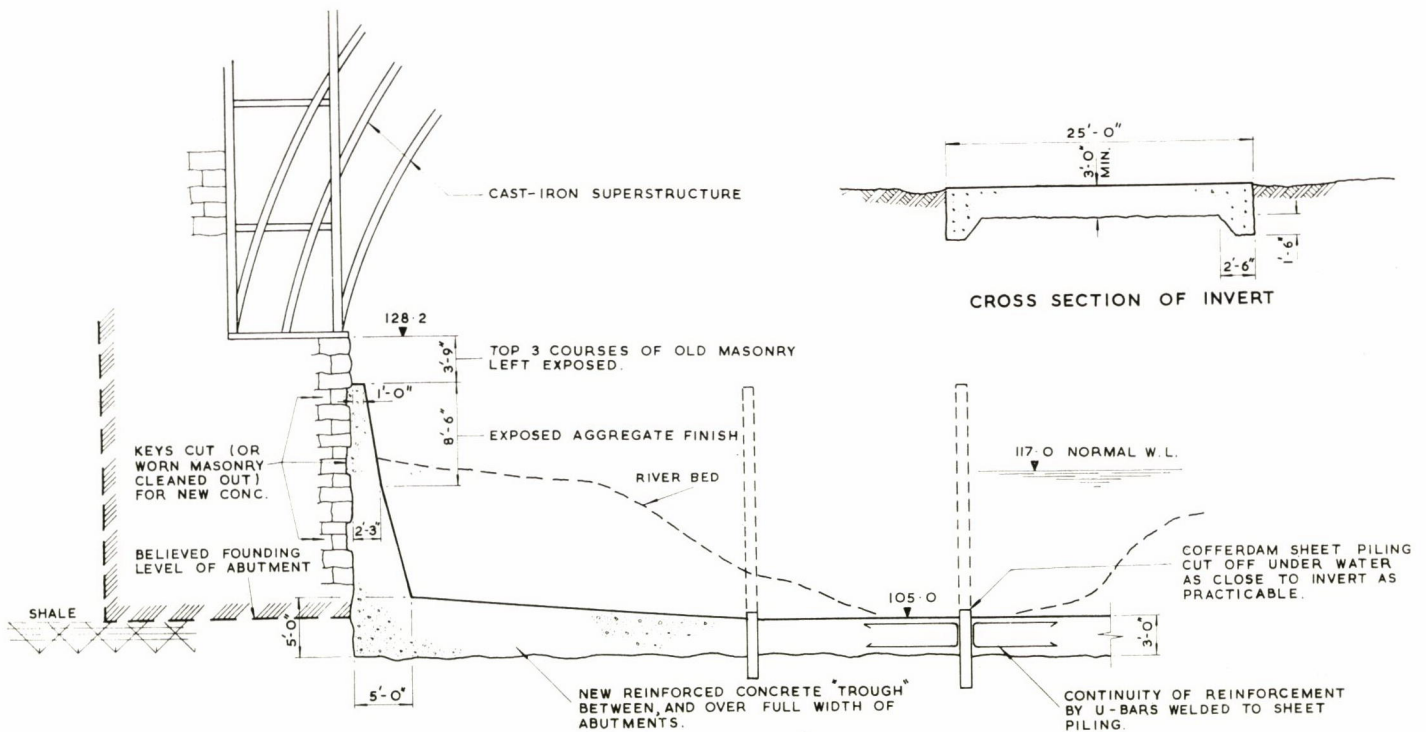
Below—Detail of Stage 2 shows the extent of the new reinforced concrete trough traversing complete width between abutments

The scheme finally selected consisted of a heavy reinforced concrete invert slab at river bed level between, and over the full width of, the abutments together with heavy reinforced concrete facing walls to the abutments. The invert and facing walls together form a very substantial trough section, the function of the invert being, as a strut, to prevent further sliding at abutment toe level, while the monolithic facing walls resist any resulting tendency for the abutments to tilt forward above toe level.

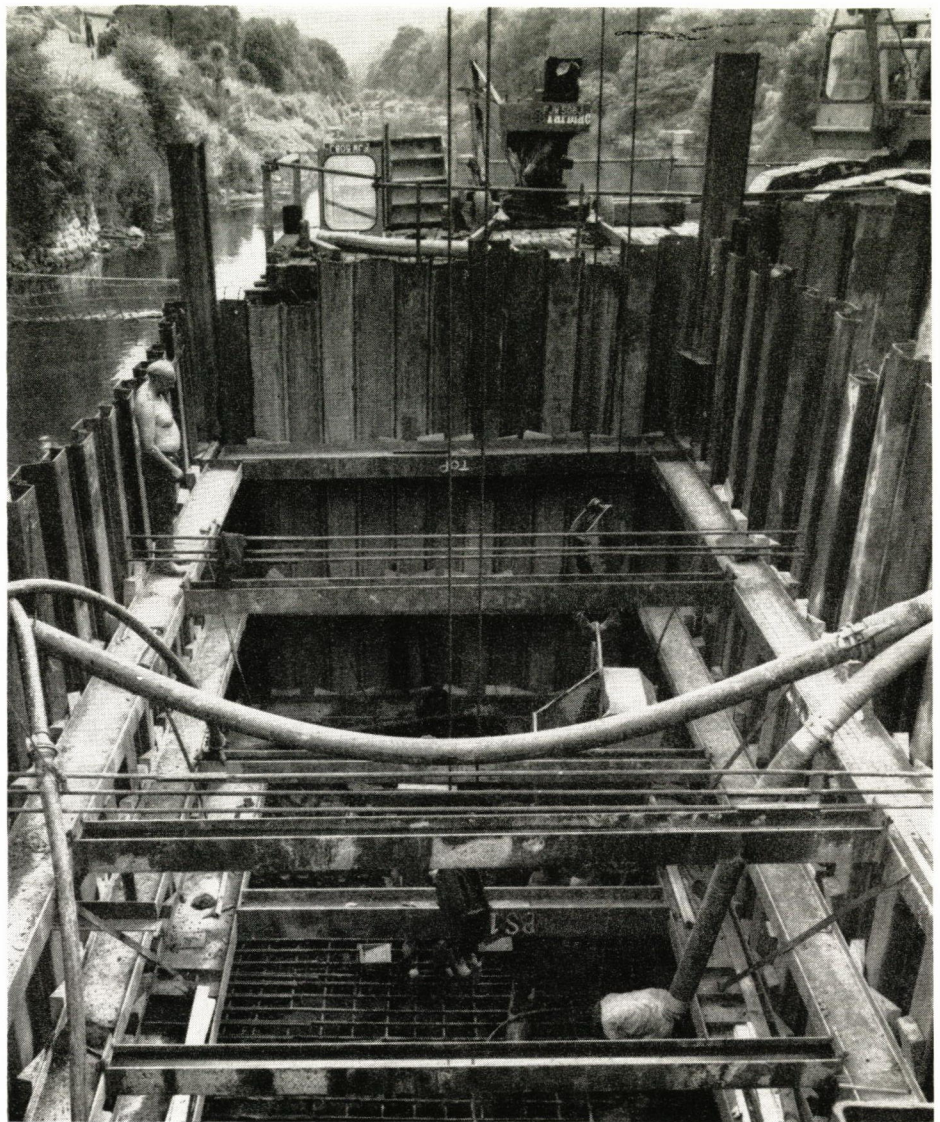
Above—Concreting of invert strut in small compartment of the south cofferdam

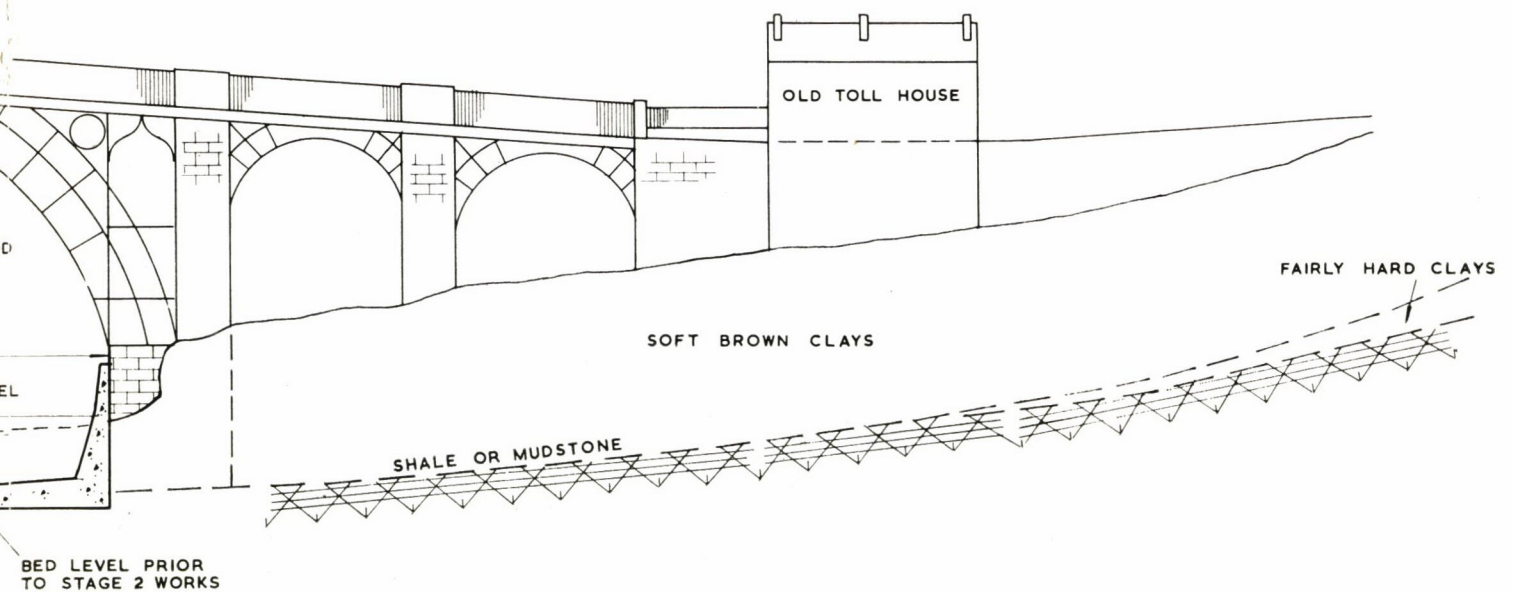
Below—General arrangement of the iron bridge remedial works showing stages of the work and the ground conditions

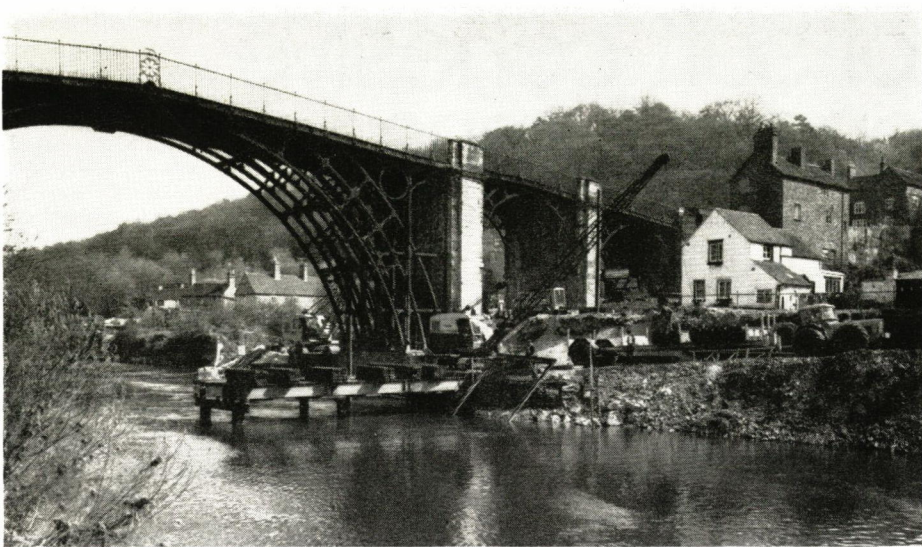
Looking south east, the upstream gantry and access road—May, 1973

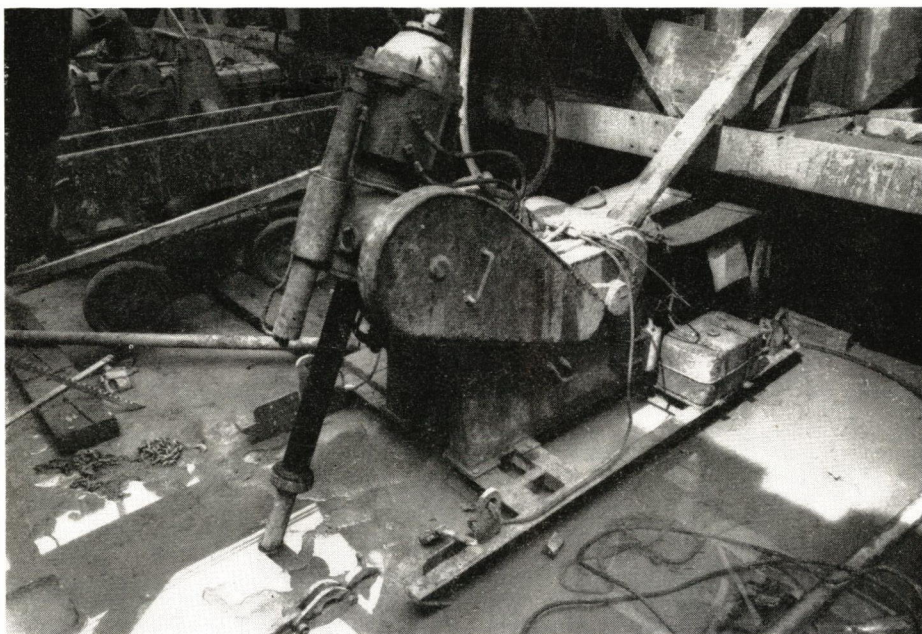
Drilling rig for rock anchor installation in small compartment of South cofferdam—September, 1973

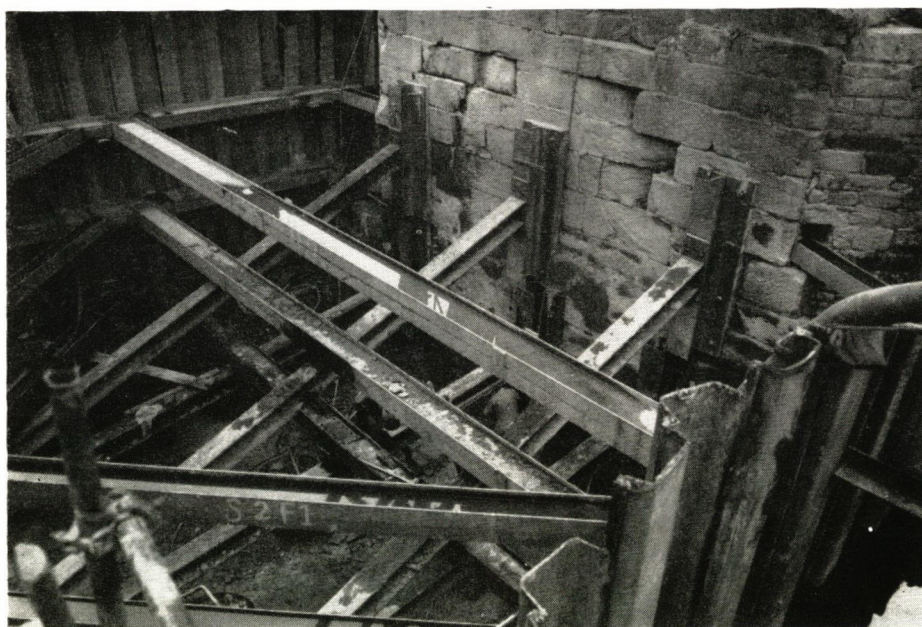
Final excavation in rock in front of South abutment, showing upper and lower raking struts
