الهيئة العامة للطيران المدني
GENERAL CIVIL AVIATION AUTHORITY

- Final Report -

AAIS Case N°: AIFN/0008/2016

Runway Impact during Attempted Go-Around

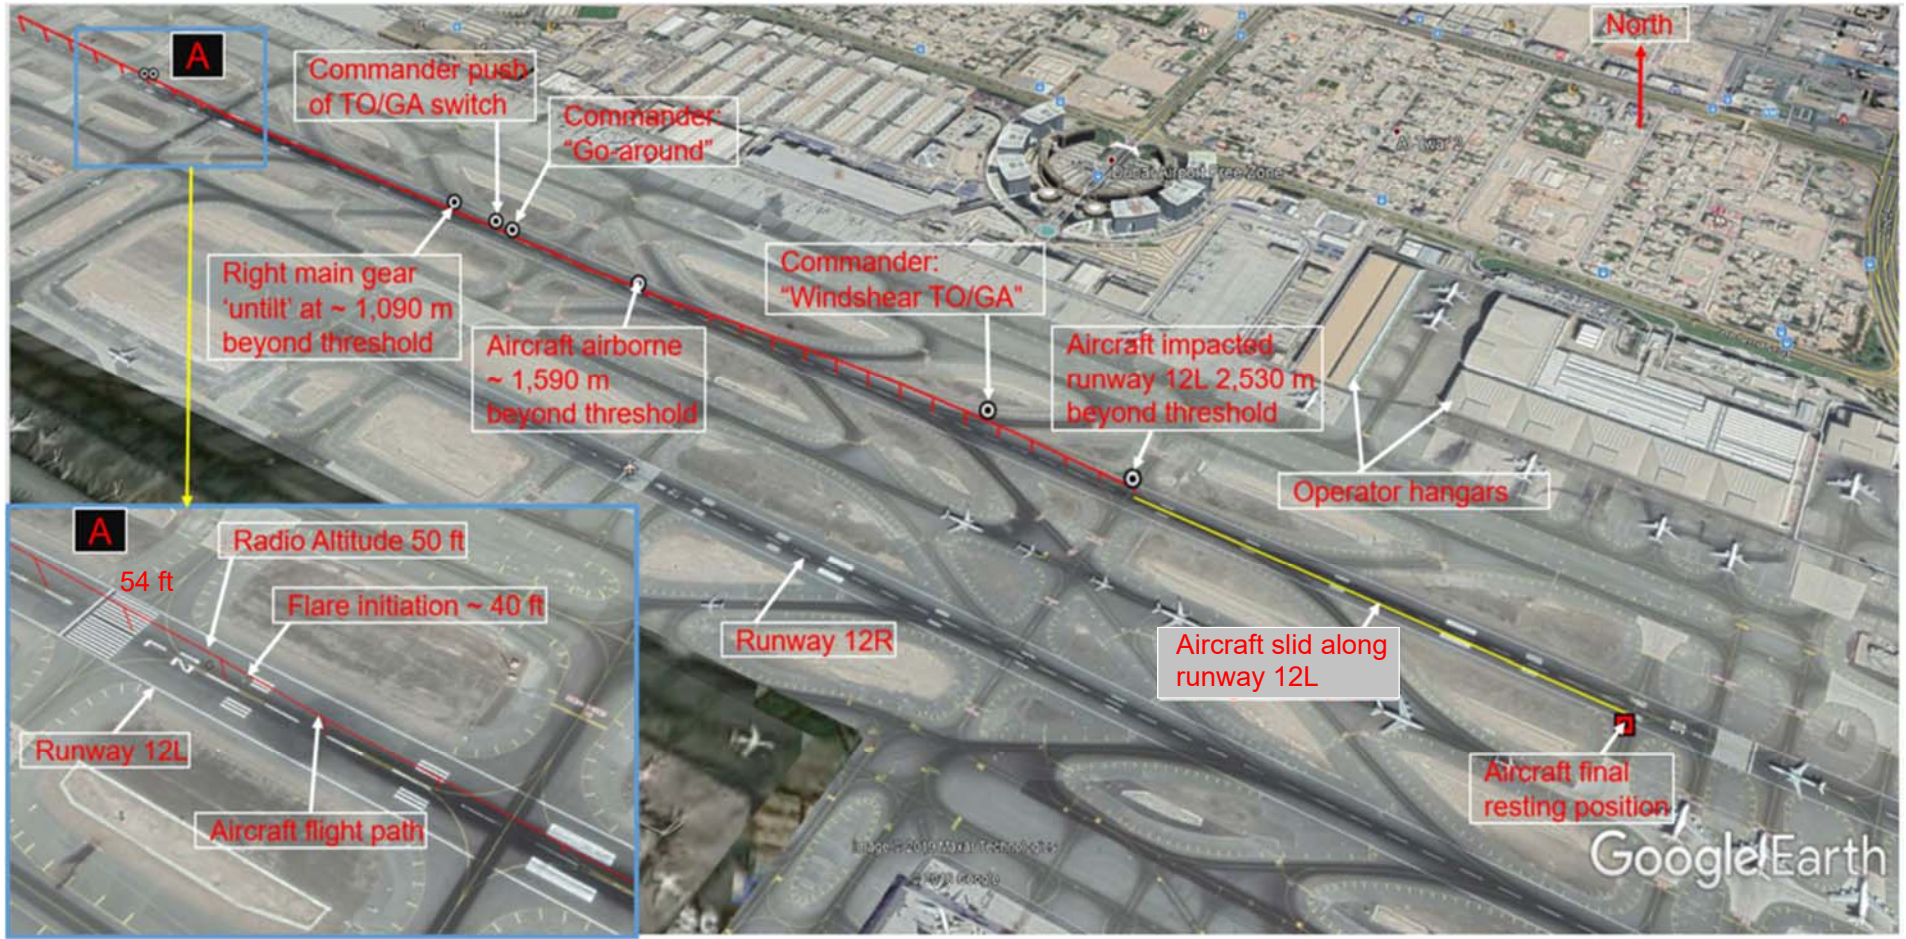
Figure 1. UAE521 flightpath and impact along runway 12L

Approximately 9 minutes and 40 seconds after the Aircraft came to rest, the center wing tank exploded which caused a large section of the right wing upper skin to be liberated. As the panel fell to the ground, it struck and fatally injured a firefighter.

The Aircraft sustained substantial structural damage as a result of the impact and its movement along the runway and it was eventually destroyed by fire.

Refer to figure 1 which illustrates the final flightpath of the Aircraft from before the runway threshold until the impact. Appendix A to this Report illustrates the FDR and CVR data recorded along the flightpath over runway 12L.

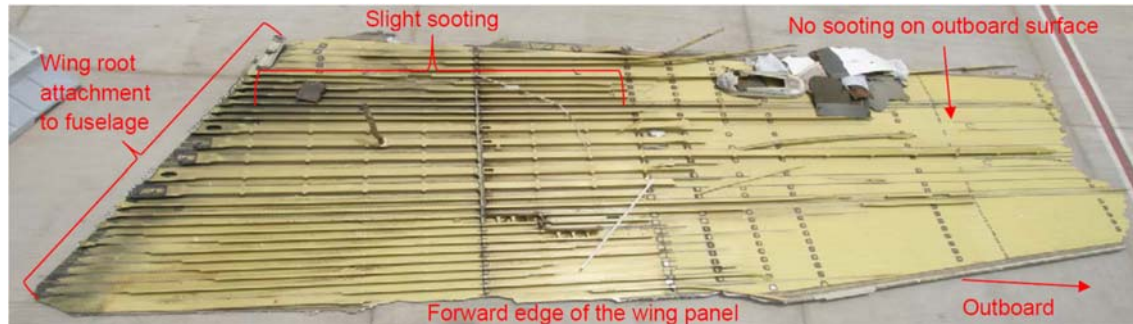
Figure 16. Upper skin panel from right wing

landing gear heating and causing the ignition of the approximately 100 kg of residual fuel in the center wing tank. The explosion caused the right wing upper skin panel of the center wing fuel tank to violently separate (figure 16).

The direction of the explosion pressure wave was from the center wing tank towards the right main wing tank. This resulted in a large section of the upper wing skin from the inboard right wing, approximately 15 m in length and the width of the upper wing surface, being separated with such force that it landed behind the right wing on the tarmac approximately 5 m from the wingtip. The wing skin panel separated from wing buttock line station (WB) 123.124 to wing station (WS) 732 (Rib 21). In addition, the explosion also caused the cabin floor over the center tank area to lift which provided a path for fire and smoke to enter into the passenger cabin.

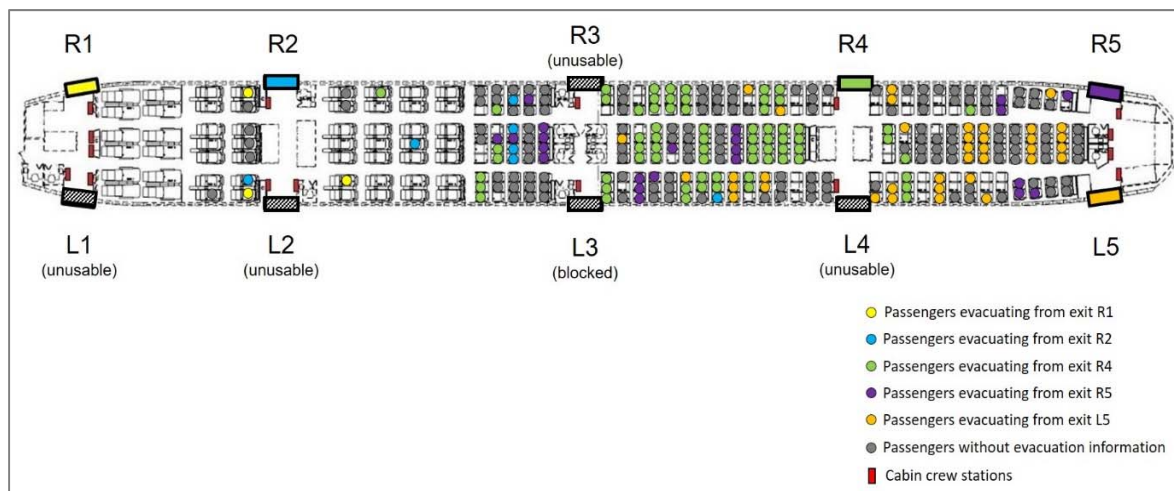
Figure 20. Passenger seating allocation and emergency exit status

Figure 20 shows the seat locations and exits used. Passengers who did not respond to the questionnaire are represented by grey dots.

One passenger, seated next to the right side over-wing exit (R3), stated that he was directed to the front of the cabin to evacuate from one of the forward exits, but he was then directed back because the forward exits were blocked. This passenger passed through dense smoke in the center cabin on his way to exit from the R4 door.

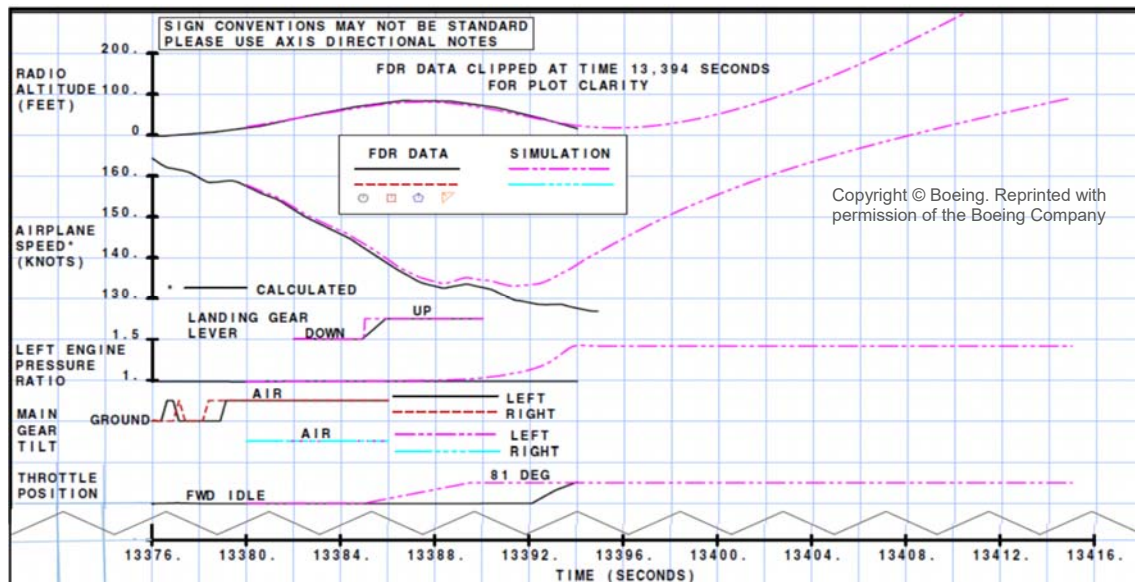
Figure 21. Calculated go-around after TO/GA switch push [source: Boeing]

For UAE521, the actual thrust lever increase, which was a manual advancement by the Commander at 13,392 seconds FDR time, was performed fifteen seconds after the Commander called for a ‘go-around’.
