Bureau enquêtes accidents pour la sécurité de l'aéronautique d'État

Safety Investigation Report

I-2016-15-A

Date of event	24 October 2016
Place	Malta International Airport
Type of aircraft	SA227 AT - MERLIN IV C
Company	CAE Aviation

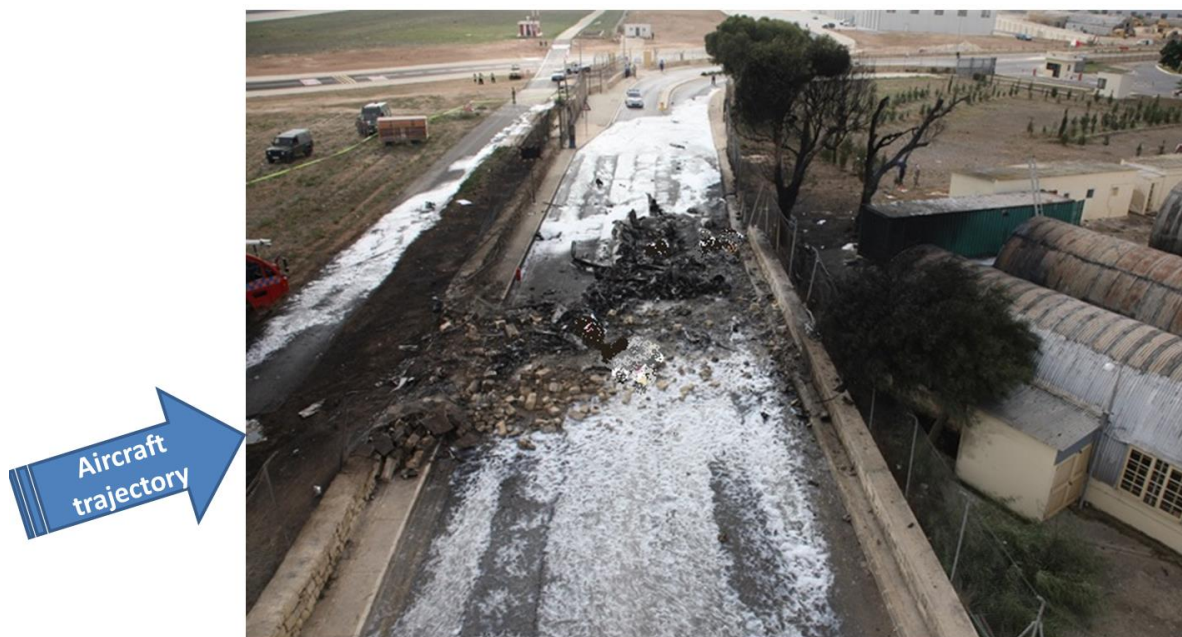
Figure 2: Damage to the perimeter wall, road and surrounding buildings

The impact zone was located at the perimeter wall of the airport. The perimeter wall and the associated fence were destroyed or damaged over a distance of approximately twenty metres. The exterior road and the wall on the other side of the road were damaged over a distance of at least about thirty metres. Three buildings located on the other side of the road were partly damaged or bear traces of the fire that broke out on the ground. Some of the surrounding trees were burned (see Figure 2).

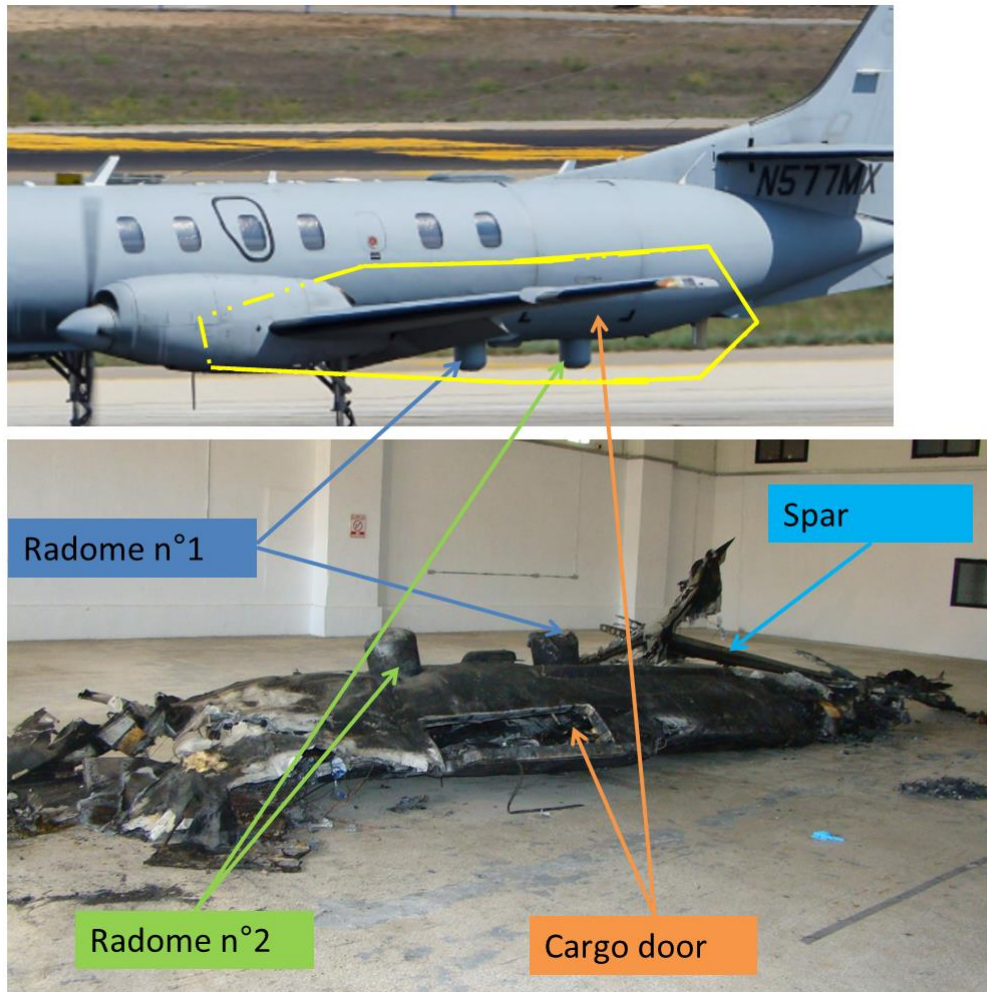
Figure 4: Remaining part of the fuselage

The aircraft was severely damaged by both the impact and the fire on the ground.

Concerning the fuselage, only the lower part behind the wing spar remains in one piece.

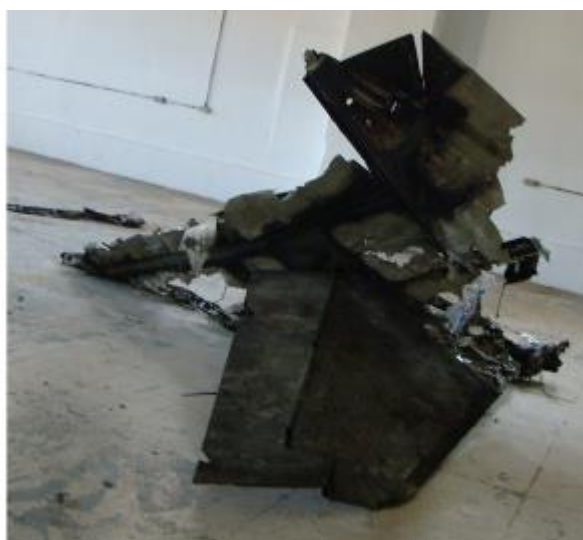
Figure 5: Empennage (lying upside down)

In the accident area, the empennage was still connected to the fuselage by the flight control cables. For the requirements of transportation, it was separated from the fuselage after cutting the cables. The empennage was damaged by fire.

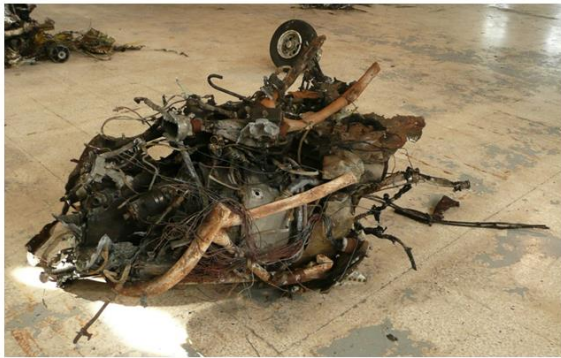
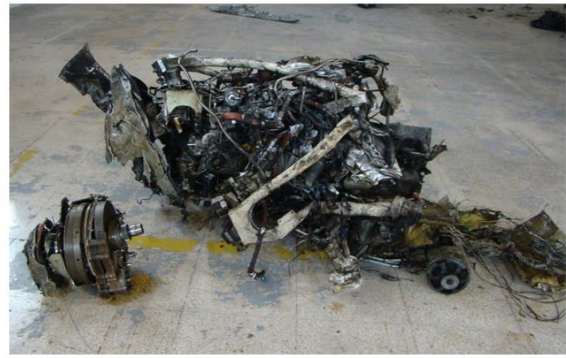
Figure 6: Engines

The two engines were separated from the airframe.

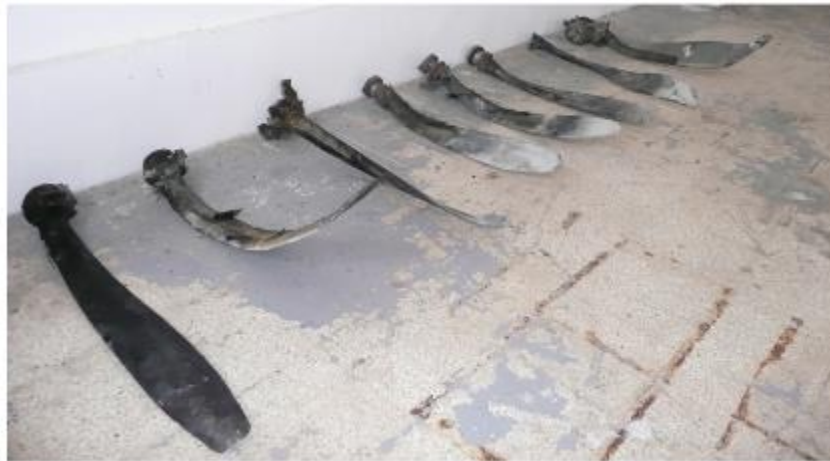
Figure 7: Blades of the 4-blades propellers

The eight blades of the two 4-blade propellers were found separated.

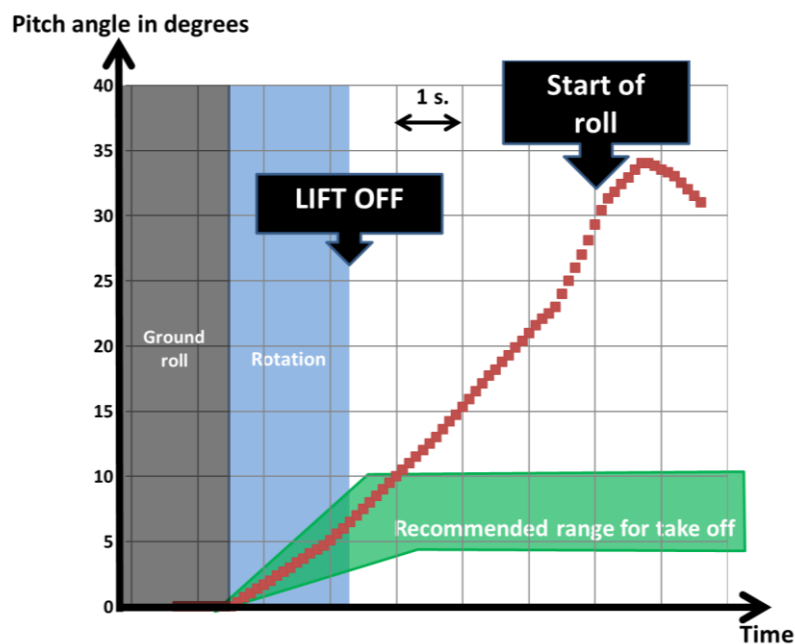
Figure 12: Change in pitch attitude between rotation and the start of the roll (attitude calculated image by image)

Analysis of the plane's attitude shows that the pitch angle increased continuously from the moment of rotation (see Figure 12). The pitch attitude before lift-off was normal, but then it continued to increase constantly until the start of the roll. A deviation can already be observed less than one second after lift-off, or soon after the pilot manoeuvred the elevator control to set the attitude.

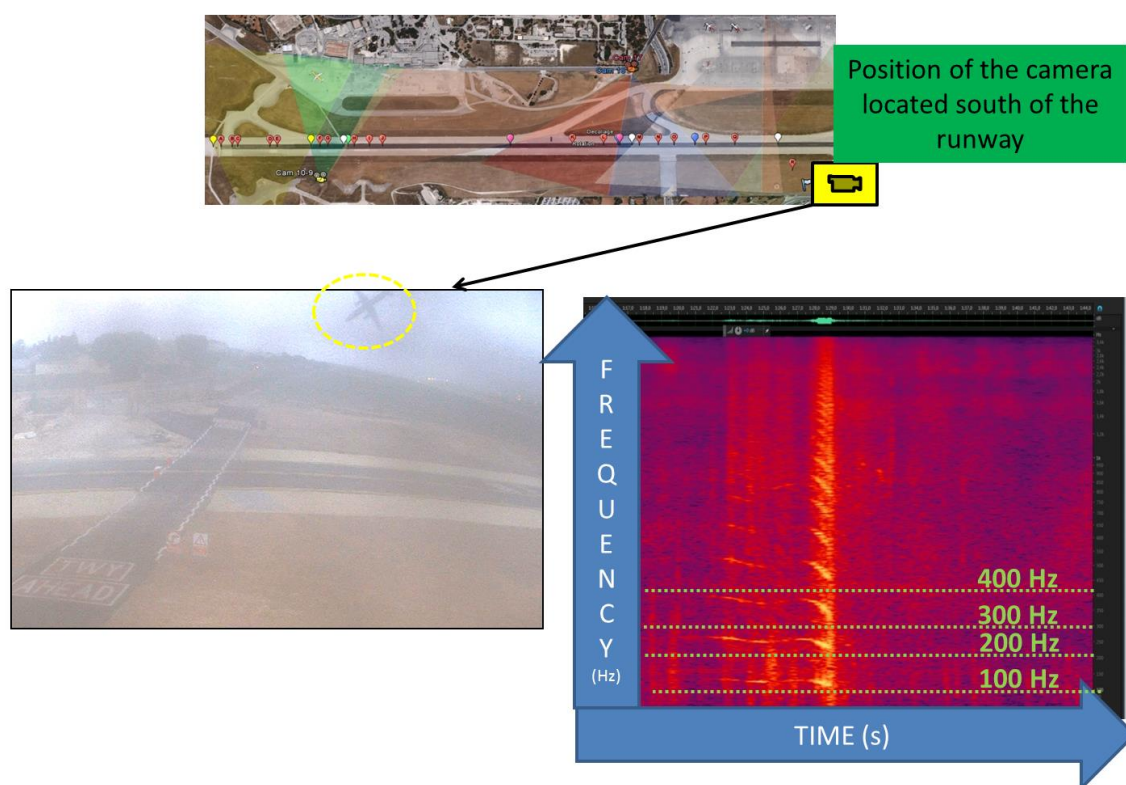
Figure 13: Spectral representation of the sound recorded by a surveillance camera

A spectral representation of the sound recorded by one of the video cameras is reproduced below. On filtering out the Doppler effect¹⁷ caused by the movement of the aircraft, the measurements taken show a frequency of between 101 and 109 Hz for the main line.

A four-blade propeller rotating at 1591 revolutions per minute normally generates a sound spectrum with a main frequency line of approximately 106 Hz and harmonics that are multiples of this frequency.

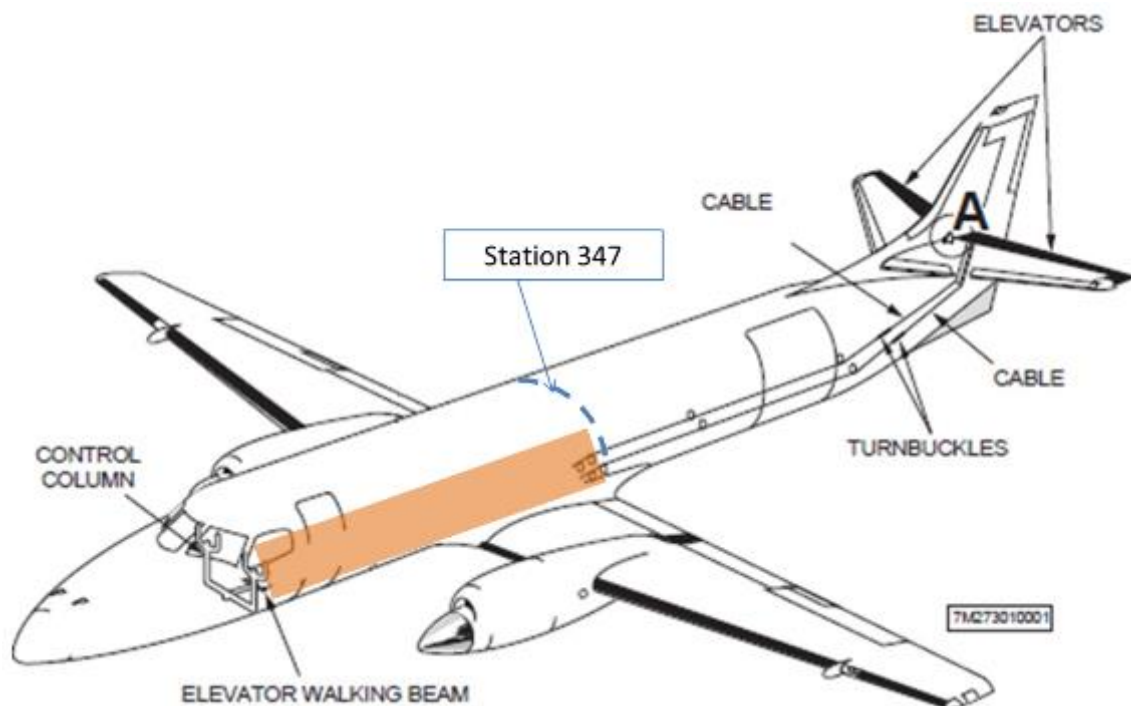
Figure 20: Illustration of the missing and unreconstituted zone of the elevator control (orange)

- the orange zone in Figure 20 (starting behind the elevator walking beam and extending to station 347 of the aircraft) designates the missing section that could not be reconstituted. This section corresponds to a zone that was modified to fit the on-board systems;

- main control: no damage pre-existing the impact was identified on the parts examined (from the pilot's control column to the walking beam and from station 347 to the elevators). The gust lock was not engaged. No indication of the position of the control surface on impact could be identified;

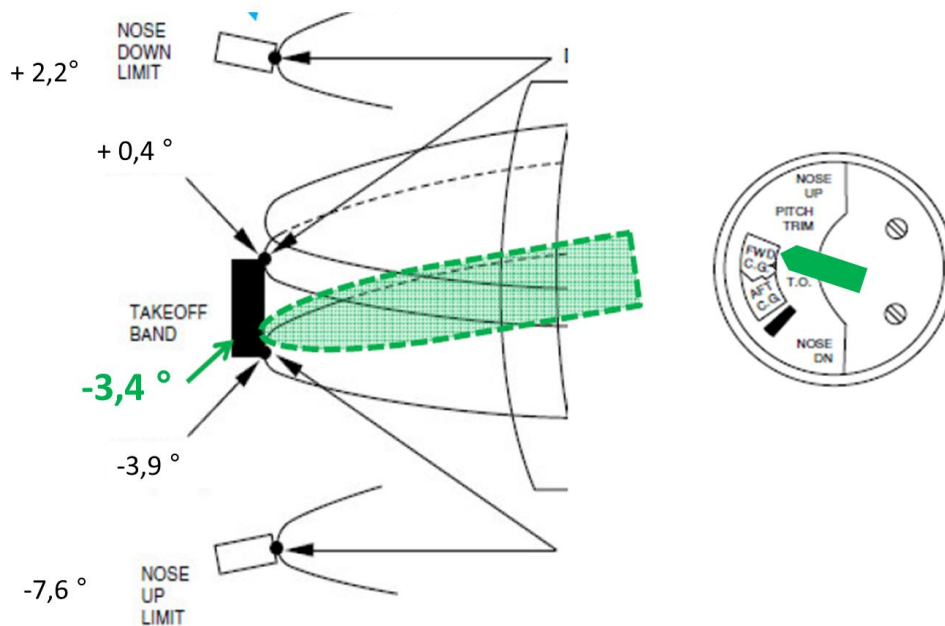
Figure 21: Illustration of the trimmable horizontal stabilizer and its assumed representation on the indicator in the cockpit

- SAS: only the cable drum of the servo control was found. The damage incurred prevented any determination of its condition before impact;
- trim adjustment position: the position of the trimmable horizontal stabilizer was defined on the basis of the trim actuator and corresponded to -3.4° . Given the balance of the aircraft in the middle of the authorized range for the aircraft, this setting induces a "nose up" tendency at low speed (see Figure 21). The variation in attitude observed during a takeoff under the same conditions but without adjusting the elevator after rotation was approximately 10° pitch angle in 3 seconds. This attitude variation is easily controlled by operating the nose-down control.

With the exception of the flaps that were more extended than recommended and the elevator trim setting, which induced a “nose up” tendency insufficient to explain the sharp nose-up observed during the accident, the configuration of the aircraft is as expected during the takeoff phase.

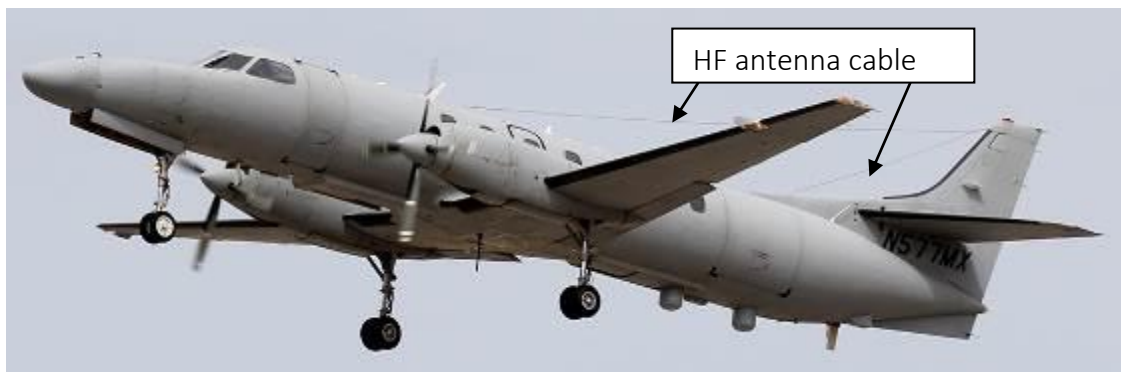
Figure 25: Position of the HF cable on the aircraft

The HF antenna (consisting of a cable installed above the fuselage) could have broken during rotation and caused the elevator control to jam in the “nose up” sector by becoming wrapped around the control surface.

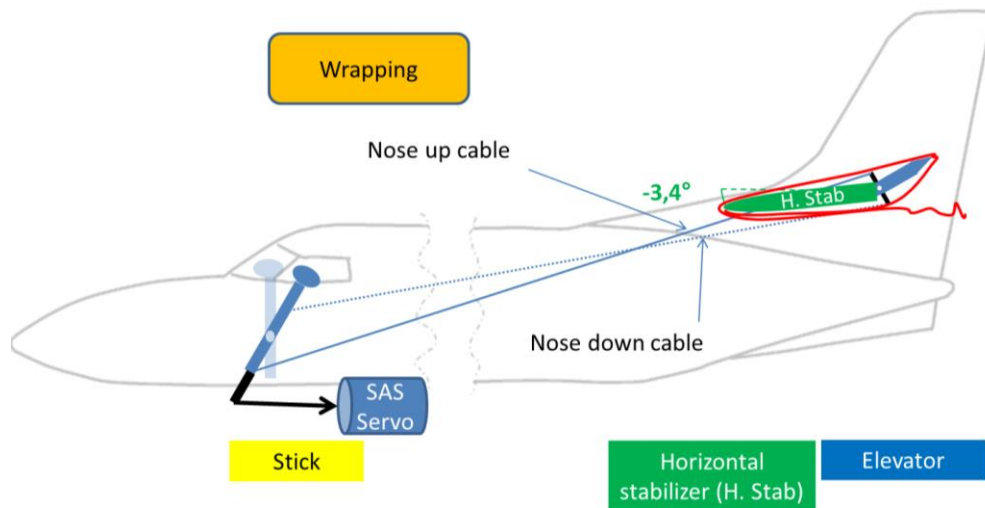
Figure 26: Schematic diagram of the antenna cable becoming wrapped around the elevator control surface

The cable would probably have been more likely to wind itself along the right-hand side, due to the direction of rotation of the propellers. This scenario can be illustrated by the accident report issued by the BEA concerning the accident that occurred on 7 August 1998 in Royan (see Annex 7), except that in this case jamming in the “nose-down” position would have to be replaced by jamming in “nose-up” position.

This jamming of the elevator control surface could not have been countered by the control stick. Any action of the control stick would have had no effect, and the pitch angle of the aircraft would have continued to increase.
