BRUSH WELLMAN

Analysis of
"Beryllium" Speaker Dome and Cone
Obtained from China

Scanning Electron Microscopy Evaluation of Speaker Dome Material for a 1 inch Cone and 4 ½ inch Cone

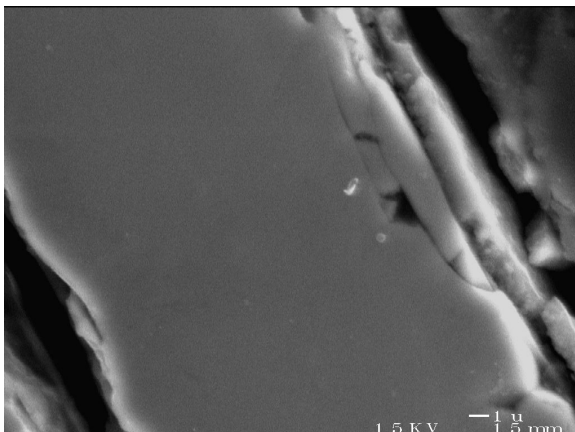
Figure 1 SEM Cross Section of 1 inch Dome

The material for the 1" speaker dome was determined to be titanium based on cross section (Figure 1) EDXA results (Figure 2). No microstructural features were apparent in the cross section.

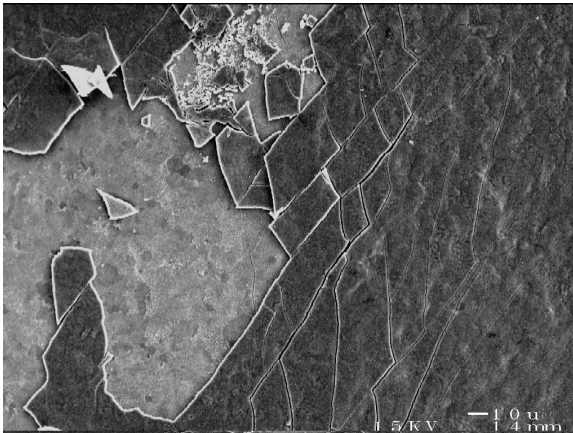
Figure 3 SEM image of 1 inch cone surface showing flaking coating and under laying material.

The material coating was quite friable and readily spalled off. The SEM image in Figure 3 shows 2 major areas. There is the dark coating that is flaking off and a lighter colored surface that is mottled underneath. EDXA spectra using 10 kV beam voltage shows only titanium peaks for both areas (Figure 4). The beam voltage was reduced to 5 kV to detect materials at the surface. Spectra for the dark area, the light regions of the light mottled area as well as the dark areas in the light mottled area shows carbon, oxygen and nitrogen. Titanium was not detecting owing to the low beam voltage. The dark coated area had very high oxygen content suggesting the coating was a paint containing oxide (probably TiO_2) as opaquing agent (Top Figure 5). The spectra for the light area of the light mottled area had the lowest signal to noise ratio suggesting this was the "metal surface" (Middle Figure 5). These results are indicative of titanium being a strong oxide, carbide and nitride former. The dark areas of the mottled area appear to be different that the coat surface, although both areas have high oxygen peaks (Top and Bottom Figure 5). The oxygen to carbon ratio appears to be different for the two spectra.

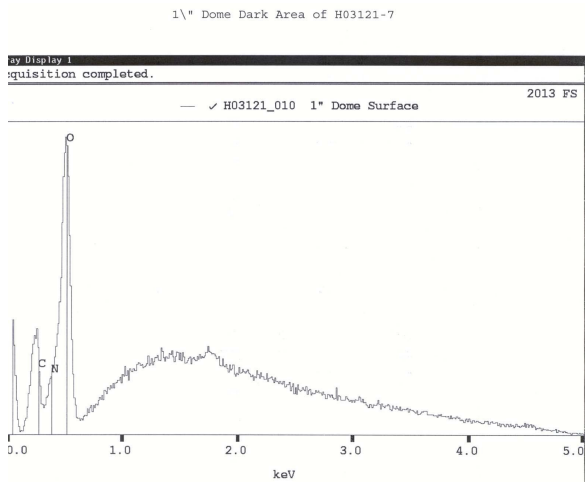
Dark area of Figure 3 showing high oxygen content

Figure 5 EDXA Spectra for dark coated area, the light area on the mottle surface and the dark area on the mottled surface

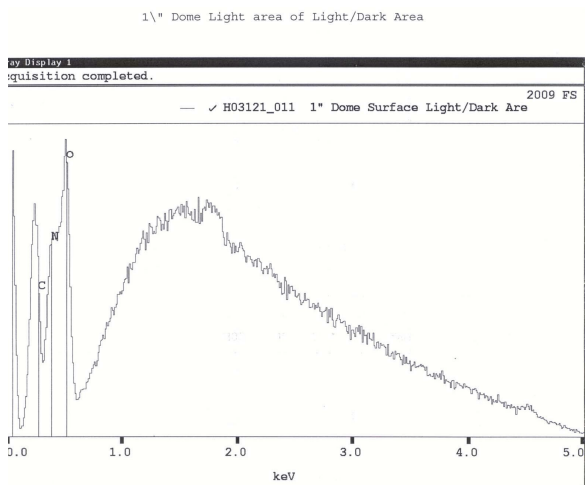
Light area of the Light Mottled Area in Figure 3

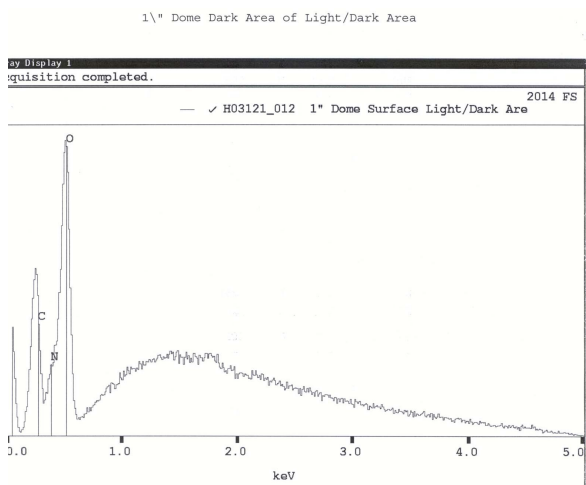
Dark area of the light mottled area in Figure 3

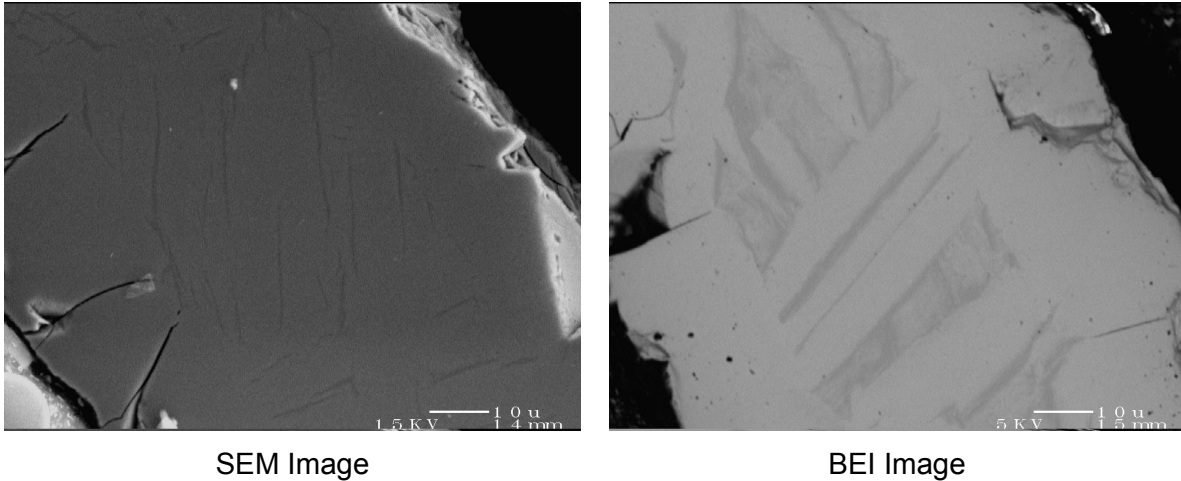
Figure 6 4 ½ inch Dome Cross Section Images

Microstructural features are shown in Figure 6 for the polished cross section of the 4 ½ inch dome. The two outer layers appear featureless while grain structure is apparent in the middle. The “color” of all of the cross section suggests all area have a very similar atomic weight and are very likely to be the same material. Cracks only appear to be contained only in the featureless outer layers.

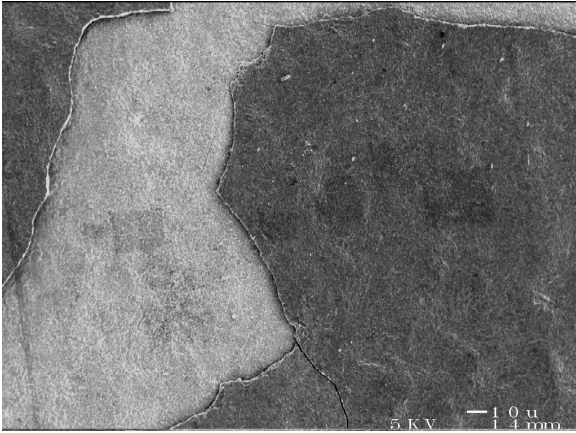
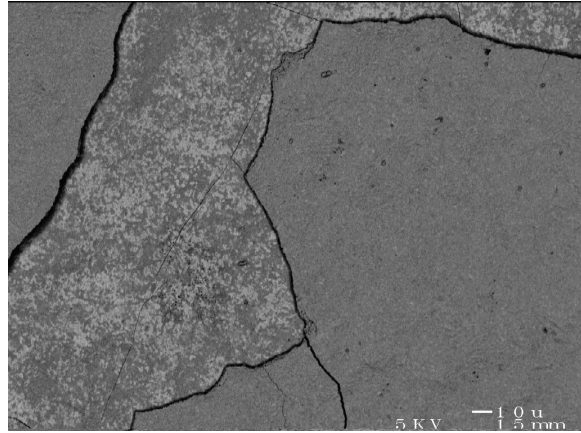
Figure 7 SEM and BEI images for 4 ½ inch dome showing similar features to 1 inch dome.

The ESCA results and surface examination results for the 4 ½ inch dome were very similar to the 1 inch dome. The surface showed a dark flaking area with a lighter colored mottled area (Figure 7I). The base material was determined to be titanium for the cross section and surface using 10 kV beam (Figure 8). Carbon, oxygen and nitrogen could be seen using a 5 kV beam (Figure 9). The carbon peak was higher for the 4 ½ inch dome light mottled area compared to the 1 inch dome.

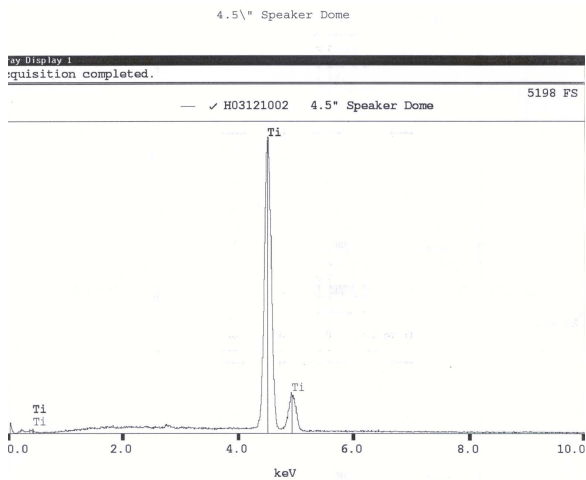
EDXA Spectra of Cross Section

Figure 8 EDXA Spectra (10 kV beam) for 4 ½ inch Dome

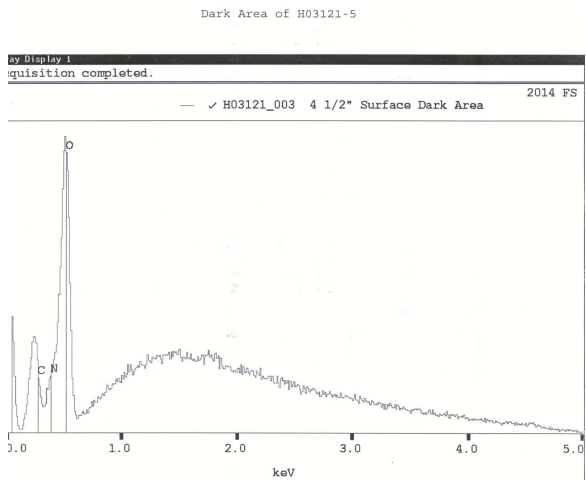
Dark Area

Figure 9 EDXA Spectra (5 kV beam) for 4 1/2 inch Dome
