Pilot/Race 177, *The Galloping Ghost*
North American P-51D, N79111
Reno, Nevada
September 16, 2011

Accident Brief

NTSB/AAB-12/01
PB2012-102899

Aircraft Accident Brief

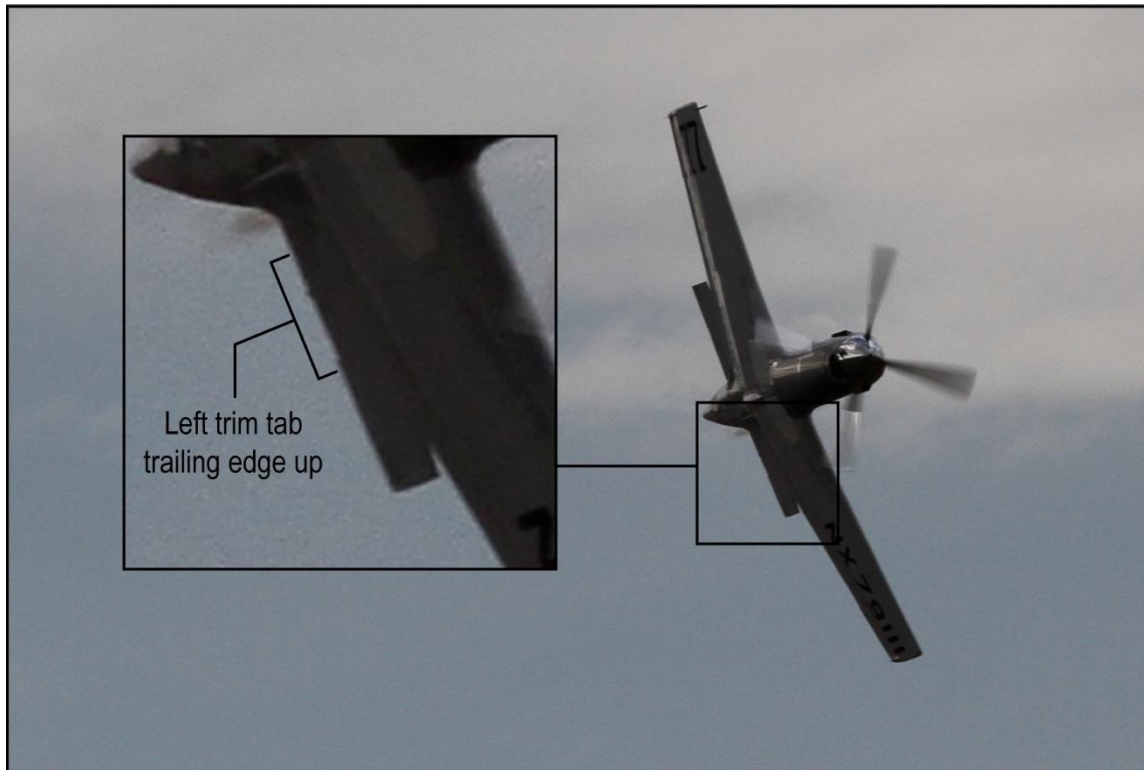
Trailing-edge-up left elevator trim tab deflection was also evident in photographs of the airplane during the accident race. One photograph showed that, as the airplane began to round pylon 8 at 1624:28.65²⁹ during the accident lap, the left elevator trim tab was trailing edge up, consistent with the position observed during previous laps (see figure 5).

Figure 5. Airplane rounding pylon 8 during accident lap before the left roll upset at 1624:28.65.
