Aerodynamic Stall and Loss of Control During Approach
Embraer EMB-500, N100EQ
Gaithersburg, Maryland
December 8, 2014

NTSB/AAR-16/01
PB2016-103251

Aircraft Accident Report

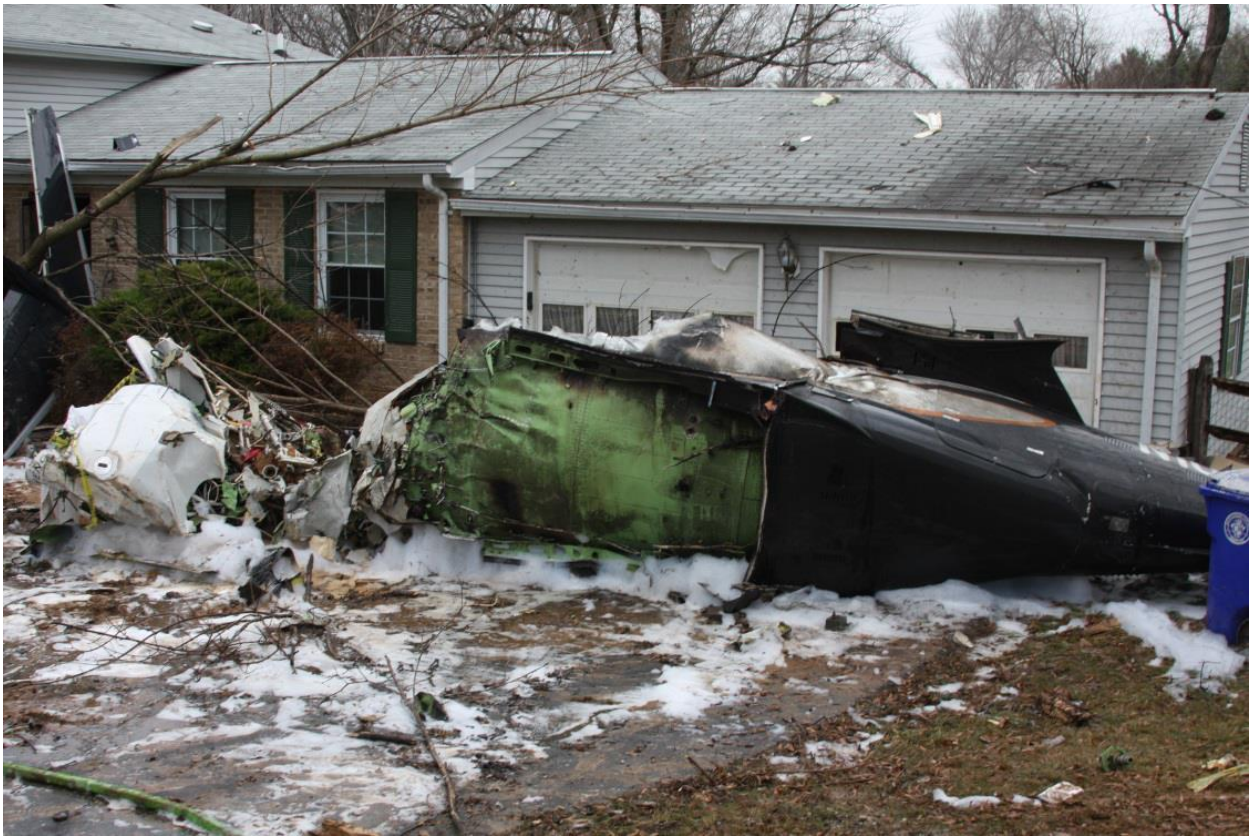
The fuselage was found on a 287° magnetic heading on the driveway of house B, facing the direction it came from. The portion with the cockpit came to rest in an inverted position, with heavy impact damage to the top half of the cockpit (see figure 6); the portion from the cabin door aft was found on its right side, and the cabin was consumed by fire. Damage to the ice protection/heating control panel was extensive, and it was not possible to visually determine the positions of the anti-ice or deice switches. The wing attach fittings on the center section of the fuselage were bent and broken, with both left fittings displaced aft and both right fittings displaced forward. The right wing leading edge was found in two segments on the driveway. Leading edge fragments from the left wing were found in the yard of house B. The tailcone and the left engine were located to the right of the house B driveway.

Figure 6. Photograph of the fuselage showing impact and fire damage to house B.

Most of the wing structure was found inside and in front of a third house (referred to as house C in this report). After impact, a postcrash fire at house C ensued. The remnants of the wing were found resting with their top surfaces upward. The wing center section had been consumed by fire. The right wing tip was found in the front yard. The main landing gear was found extended in the debris in front of the house. The right engine was found in the backyard of house C with fuel burn in the grass directly beside the engine.
