# NATIONAL TRANSPORTATION SAFETY BOARD

## AIRCRAFT ACCIDENT REPORT

**CHINA AIRLINES BOEING 747-SP, N4522V  
300 NAUTICAL MILES NORTHWEST OF  
SAN FRANCISCO, CALIFORNIA  
FEBRUARY 19, 1985**

NTSB/AAR-86/03

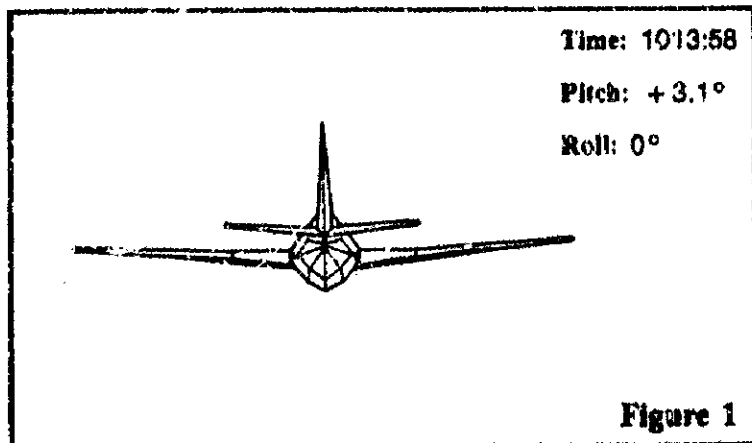
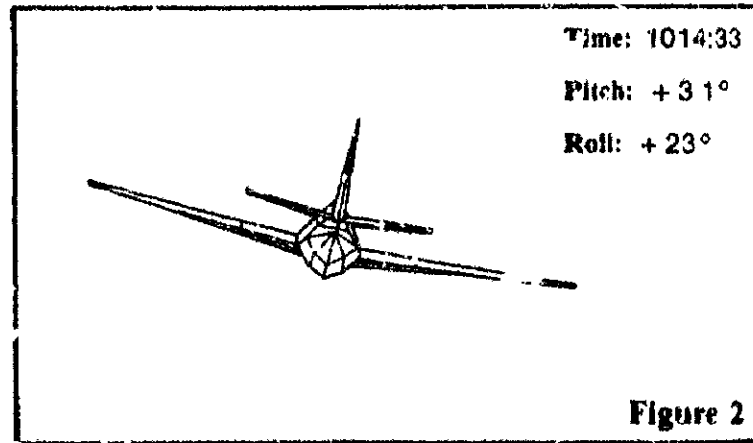
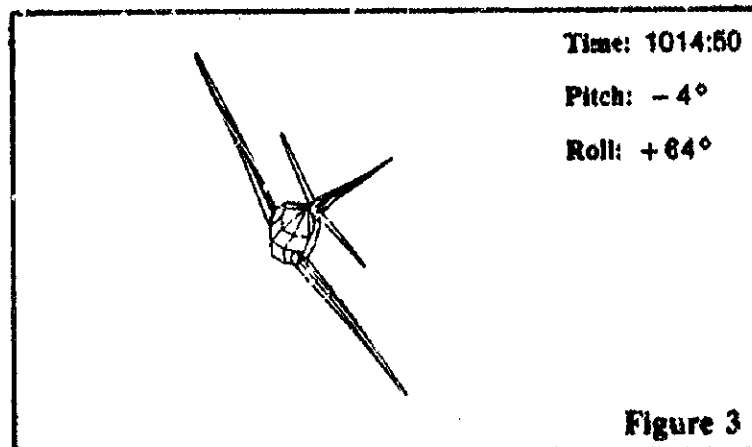
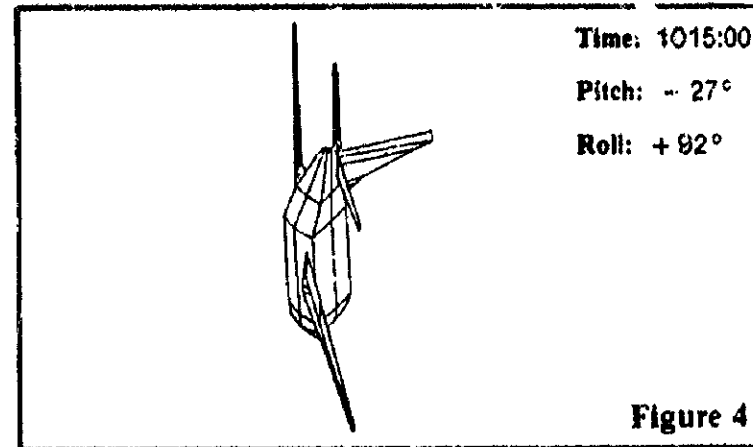
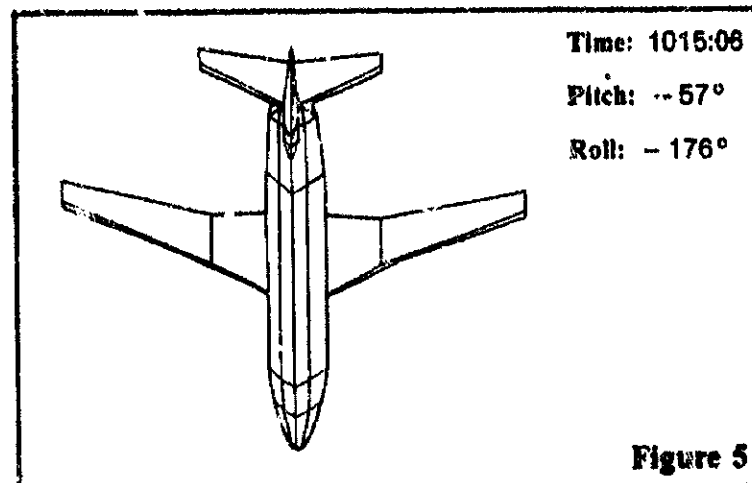
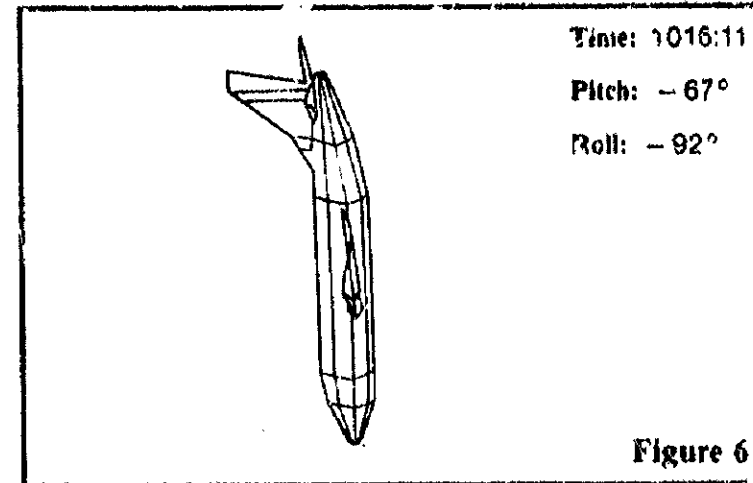
Figures 1.--Excerpts from Computer Animation.

At 1011:10, after the airspeed had decreased to about 251 KIAS, the EPRs on engines 1, 2, and 3 began increasing and, by about 1011:30, they had reached about 1.5 EPR. (At 41,000 feet, 0.85M, and with two air conditioning packs operating, the "max cruise" EPR limit is 1.543 EPR.) Thereafter, these three EPRs remained at about 1.5 until shortly after the start of the upset. During this period, the No. 4 engine's EPR

increased from 0.9 to about 1.02 and remained fairly constant at that reading until 1012:06. Between 1012:06 and 1012:41, the No. 4 EPR increased slightly to about 1.05.
