AIRCRAFT ACCIDENT REPORT

STALL AND LOSS OF CONTROL ON FINAL APPROACH
ATLANTIC COAST AIRLINES, INC./
UNITED EXPRESS FLIGHT 6291
JETSTREAM 4101, N304UE
COLUMBUS, OHIO
JANUARY 7, 1994

Adopted: October 6, 1994

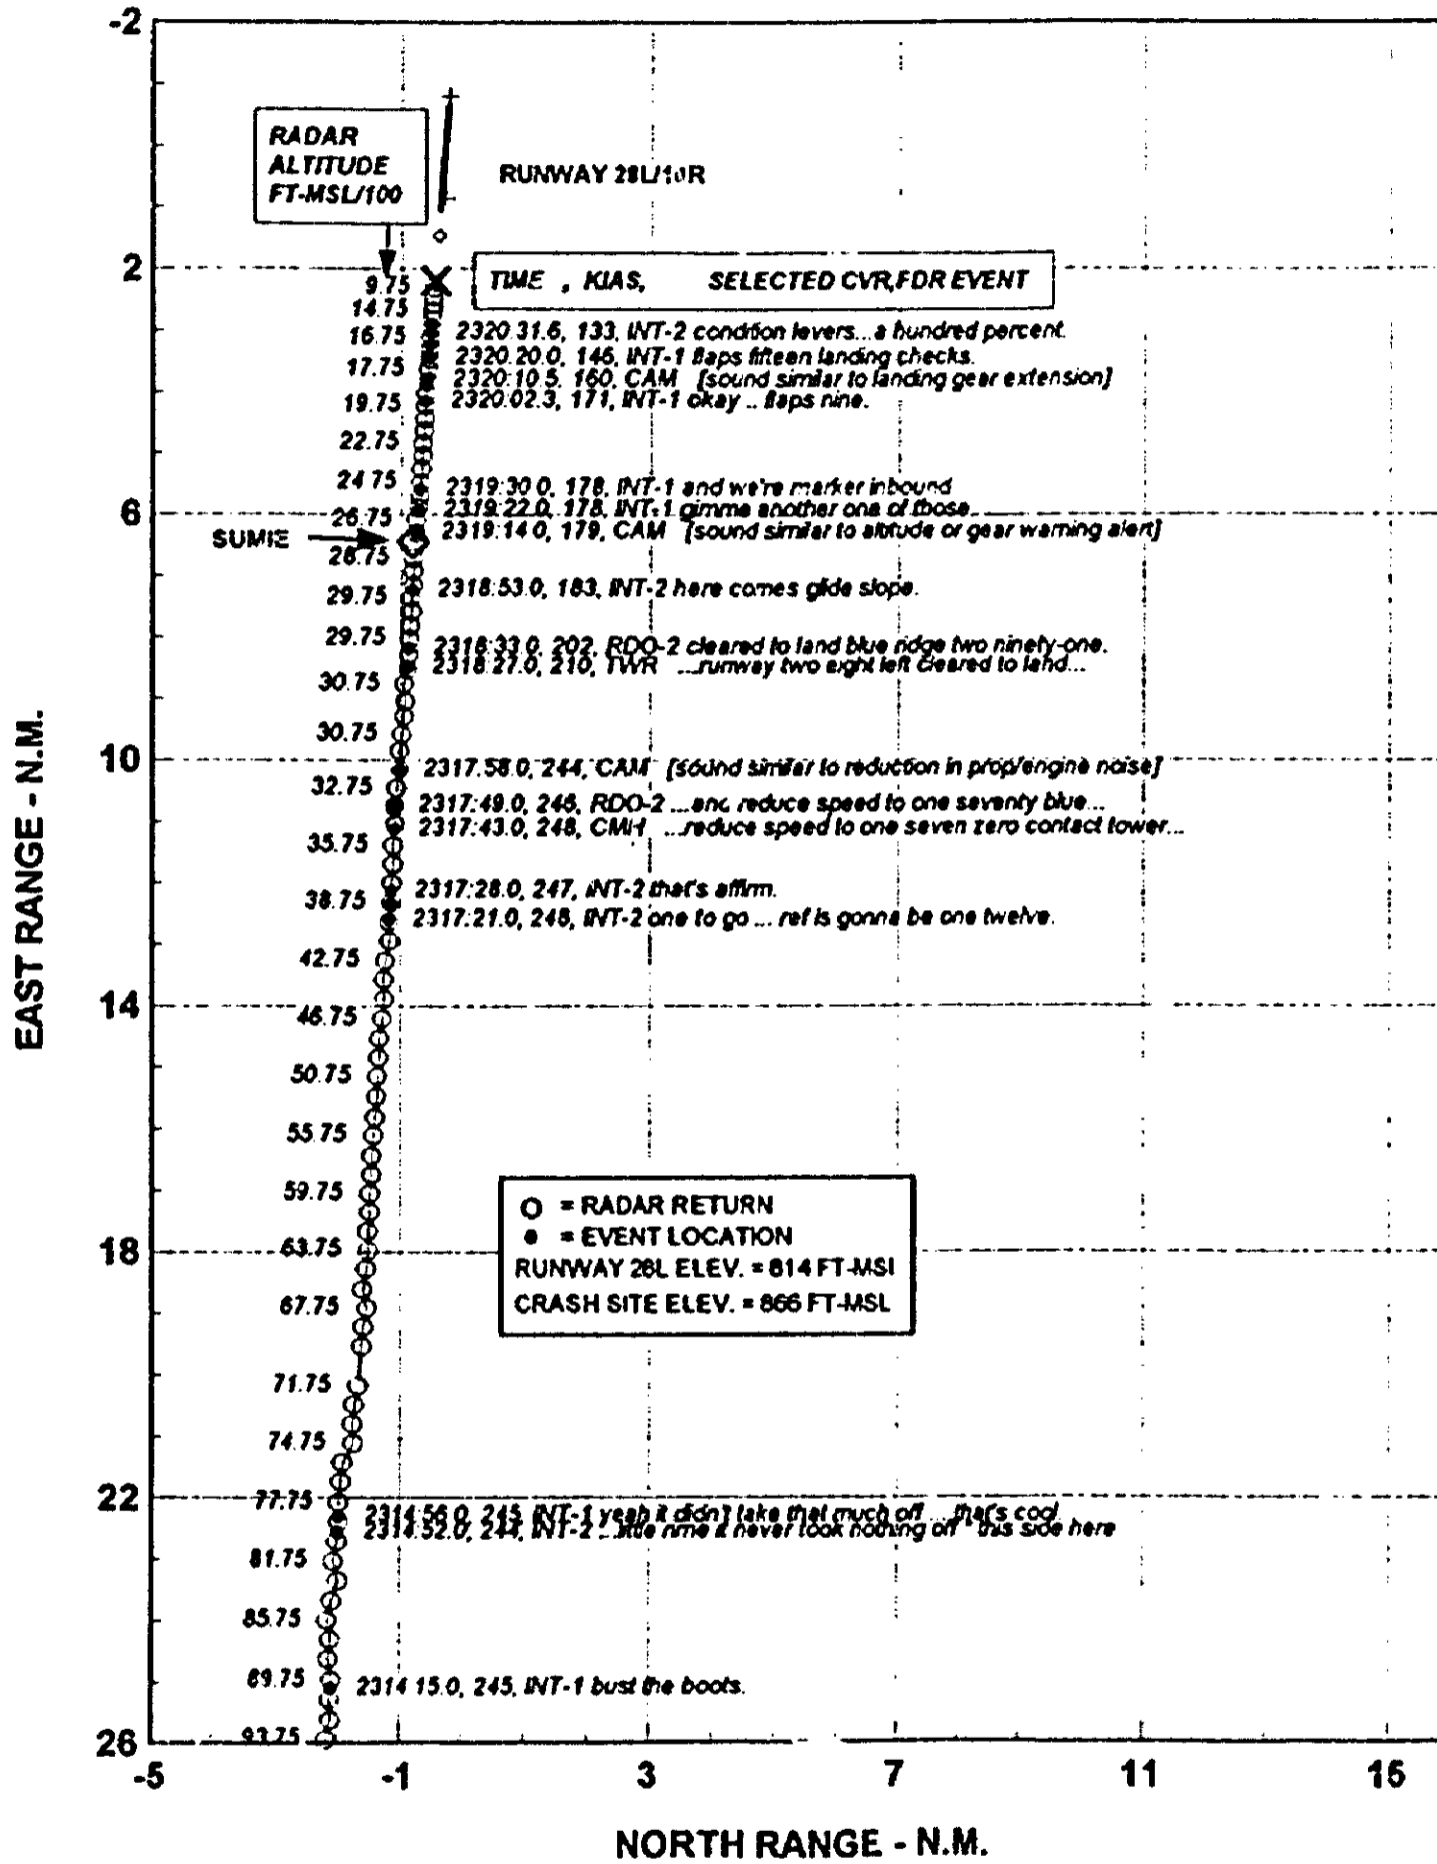
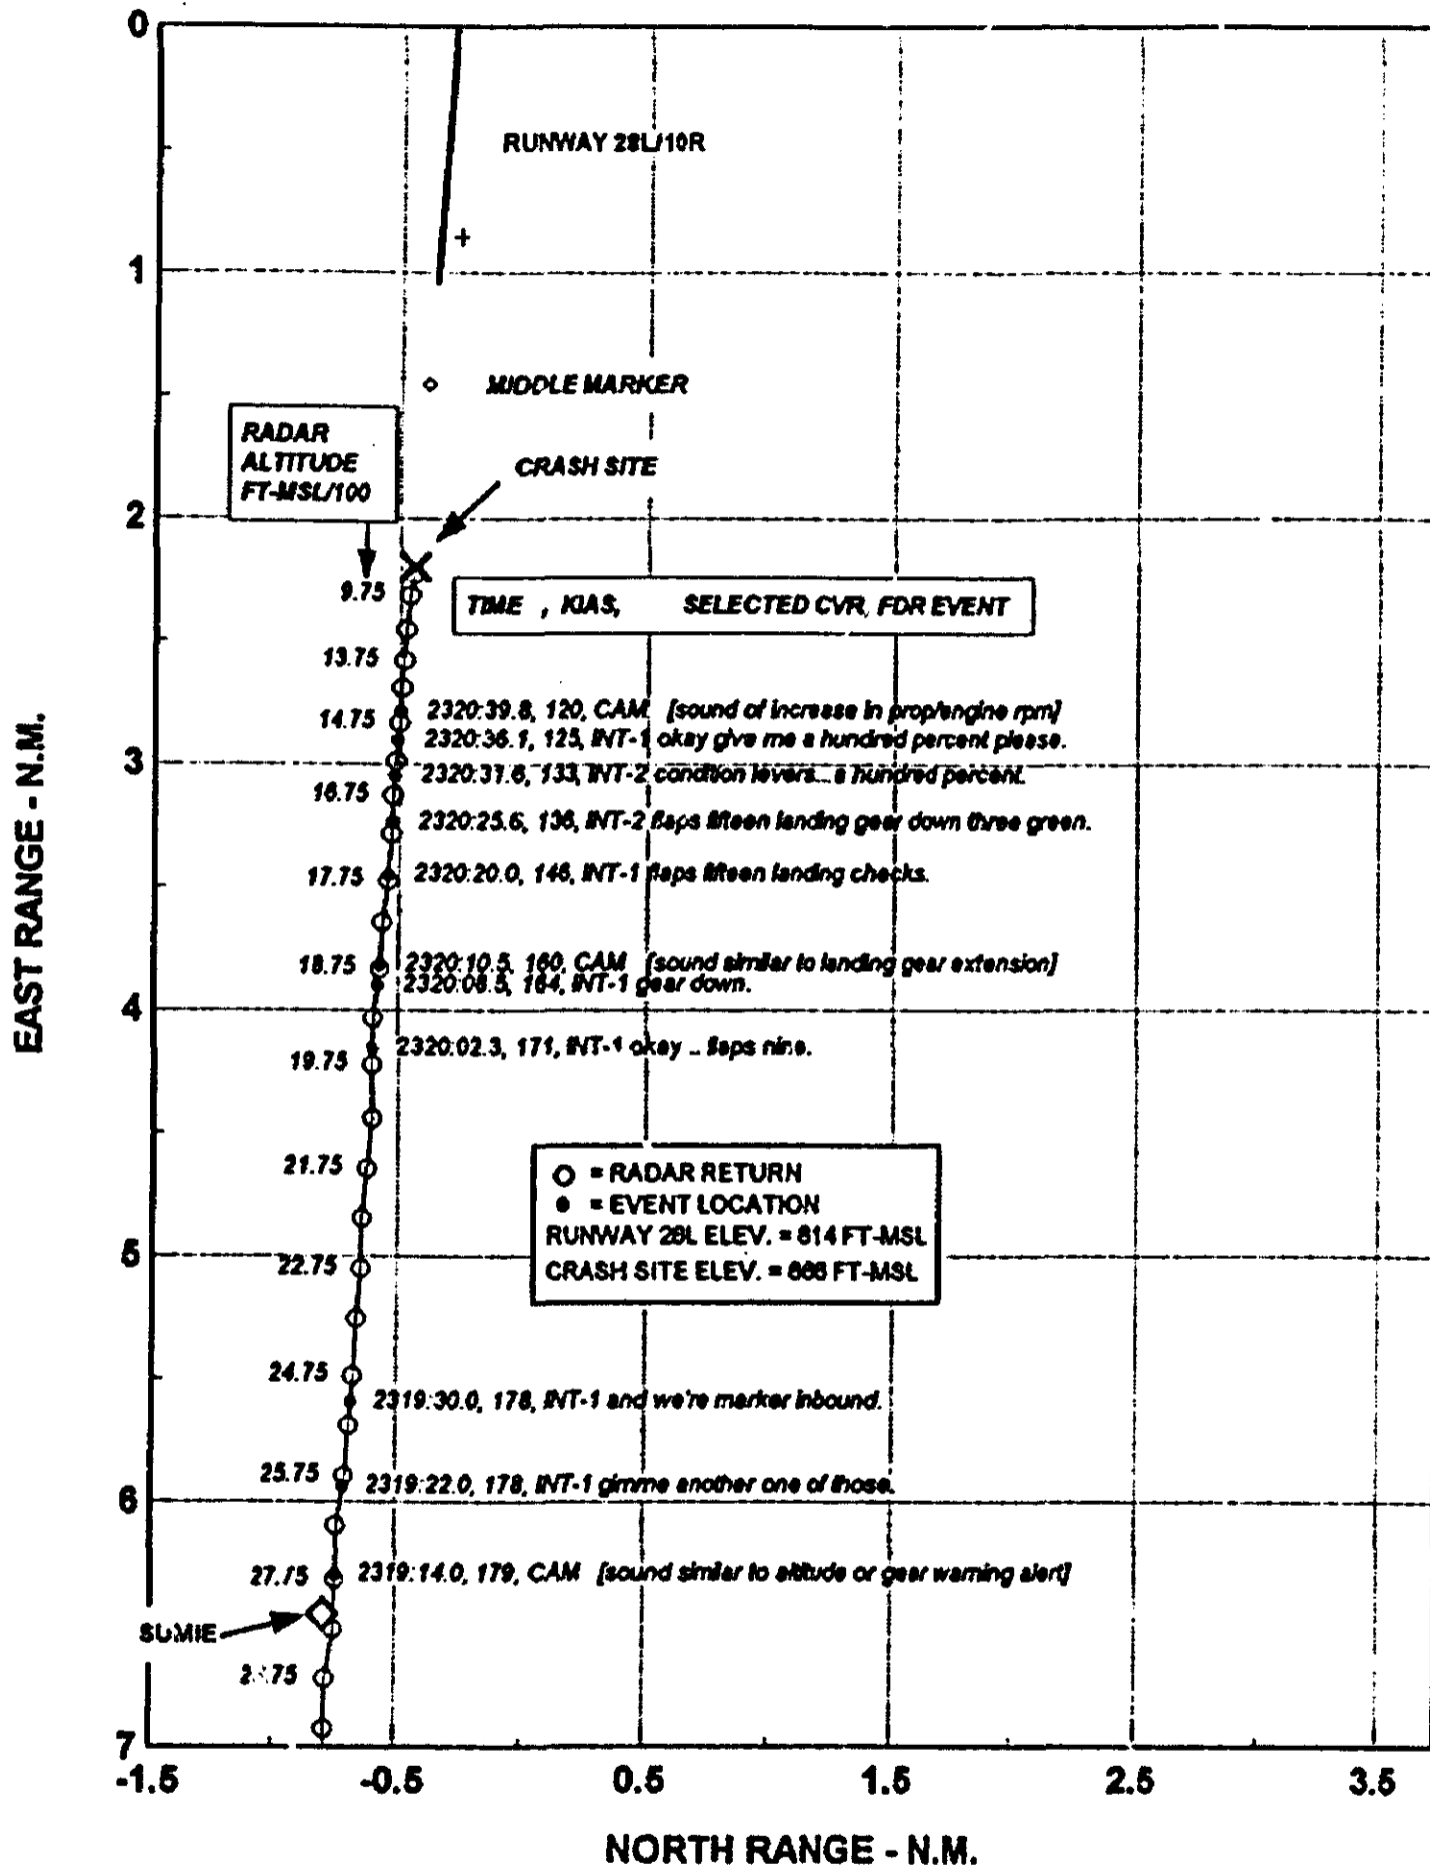
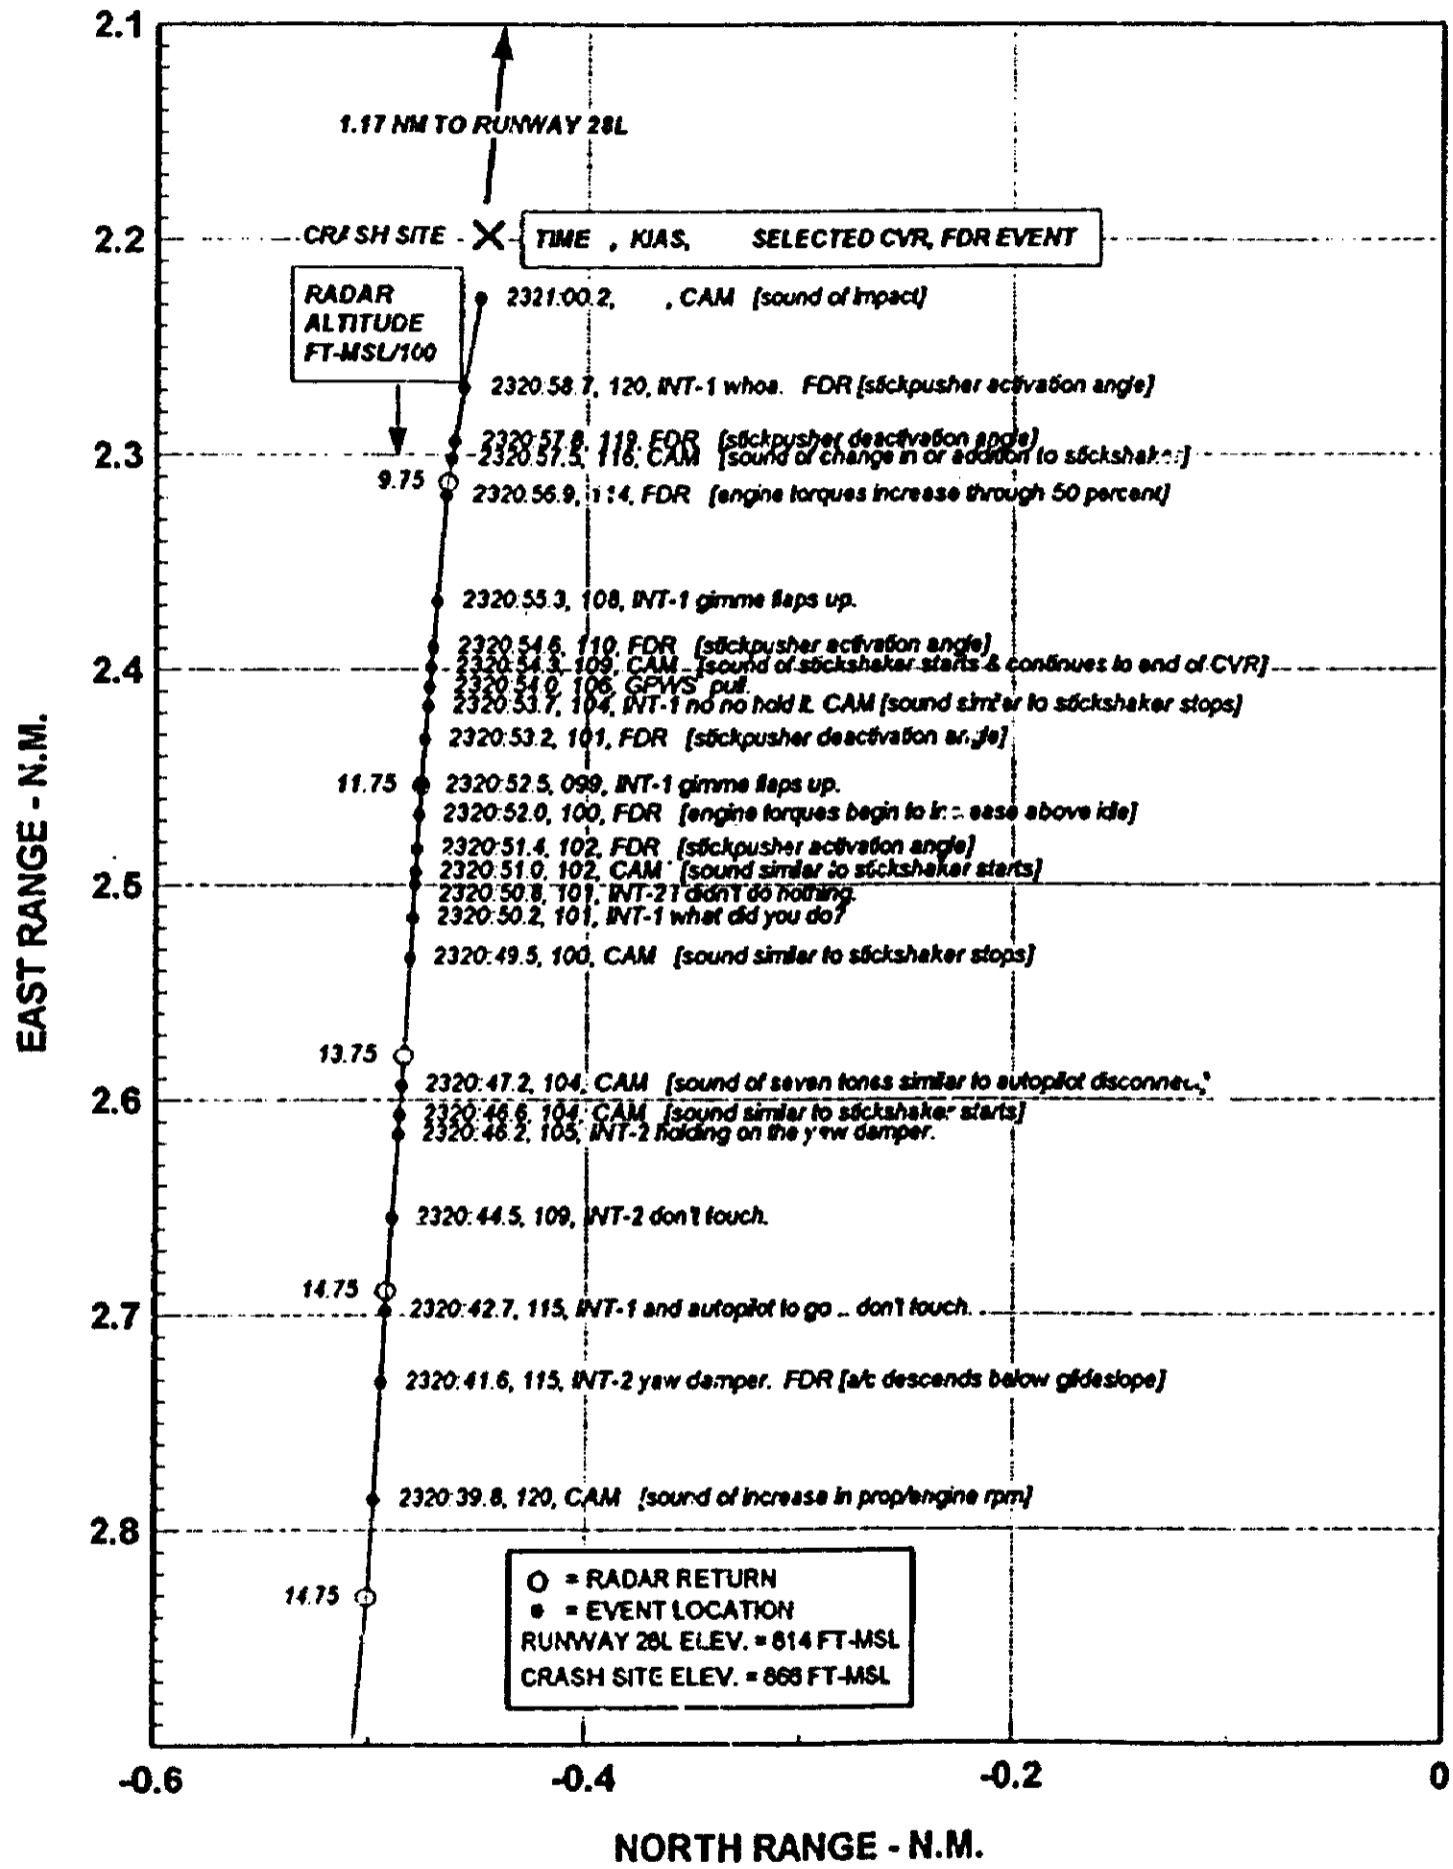
Figure 2.--Selected events from the CVR and FDR.

Figure 3.-- Selected events from the CVR and FDR.

Figure 4.-- Selected events from the CVR and FDR.

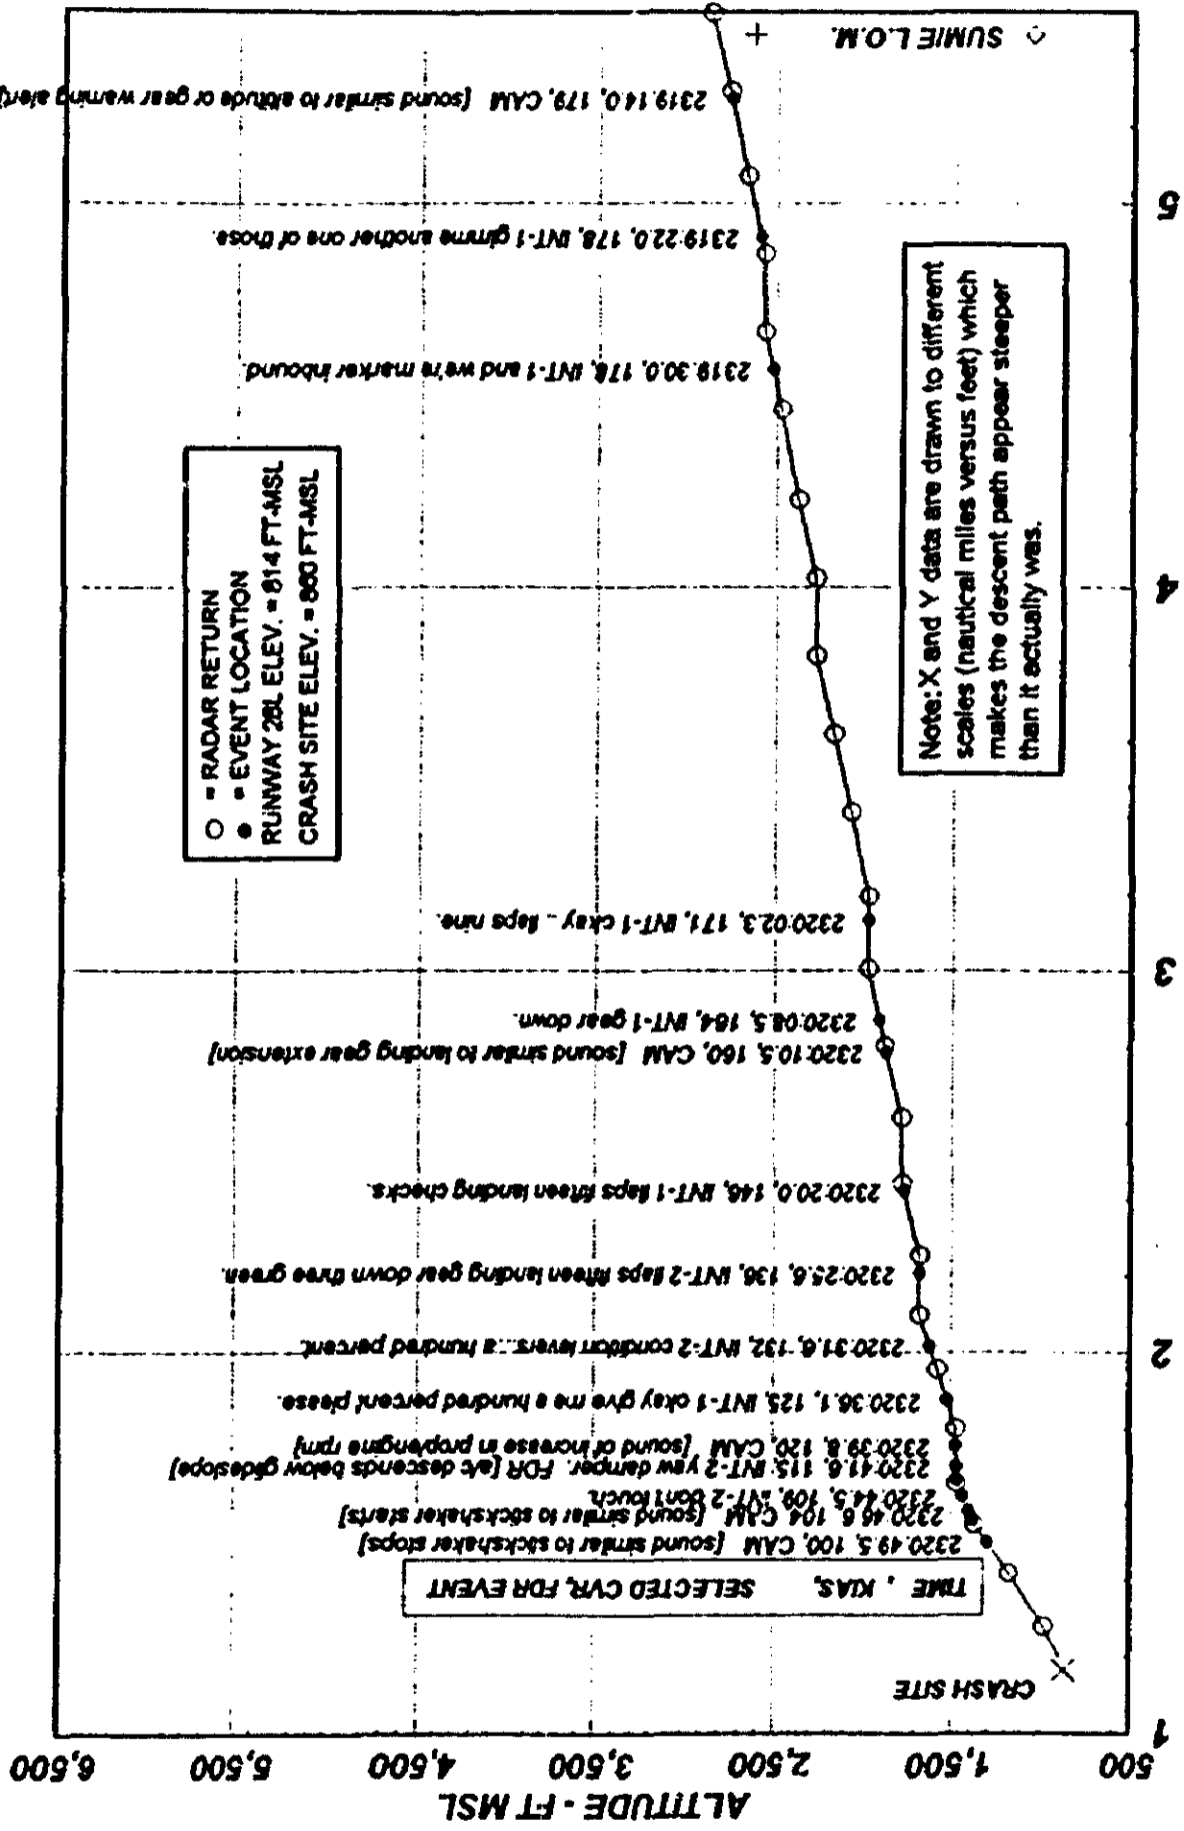
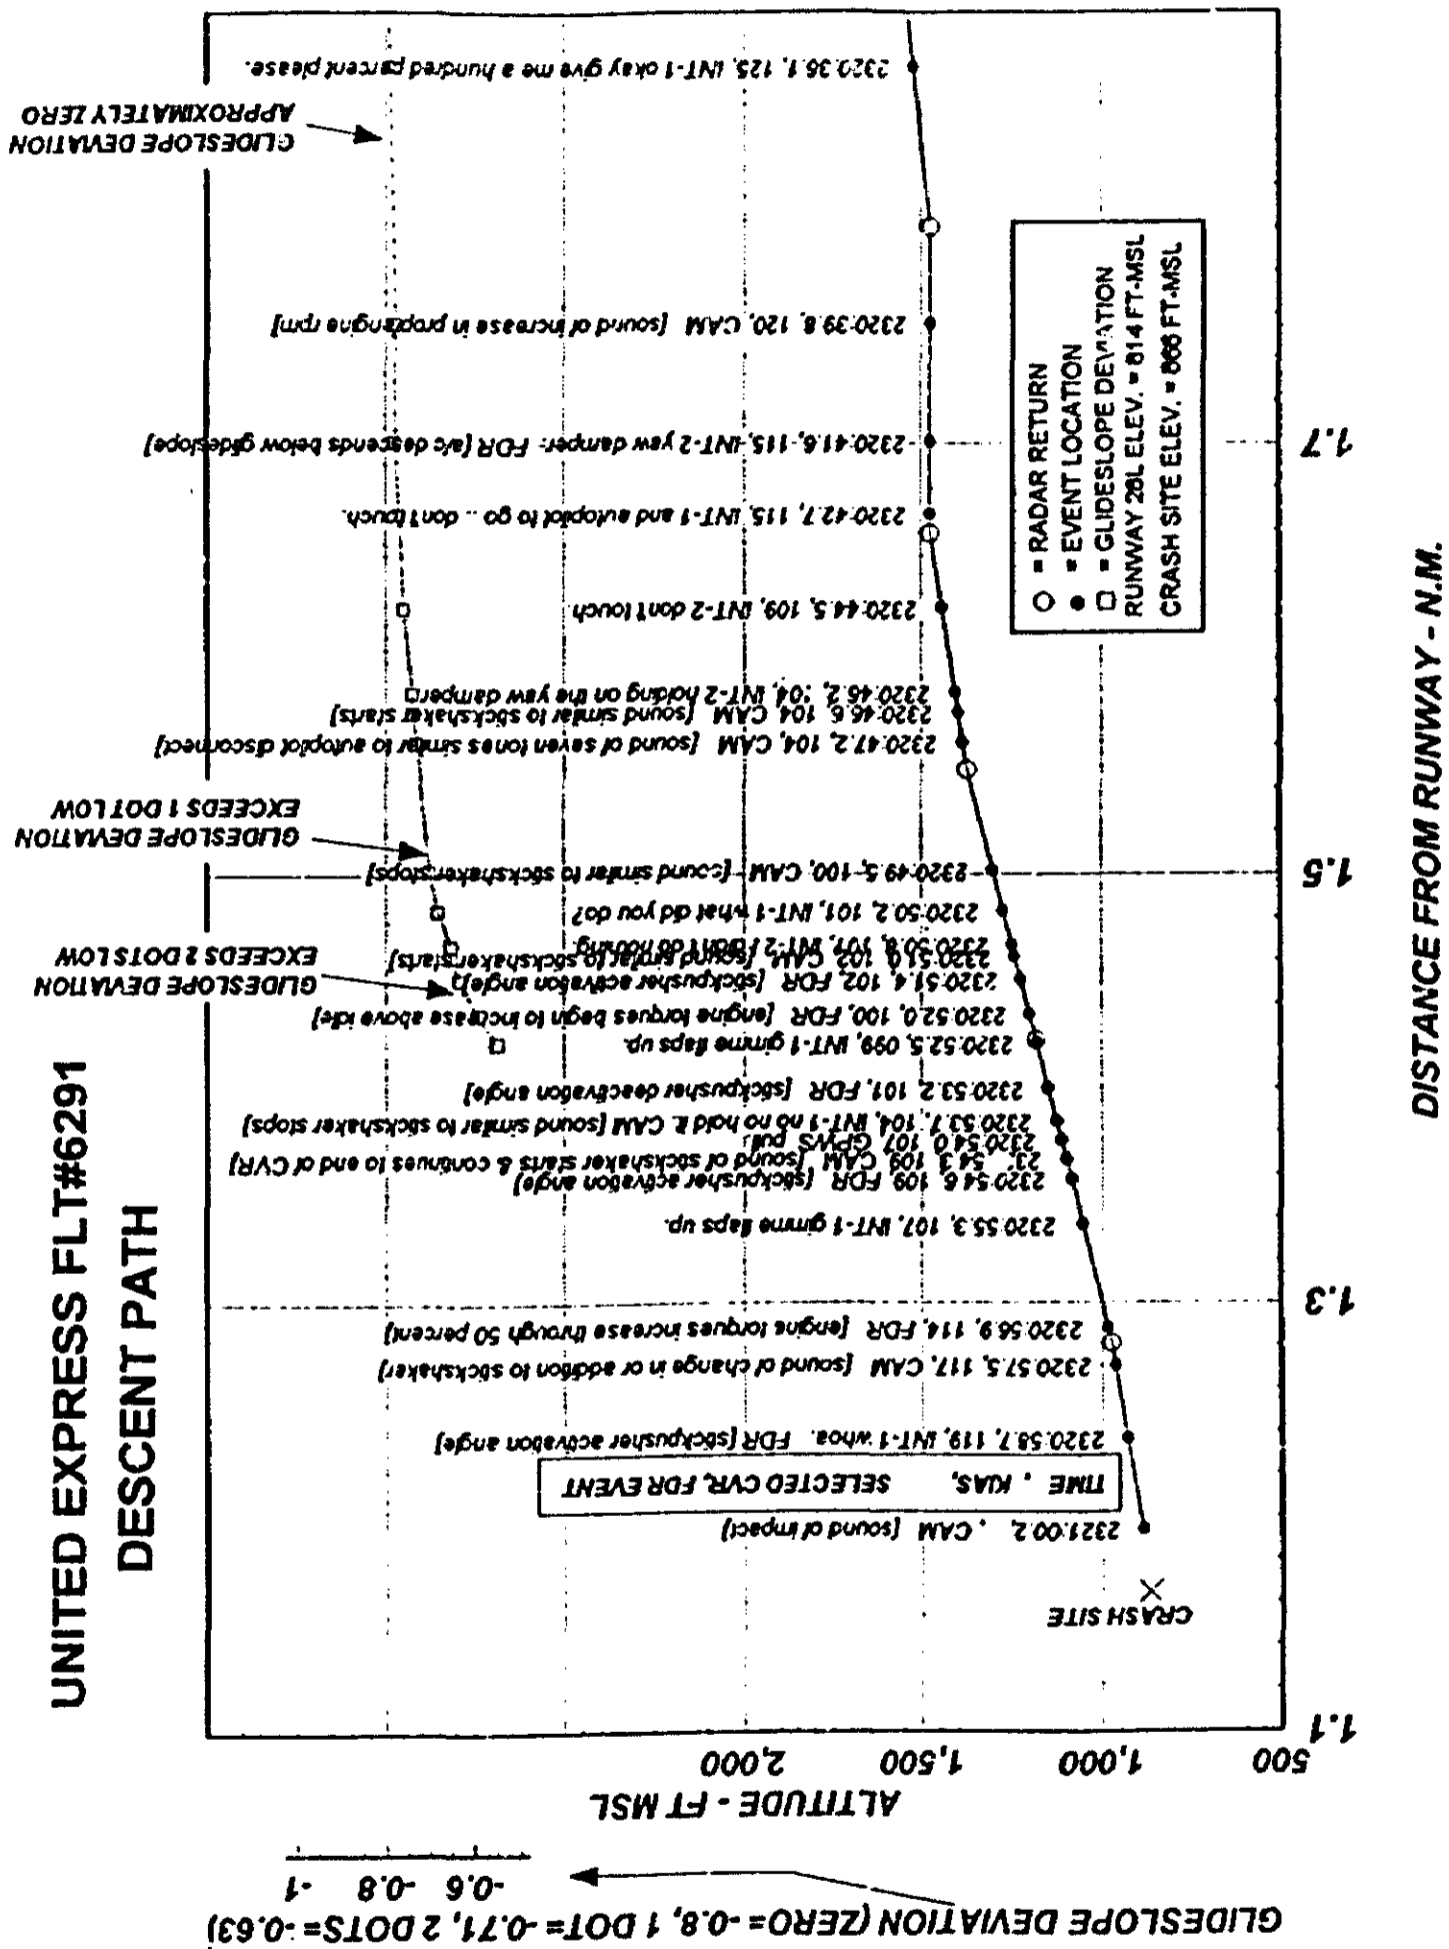
Figure 5.--Profile view of approach.

Figure 6.--Profile view of approach.

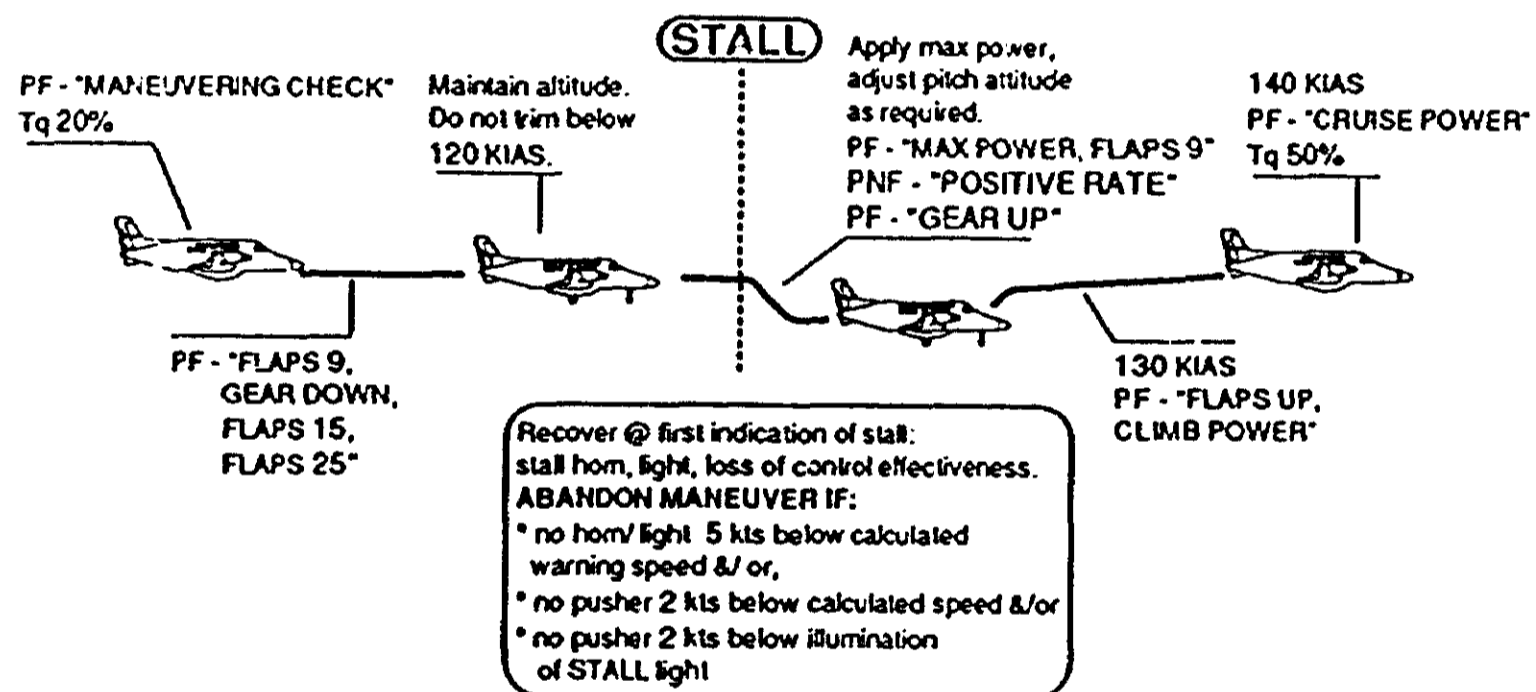
Figure 7.--J-4101 approach to stall -- landing configuration.

Figure 7 contains a graphic depiction of a J-4101 in landing configuration encountering a stall condition. It contains the procedure used to recover from such a situation.

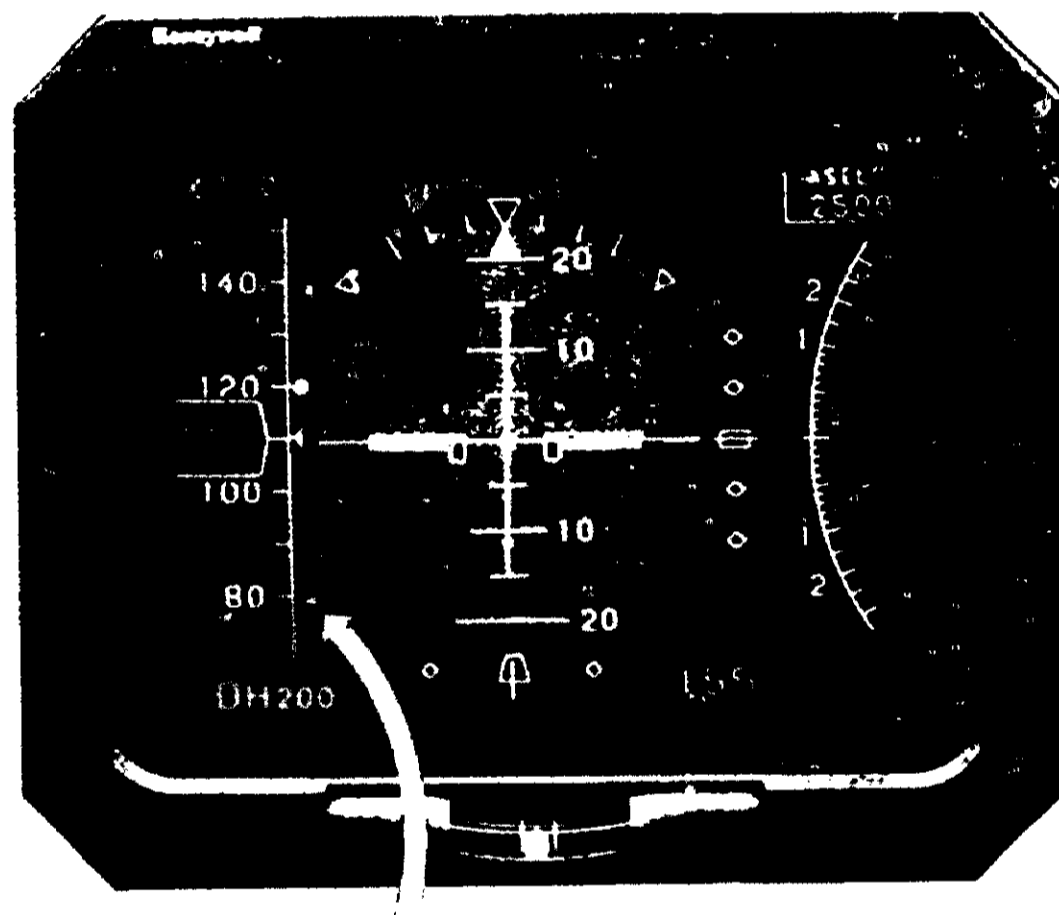
Figure 9.--Electronic attitude director indicator.

This format is similar to that of electronic displays of newer generation "glass cockpit" aircraft that have been introduced into service within the last 8 years. Pilot acceptance of the displays has generally been favorable, and, more important, they have not been suggested as contributory to accidents. Moreover, their presentation format across aircraft types has generally been consistent with human factors principles of presenting visual information. For example, in the

low airspeed
awareness indicator [red color]
