**Technical Report Series**

## **The World Trade Center Bombing: Report and Analysis**

**United States Fire Administration  
National Fire Data Center**

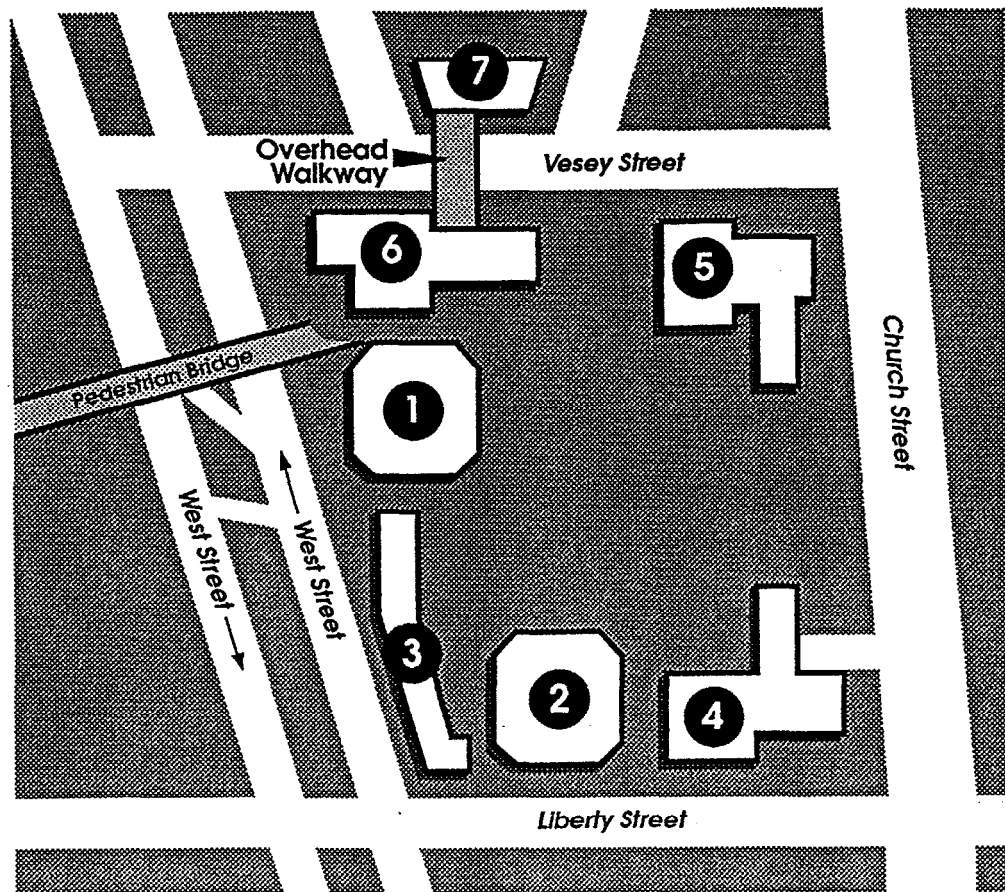
# World Trade Center Complex

- 1 World Trade Center - 110- story office tower
- 2 World Trade Center -110- story office tower
- 3 World Trade Center -22- story Vista Hotel
- 4 World Trade Center -9- story office building
- 5 World Trade Center -9- story office building
- 6 World Trade Center -8- story Customs House
- 7 World Trade Center -47- story office building

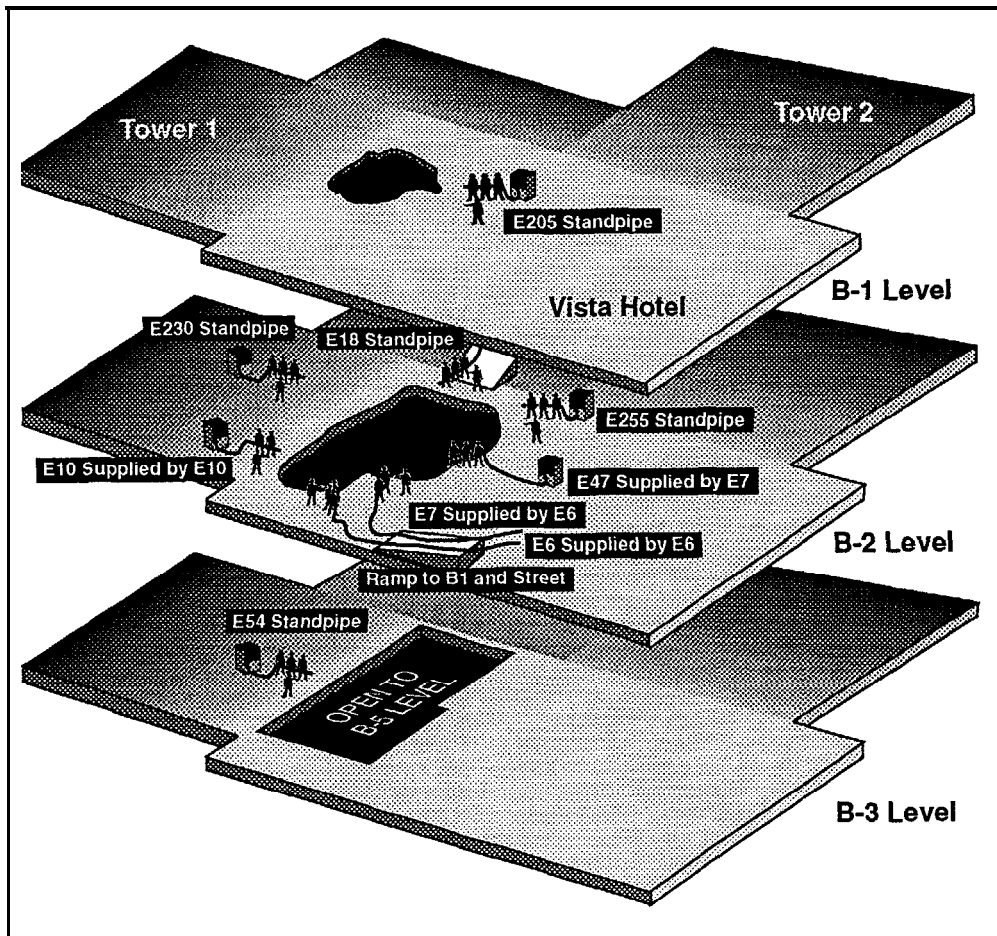
# Handlines Deployed in Fire Extinguishment

There were numerous fires on both the B-2 and B-3 levels. Members extinguished fires in offices, a cafeteria, locker rooms, workrooms, free-burning rubble, and at least 50 burning automobiles; lines also provided protection to Firefighter Kevin Shea, who had fallen into a crater and was vulnerable to numerous fires burning around him. As they advanced, firefighters on the attack lines searched for, and in some cases removed, victims from cars and under rubble.

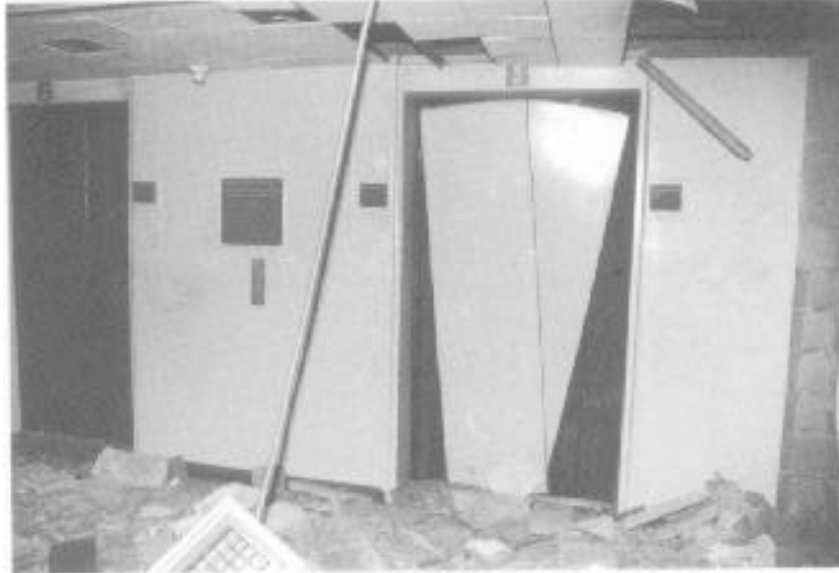
Damaged elevator doors and enclosures on the B-2 level presented a vertical channel for smoke spread into Tower 1. (Photo courtesy of Port Authority Risk Management.)

Above grade. The large quantities of smoke that had been generated prior to the fire's knockdown became a major operational factor. Due to the destroyed elevator shaft doors at the B-2 level, the hole in the Vista Hotel meeting room with the blown-out glass partition wall between the Vista Hotel and Tower 1, and doors being opened on all floors by people evacuating - and with the stack effect working - most floors and all stairways of Tower 1 and the Vista Hotel became charged with smoke. Tower 2 had a smoke condition but to a lesser degree. The smoke condition in Tower 1 was the worst of the three buildings above grade.

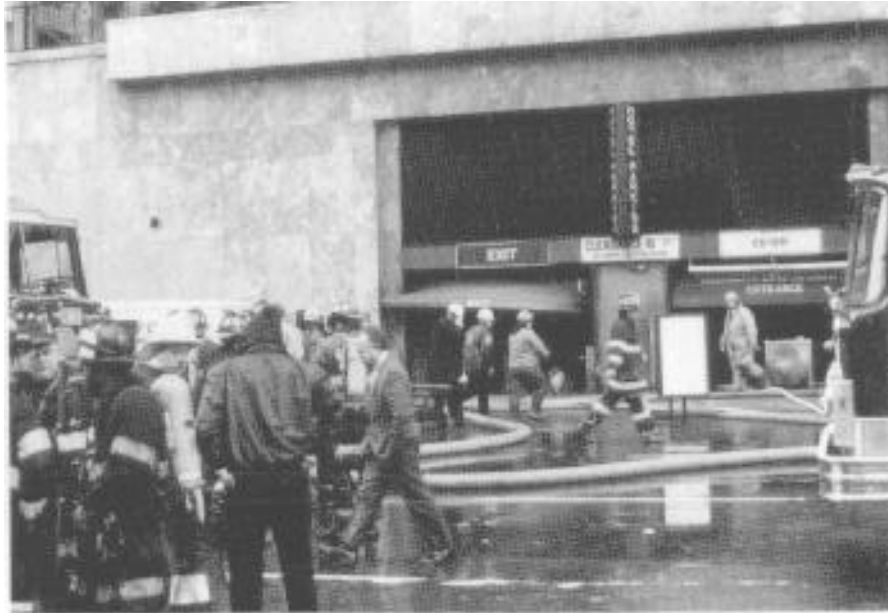
A view of the parking garage entrance on West Street, through which first fire companies launched the initial tire attack. (Photo by Arthur Knobloch.)

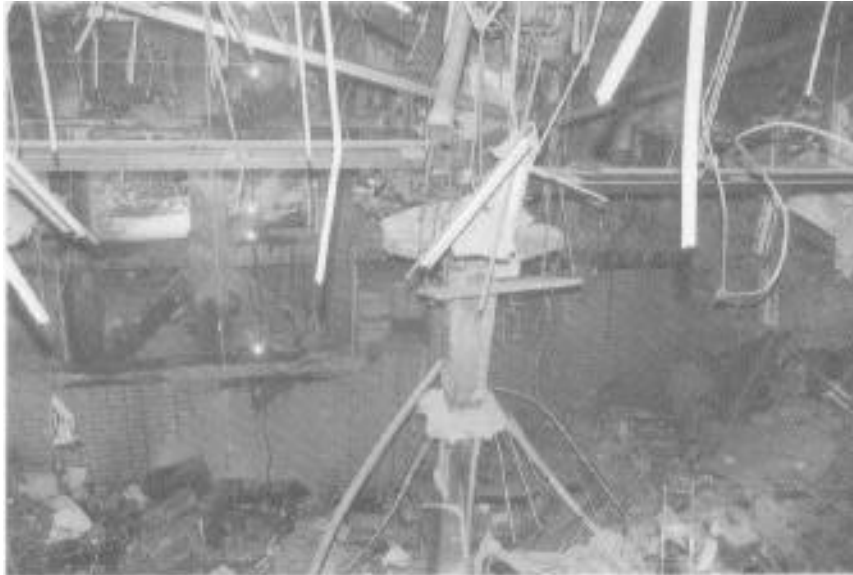
A view of the crater from the B-1 to B-5 levels. Note the steel column. Horizontal supports were destroyed in some cases, but the columns did not give. (Photo courtesy of Port Authority Risk Management.)

*Damage/hazard assessment.* Lights were brought into the below-grade areas. Damage from the blast was extensive. The B-2 level surrounding ground zero was completely destroyed. Piping and conduit were snapped like twigs. Masonry walls and steel-reinforced concrete flooring were blown apart. Cars were strewn about like toys. Steel columns were shocked but held.

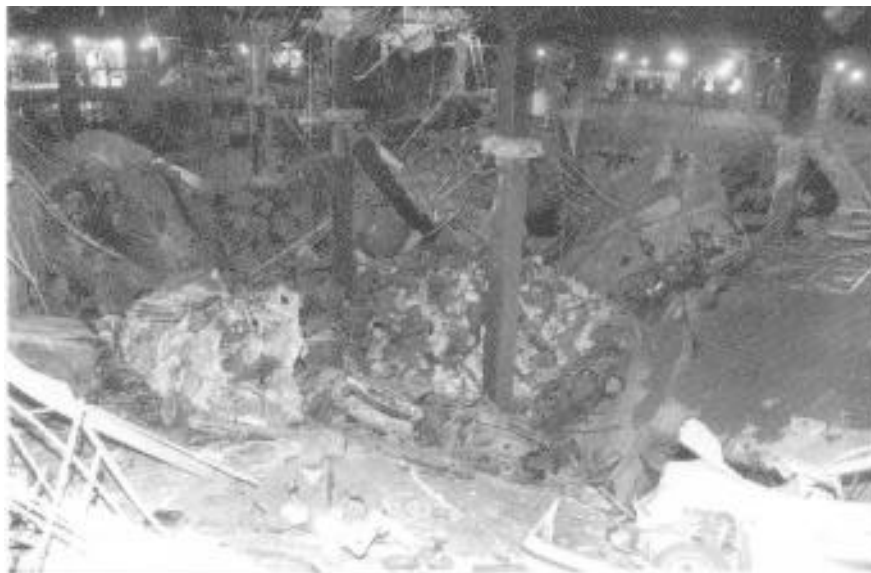
The crater, looking from the B-2 level down to B-5, taken during the investigation/restoration phase. (Photo courtesy of Port Authority Risk Management.)

- An L-shaped crater, approximately 130 by 150 feet at its maximum points, was opened, collapsing reinforced concrete and debris onto levels below.
- At least nine steel columns were heavily damaged and left without lateral support.
- Many walls collapsed, including a concrete block wall adjacent to the blast area that collapsed onto and killed five WTC personnel.
- Doors/enclosure walls of Tower 1 elevator shafts were heavily damaged.
- Some 200 vehicles were fully or partially destroyed, and many were on fire.
- Primary electrical power feeder lines were damaged.
- Stairway doors and shaft walls were heavily damaged.
- Some standpipes were damaged.
- The sprinkler system in the immediate blast area was destroyed.

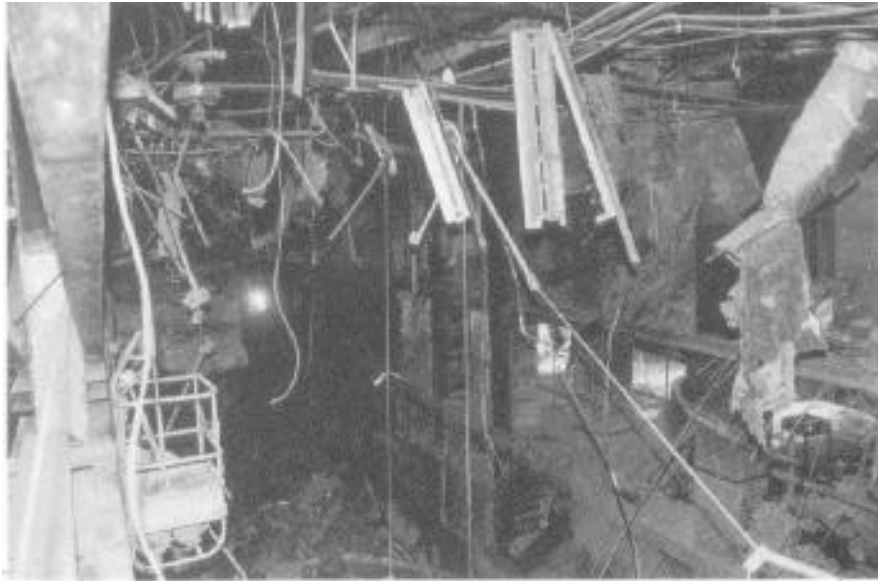
Firefighter Shea's fall was a long one—some 40 feet. The smoke condition in the crater was such that visible contact with Shea was impossible. (Photo by FDNY Photo Unit.)

At about the same time that Chief Burns advised me of the missing wall in the Vista Hotel, Assistant Chief Ralph Palmer, who with Assistant Chief Eugene Dockter had assumed command of the Vista Hotel sector, reported that a firefighter was missing. It was believed that he had fallen in a large hole (this turned out to be the explosion crater).

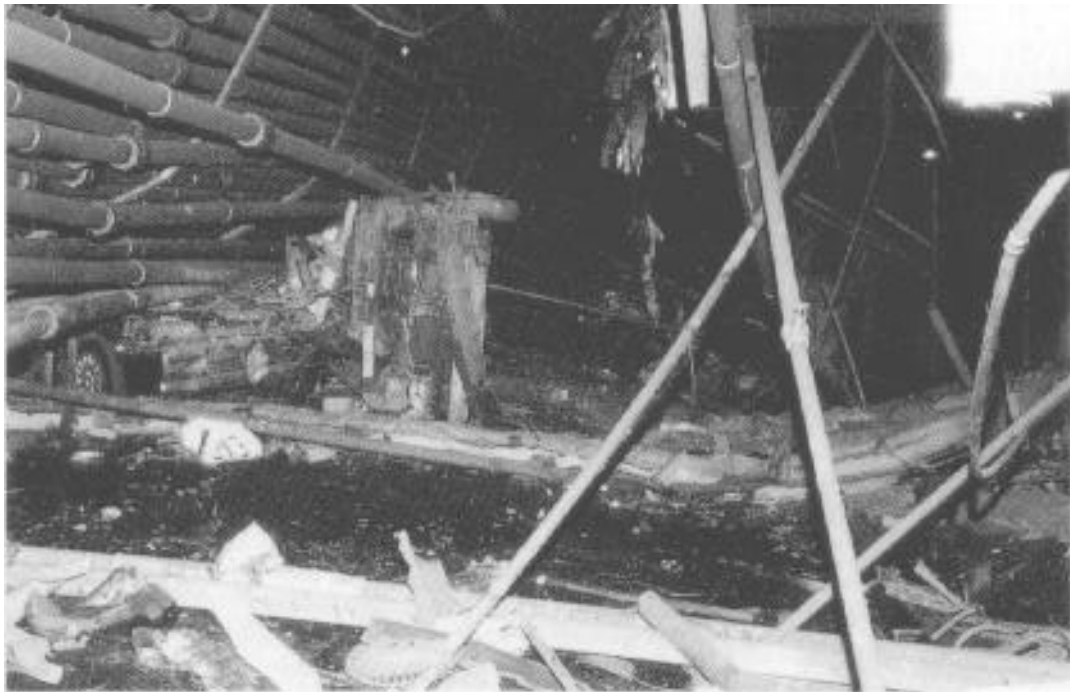
Building systems in the vicinity of the blast were destroyed. Here, twisted electrical conduit has landed on top of what was once a car. (Photo by FDNY Photo Unit.)

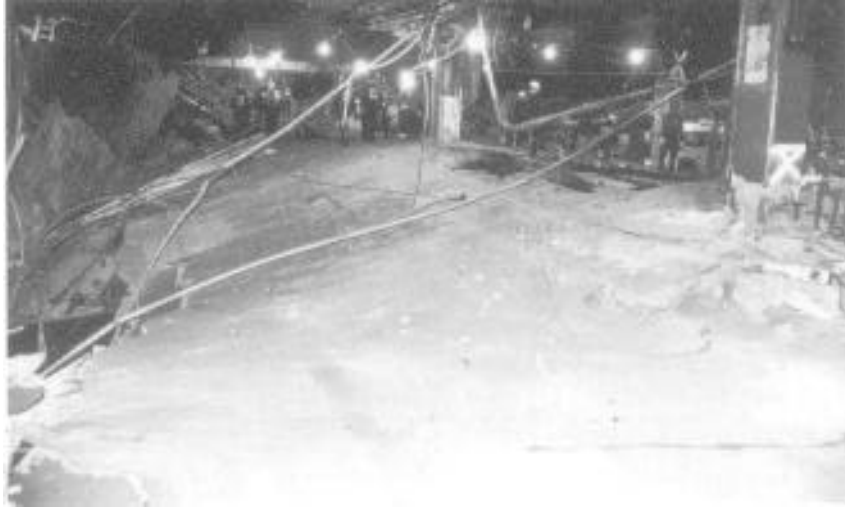
The sloping, hanging steel-reinforced concrete floor at the perimeter of the crater was a major hazard for units operating on the crater fire, particularly in the heavy smoke condition. (Photo by FDNY Photo Unit.)

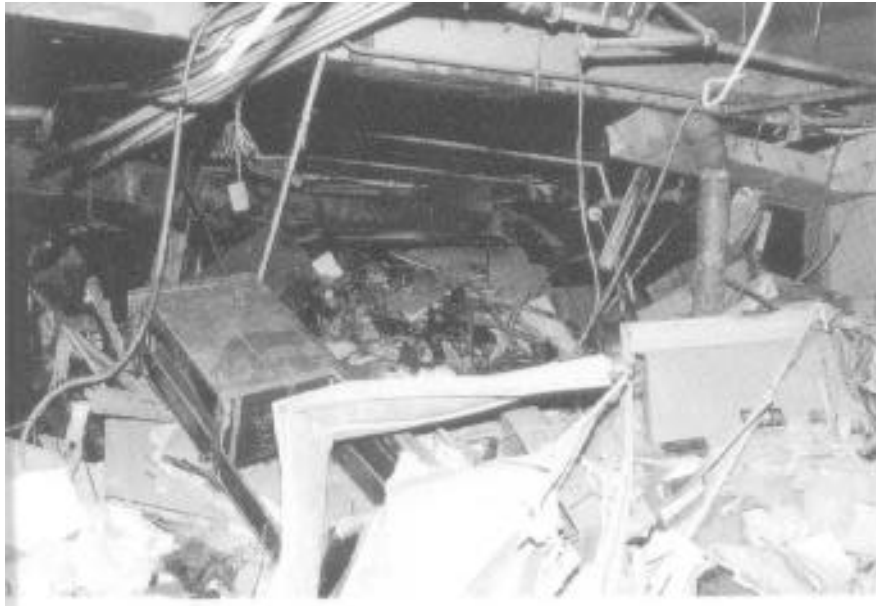
This destroyed office area on the B-2 level is typical of the debris piles faced by searching firefighters. (Photo courtesy of Port Authority Risk Management.)

Port Authority personnel assisted by establishing a probable victim location in occupied work areas on the B-2 level under the Vista Hotel and Tower 1. The blast destroyed a dividing wall between the garage and this work area (demolished, it was later found, by a steel support beam hurled through it with the unimaginable force created by the blast). A search first

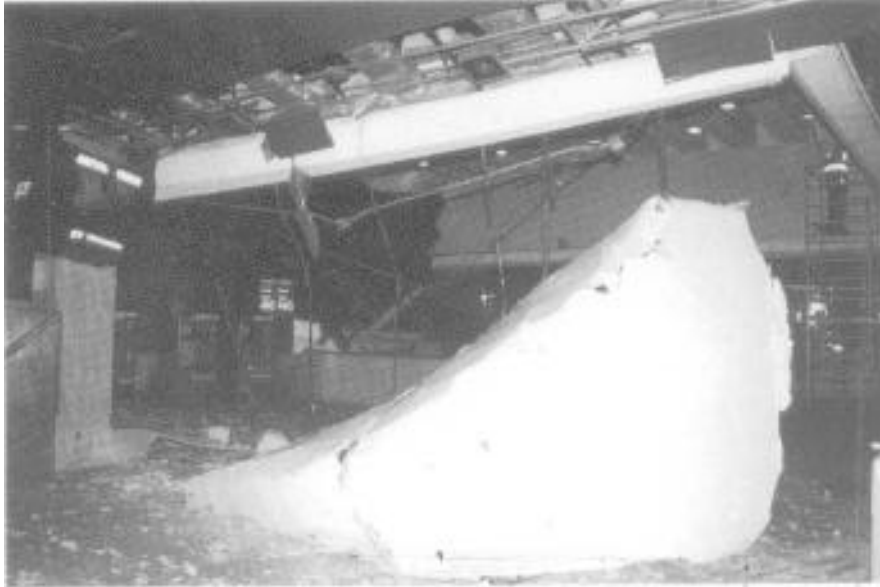
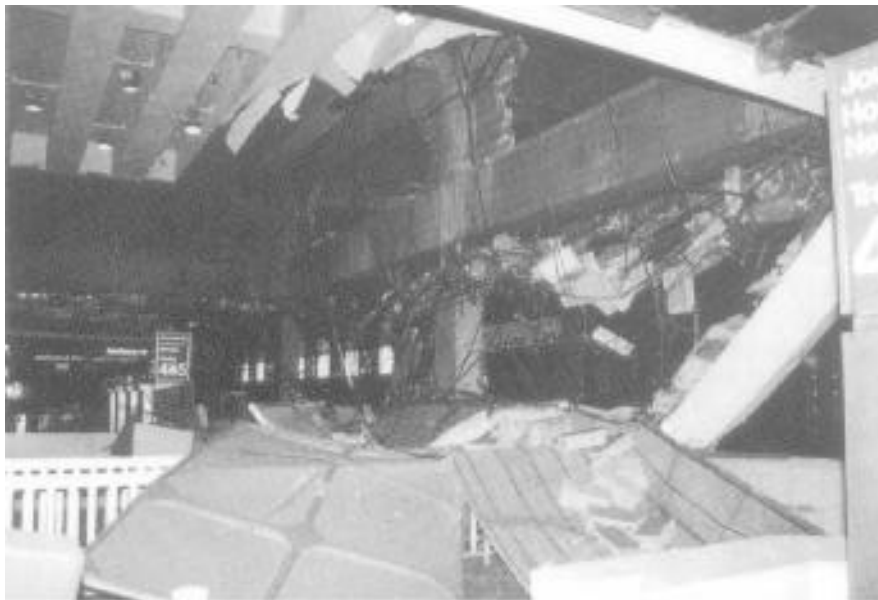
The explosion collapsed a portion of ceiling on the B-5 level onto a PATH train concourse. (Photos courtesy of Port Authority Risk Management.)

- Debris from the blast traveled through a three-level architectural opening (spanning B 3 through B 5) and crashed down on refrigeration equipment on B 5.
- A ceiling of the PATH train station on the B-5 level collapsed.
- A 24-inch-diameter water supply pipe from the Hudson River to the air-conditioning chillers, as well as other smaller refrigeration/air-conditioning and domestic water pipes, were ruptured.
- Domestic water lines to the emergency generators were damaged on the B-6 level.

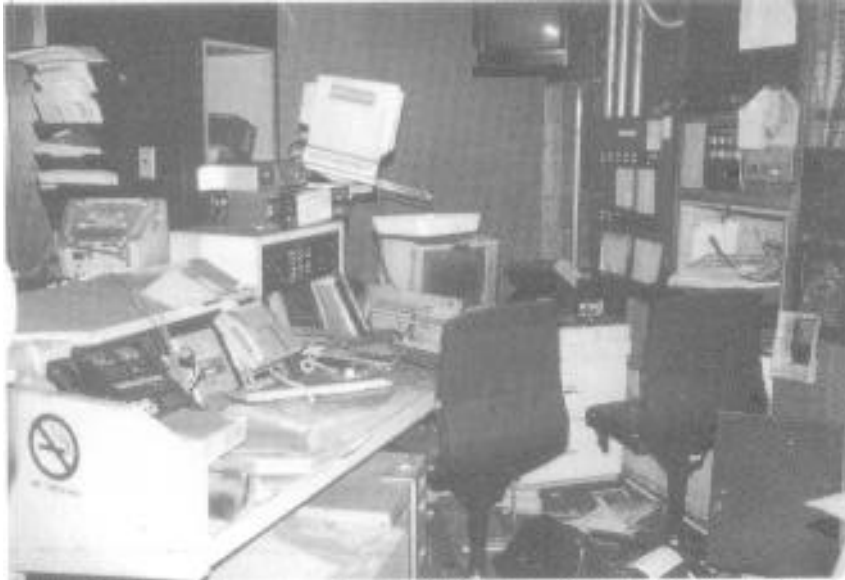
The Port Authority Command/Communications Center on the B-1 level, approximately 50 feet from the blast hole on that level, was damaged and communication with occupants in the towers was lost. (Photo courtesy of Port Authority Risk Management.)

- the complex's fire alarm and public address systems were out of service;
- the PA Police Department fire command station was out of service;
- the complex's standpipe systems was damaged due to destroyed piping on the lower levels but was effective in some areas for some units;

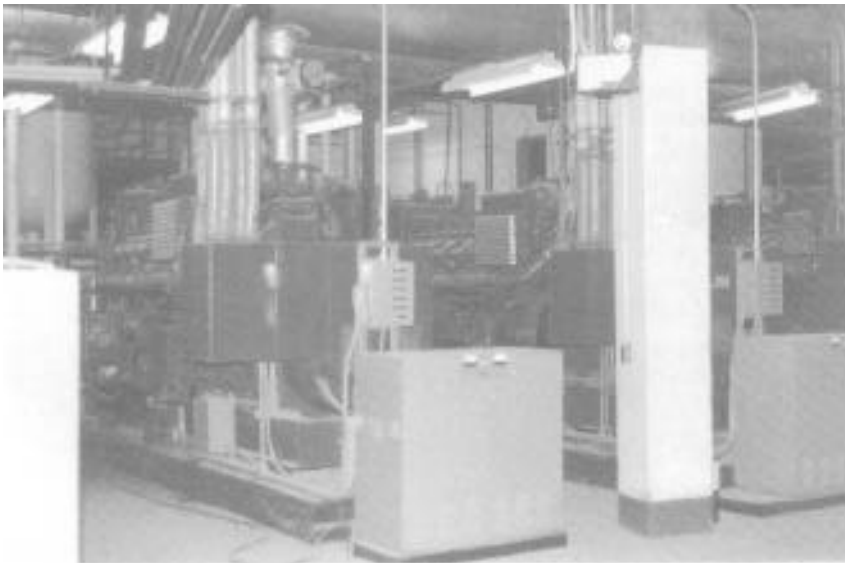
Emergency generators on the B-6 level. Cooling water lines for these units were ruptured by the blast, shutting down all emergency power. (Photo courtesy of Port Authority Risk Management.)

- emergency generators, located in the B-6 level, had their domestic water cooling lines broken by the blast. They ran for 20 minutes, then shut down because of overheating;

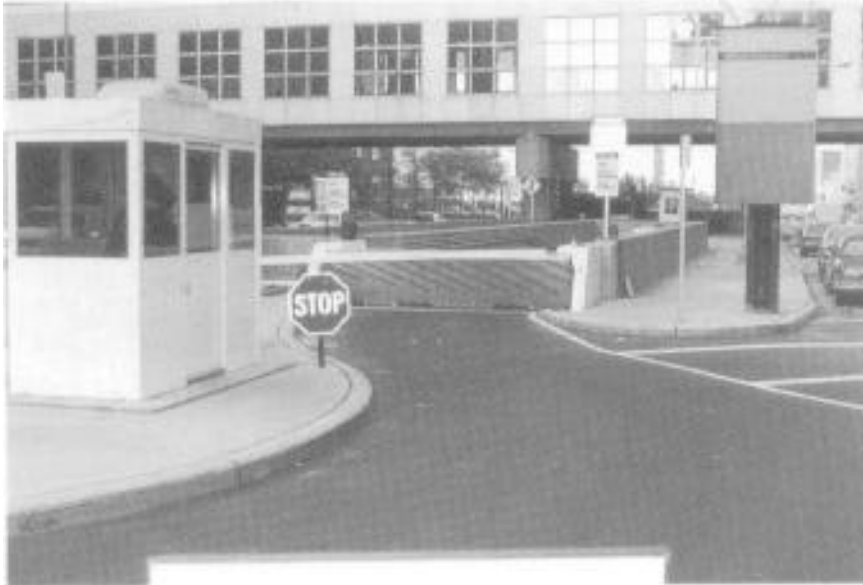
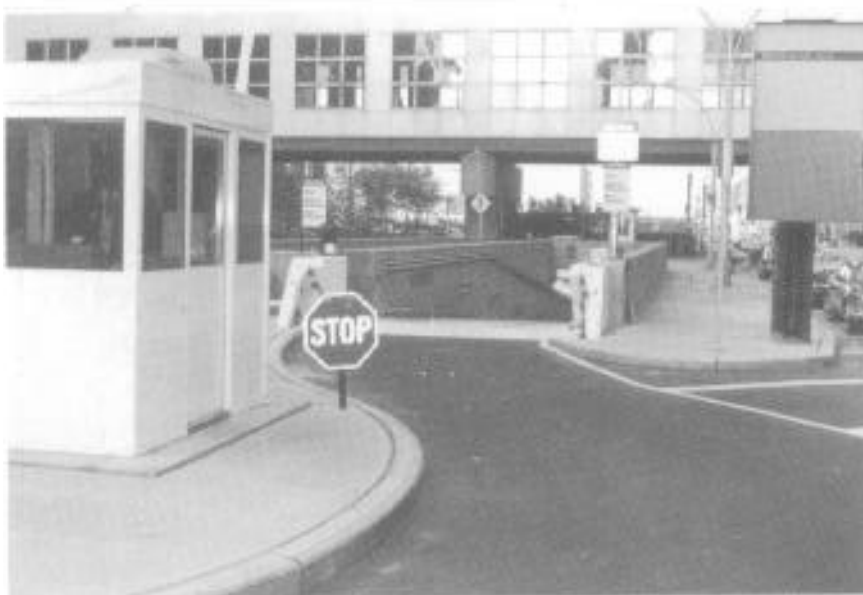
Controlling access to public buildings is a major concern for building management. After the incident, Port Authority, in addition to many security changes, installed substantial barriers to unauthorized vehicle access. The barrier, controlled by security personnel in the booth, folds down when the driver has been cleared to enter. (Photos courtesy of Port Authority Risk Management.)
