Bus Drivers' Exposure To Mechanical Shocks Due To Speed Bumps

Johan Granlund¹, and Anders Brandt²

¹Swedish Road Administration Consulting Services, Röda Vägen 1, SE-781 87 Borlänge, Sweden

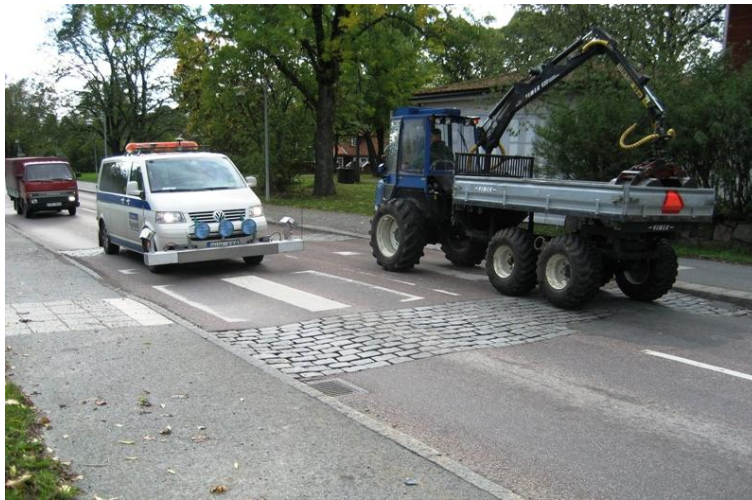
The 3-D geometry of each speed bump was scanned, using a laser/inertial Profilograph as shown in Figure 1. This type of Profilograph, equipped with a ramp of lasers scanning the road surface, is routinely used for surveying of the condition of paved public roads in Sweden. The resolution is 0.1 mm, while accuracy (precision and trueness) are within fractions of a millimeter under normal operation conditions. The Profilograph allows accurate measurements while driving at speeds up to 165 kmph, while 15 to 90 kmph are normally used.

Figure 1. Profiling a flat top bump with cobble stone with the Profilogaph.

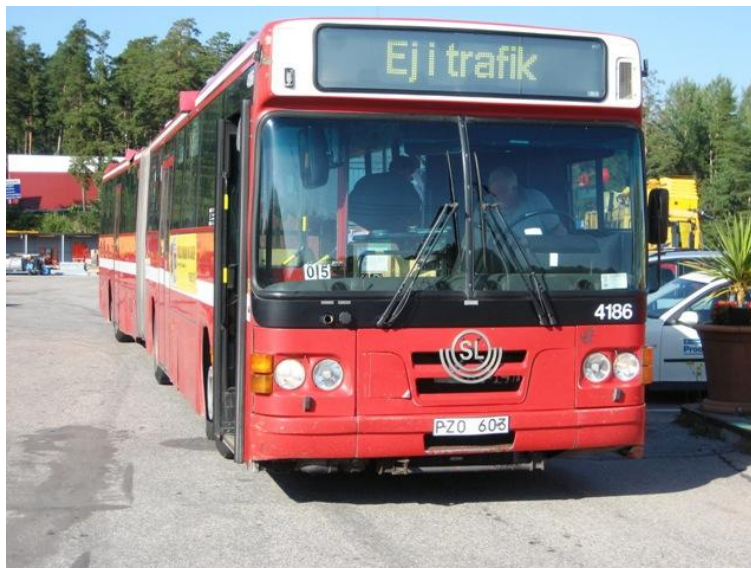
Transient vibration was measured in two different buses while driving at various speeds. Most measurements were made in a long articulated low entrance bus for urban traffic, seen in Figure 2. Some measurements were also made in a short bus, designed for rural traffic.

Figure 2. Long articulated low entrance bus.

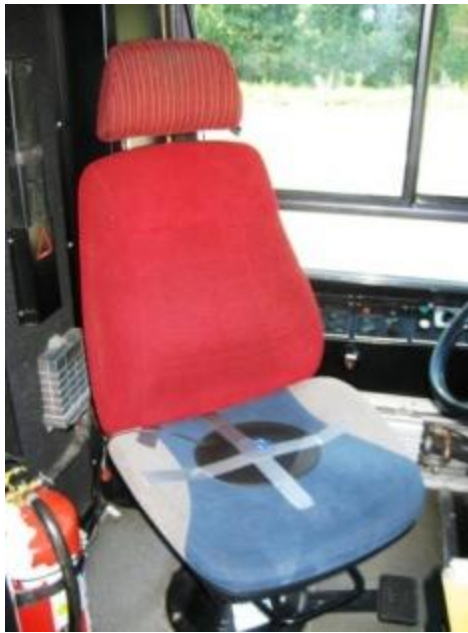
Vibration was recorded on the bus driver's seat, using a triaxial seat pad complying with ISO 8041, as seen in Figure 3. The vibration measurements were made with a system that fulfils the accuracy demands in standard ISO 8041. The seat was of a non-suspended type; the type of seat normally being used in urban buses in Sweden. The bus driver's weight was 90 kg.

Figure 3. Triaxial seat pad mounted on the bus driver's seat.

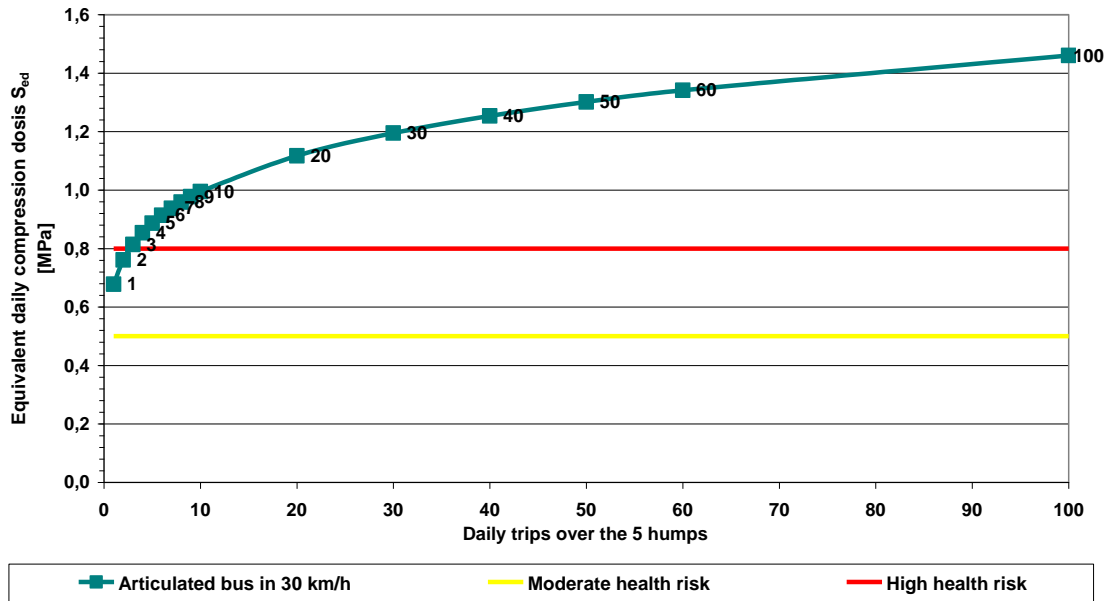
Some flat top bumps showed extremely high shock levels. The graph in Figure 4 shows results from a street with five “very aggressive” flat top bumps. The resulting graph shows that the driver seat transient vibration caused an S_{ed} value exceeding the limit of 0.5 MPa (low health risk) already at one trip per day, while the High health risk limit of 0.8 MPa was passed at three trips daily. Unfortunately no measurement were planned or executed on passenger seats. Assuming that passengers are exposed to somewhat similar shock levels as the bus driver, these data raise concerns for health risks also for commuting passengers.

Figure 4. Health risk vs. number of daily trips per day (flat top bumps). Bus having nominal speed, 30 kmph.

The health risk increases with increased number of bumps per day, see Figure 4. These data are the results from an articulated bus driving at 30 kmph (approx. 20 mph), assuming from 1 to 100 daily trips. An increase from one to two daily trips over the streets five bumps will increase the S_{ed} -value by 12 %. An increase from nine to ten trips daily will increase S_{ed} by 2 %. An increase from 99 to 100 trips daily will increase S_{ed} by only 0.2 %. The alarming fact is, that even after as few as three daily trips on this stretch, the health risk is high. Some bus drivers frequents this stretch tenfolds per day, which results in very severe health risks. It should be noted, however, that the results in Figure 4 assume a driving speed at the regulated speed of 30 kmph which causes great uncomfort, making some drivers drive slower than 30 kmph when passing the bumps. This is further discussed below.

The speed where the limit value $S_{ed} = 0.5$ MPa is reached, varies with the number of bumps per day. The highest acceptable speed over the same road as presented in Figures 4 and 5 is presented in Figure 6 as a function of the number of daily trips over the 5 bumps on this street. Drivers who make some 30 trips daily ($30 \cdot 5 = 150$ bumps/day) on this road, cannot drive more than 10 km/h before the limit value is exceeded. Since the drivers also drive over other bumps, S_{ed} will be higher in practice. This reduces the maximum acceptable speed further.

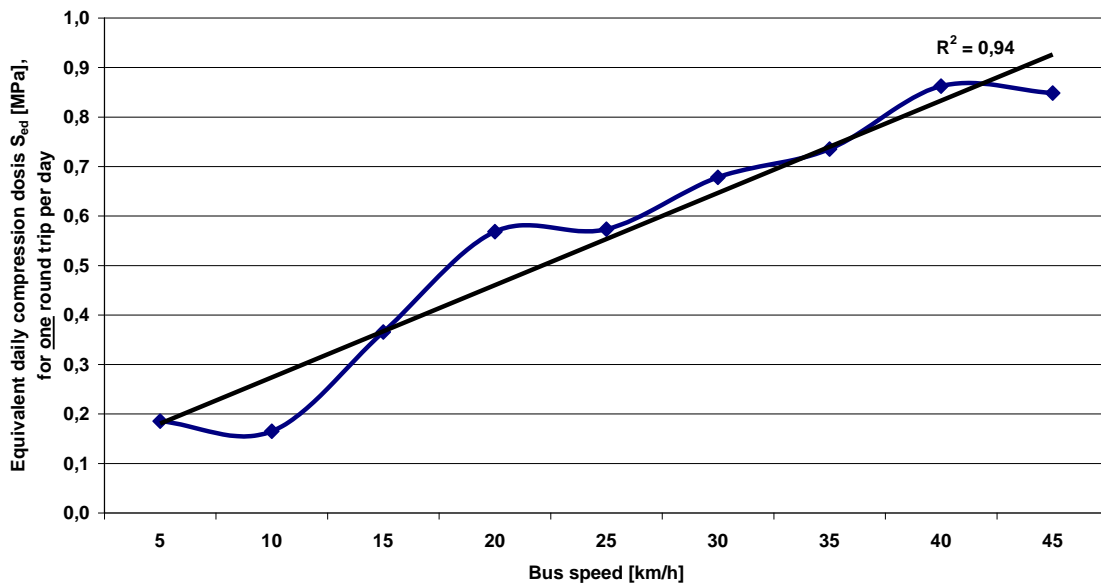
Reproduced measurements at various nominal speeds show that the S_{ed} -value (and thereby the health risk) increase with increased speed, see Figure 5.

Figure 5. Health risk increases with speed; data from an articulated bus on flat top bumps.

From Figure 5 it is clear that the static compression dose is not following a linear relationship with speed, as can be seen between 10 and 20 km/h. This can be partly explained by the fact that the frequency content of the shock changes with speed, and thus the relationship between the speed and S_{ed} will be a rather complicated relationship. Furthermore, the S_{ed} model itself is nonlinear. It is still apparent from Figure 5 that the static compression dose generally is increasing with speed.

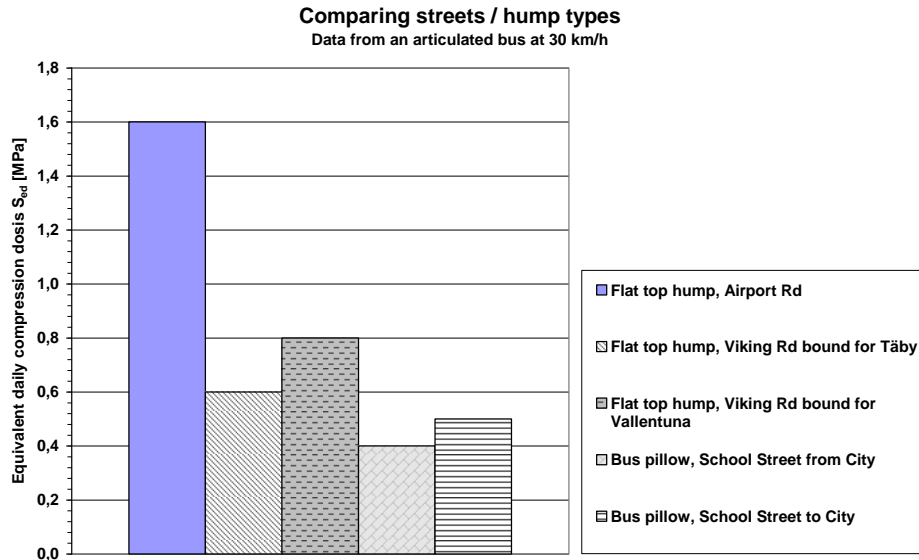
The project objective was to investigate several different speed bump designs with respect to health risk. Measurements of different speed bumps using the same driver, and bus, and constant nominal speed showed a very large variance in S_{ed} -values, and thus also in health risk. Figure 7 shows that the bus driver was exposed to some 1.6 MPa over the flat top bumps at the Airport Rd, which is about 170 % more than the 0.6 MPa achieved over the flat top bumps at the Viking Rd. The variance was large also among the other tested bumps. This indicates that the status of current speed bumps is so poorly standardized (design, construction variance as well as wear and tear conditions), that each bump should be regarded as an individual. Overall, some bump types are still consistently showing lower static compression than other types.

Figure 7. Health risk per street (rather: per group of bumps)

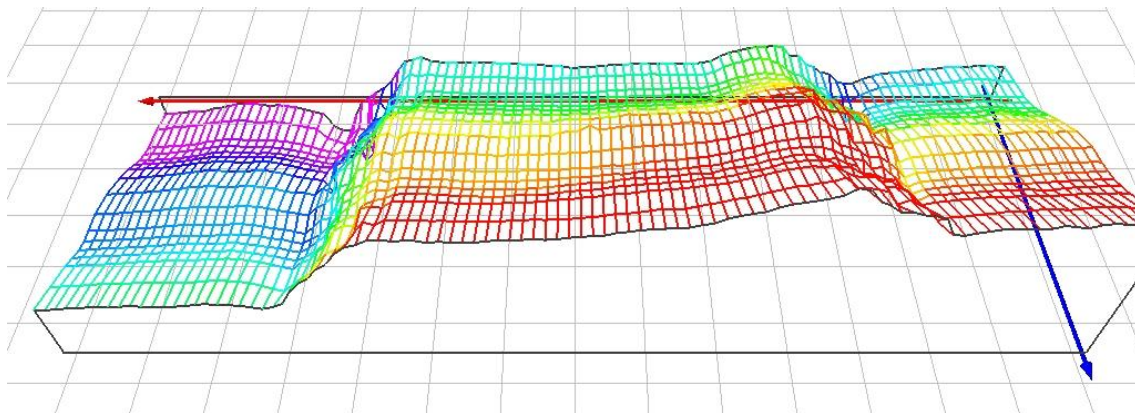
The Profilograph inertially compensated laser scans showed that many bumps were deformed compared with their nominal geometry. An example was the cobble stone ramps at some of the flat top bumps, an example of which is shown in Figure 8. These ramps were also found to generate much traffic noise.

Figure 8. 3D geometry of one of the bumps at the Viking Rd
