## ENHANCED EROSION PROTECTION FOR ROTOR BLADES

### ABSTRACT

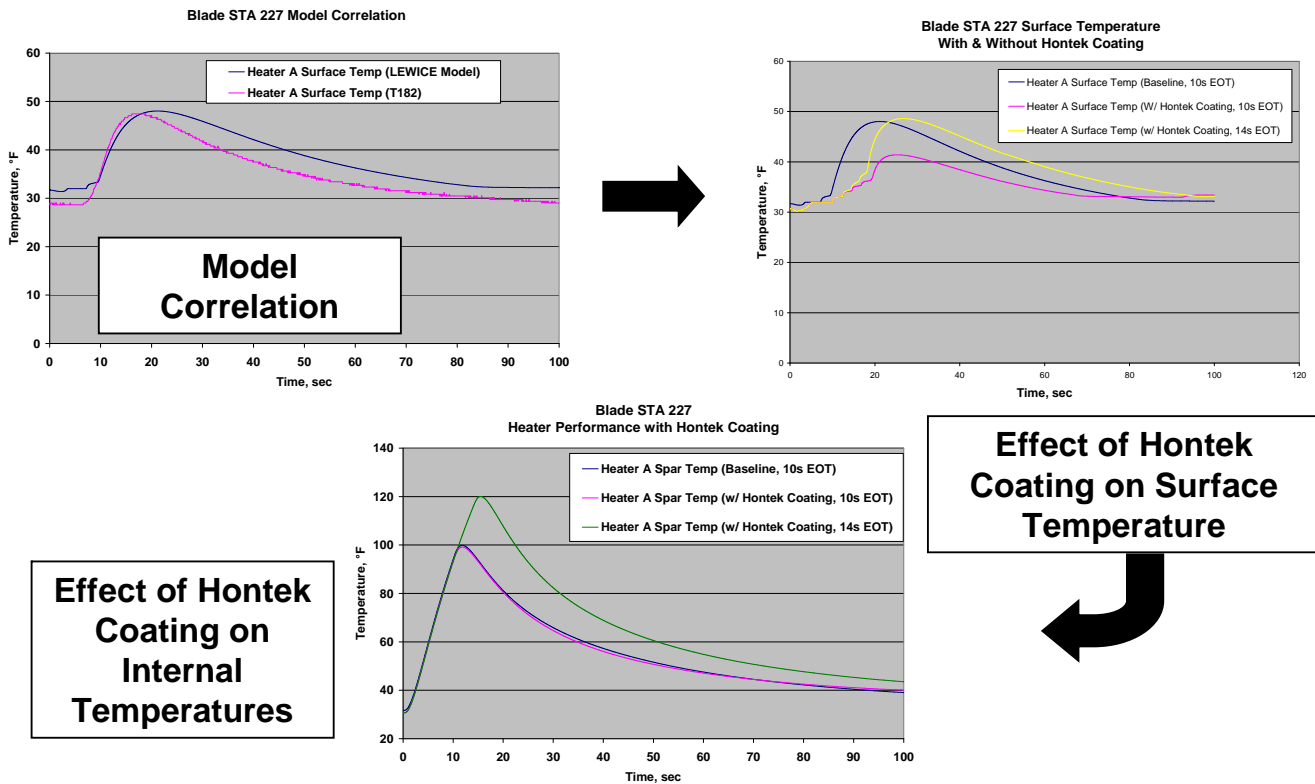
Fig. 4. Thermal analysis procedure for ice protection analysis.

The models of the blade structure without the Hontek coating were built at different locations where there were existing flight test data from the Nova Scotia testing. The models were correlated to the flight test data at an outside air temperature of  $-10^{\circ}\text{F}$  ( $-23.3^{\circ}\text{C}$ ) to ensure model integrity. With the validation of the models for the as-built blade structure, the extra coating layer was applied to the thermal model. The coating was defined to have a nominal coating thickness of 0.020 inch. The analyses for the different blade stations were rerun at the ambient temperature  $-10^{\circ}\text{F}$  ( $-23.3^{\circ}\text{C}$ ) to determine the impact of the coating on the transfer of heat from the thermal blankets to the iced blade surface. To ensure that there was margin to allow for variations in the thicknesses of the different structures in the blade design, a minimum peak surface temperature of  $45^{\circ}\text{F}$  ( $7.2^{\circ}\text{C}$ ) was required after heat was applied at the embedded heater location. If the surface temperature did not achieve  $45^{\circ}\text{F}$  ( $7.2^{\circ}\text{C}$ ), it was determined that the erosion coating had degraded the ability of the blade to melt and shed accumulated ice. After the analyses of the heat transfer to the blade surface were performed, additional analyses were performed to ensure that the coating did not retain the heat in the blade structure, causing it to rise to levels where the composite

structure might be degraded. A schematic of this process is shown in Fig. 4.

The modeling effort produced several results. The SINDA/G software successfully matched the instrumented test results at various locations along the blade at  $-10^{\circ}\text{F}$  and  $12^{\circ}\text{F}$  ( $-23.3^{\circ}\text{C}$  and  $-11.1^{\circ}\text{C}$ ) outside air temperatures. The addition of the Hontek coating did not hinder the blade surface from reaching this required minimum  $45^{\circ}\text{F}$  ( $7.2^{\circ}\text{C}$ ) temperature, except in one inboard deice zone. Since erosion damage is less severe on the inboard section of rotor blades, it was proposed that a reduced Hontek coating thickness might prevent the reduced erosion while retaining ice protection. A follow-on analysis was performed to determine if a reduced coating thickness of 0.010 inch, half the nominal coating thickness, might enhance the ice protection. The analysis showed that this would have little impact for ice protection relative to the full 0.020 inch thickness.

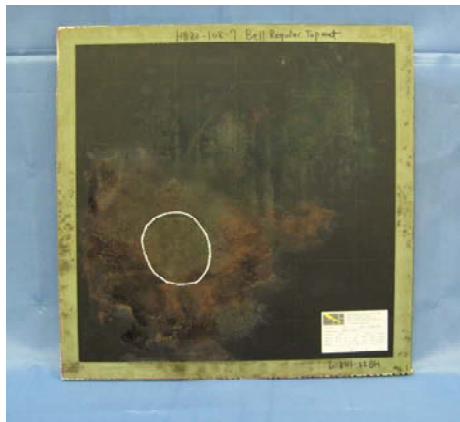
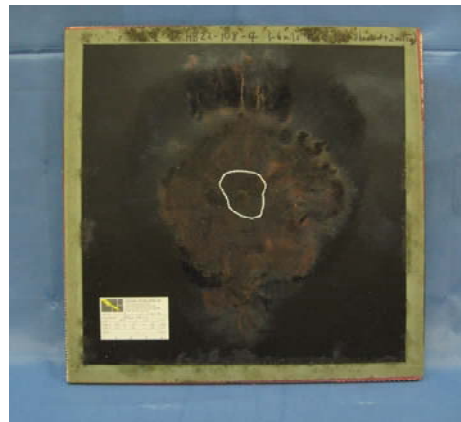
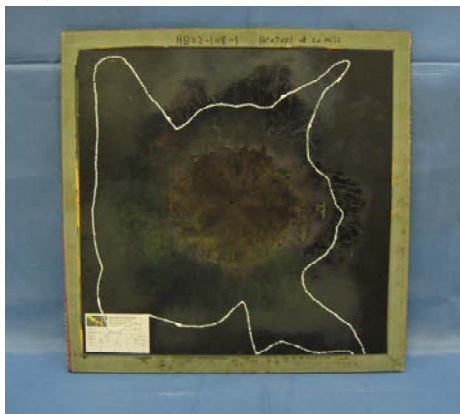
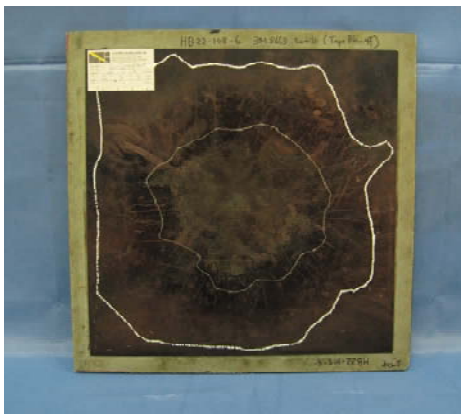
Bell Topcoat  
(0.005-0.007 inch thick)

Hontek  
0.006 inch thick

Hontek 0.020 inch thick  
(same as Full Blade Test)

Bell Topcoat + 0.020 inch thick  
tape

Fig. 7. Lightning strike panels tested with different coating thicknesses.

area was determined. Figure 7 shows the range of damaged area, outlined in white, on several tested panels. The damage consisted of skin-to-core disbonds and crushed core.

The panels with the thinnest coating showed the least damage. The panel with the 0.020 inch thick Hontek coating and the panel with the Bell topcoat and 0.020 inch tape showed the most damage. In the case of the latter panel, this damage extends to the edges, where only the clamping pressure during testing resisted further skin disbonding. The damage area was found to be related to the coating thickness. Figure 8 shows the relationship between coating thickness and damage area.

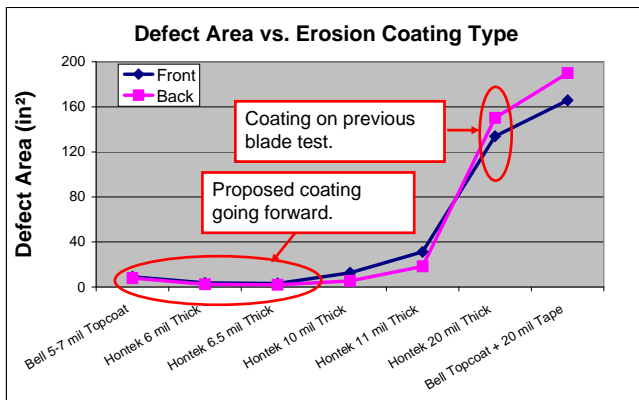
Fig. 8. Lightning strike damage as a function of coating thickness.

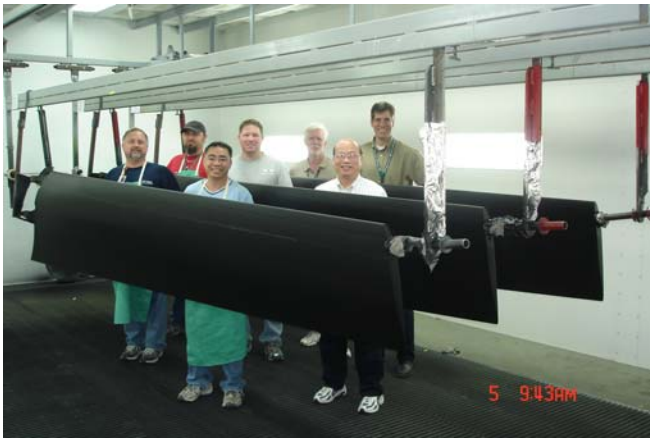
**Fig. 10. Hontek-coated field trial blades and the team that produced them.**

requires unique controls to ensure that the coating is applied with a uniform thickness on a blade structure with many contours. After numerous trials, including the coating of the two blades used for lightning strike testing, Bell and Hontek developed mask and spray processes for the controlled application of the coating to V-22 blade surfaces. The culmination of this effort was the application of the Hontek coating to three blades for a field trial. These three blades, and the team that accomplished the coating, are shown in Fig. 10.
