FINAL REPORT

**accident occurred
to the aircraft B737-8AS registration marks EI-DYG,
Ciampino Airport,
10th November 2008**

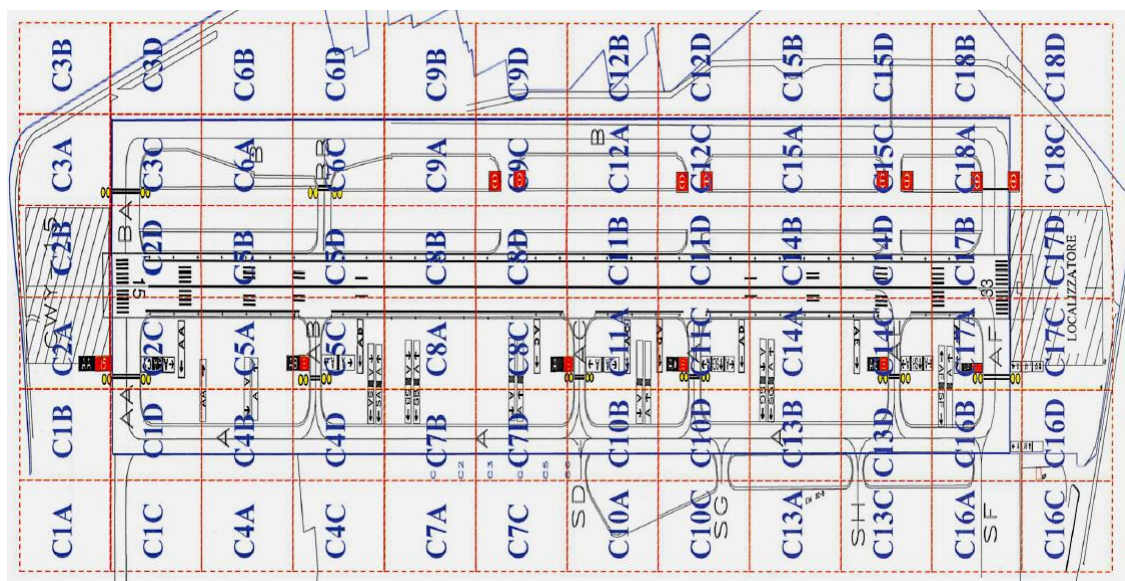
Figure 10: birdlife inspection grid.

A scheduled inspection (sunset) took place on the evening of the day before the accident, starting at 16.25 and ending at 17.00, which had shown the presence of about 1000 starlings, resting on the grass, affecting sectors C2B and C3A and 300 starlings resting on the grass in sectors C1B and C1A.

Whilst the aircraft was in this position, about 300-400 small birds rose into flight from a point on the ground about 50 m from the runway threshold, corresponding to areas C2A and C2B in the grid shown in Figure 10, and hit both the front part of the aircraft and its engines. The Captain also stated that he clearly heard the noise caused by the compressors stalling despite being inside another aircraft. He then added that the Boeing 737 EI-DYG, instead of touching down considering the very low height, changed attitude rising above the trajectory to a maximum estimated height of about 150 feet, which was reached near the half-way of the runway in front of the airport’s control tower.

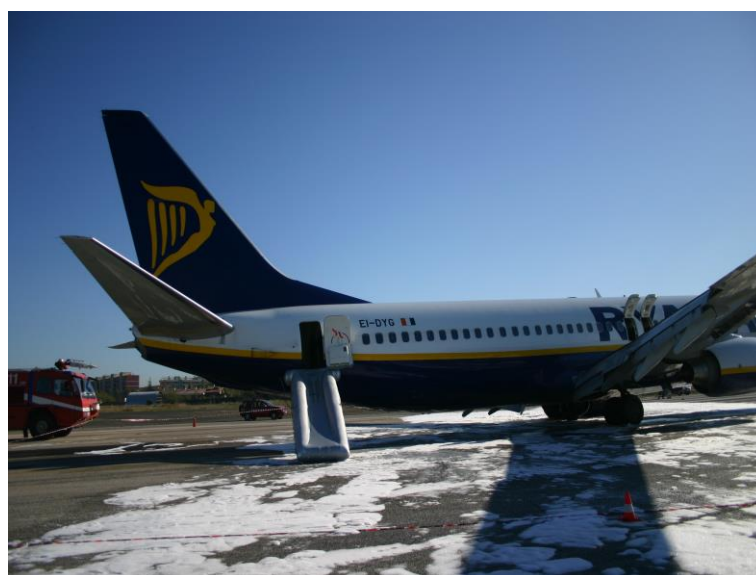
The right hand side slide had been deployed during the disembarkation of the passengers and crew from the aircraft.

Photo 9: slide from the rear right hand door activated.

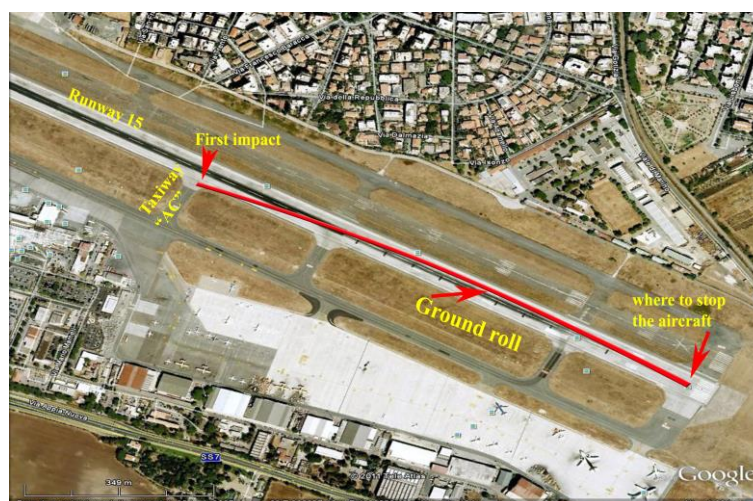
Photo 20: ground roll of the aircraft.

The marks on the ground show how the lower part of the tail contacted the asphalt near the “AC” taxiway; the main right hand landing gear contacted the grass alongside the runway and the main left hand landing gear on the right centre-line of the runway.

The point of contact is positioned 1150 m from the start of the runway, 790 m from the aiming marks and 1057 m from the end of the runway.

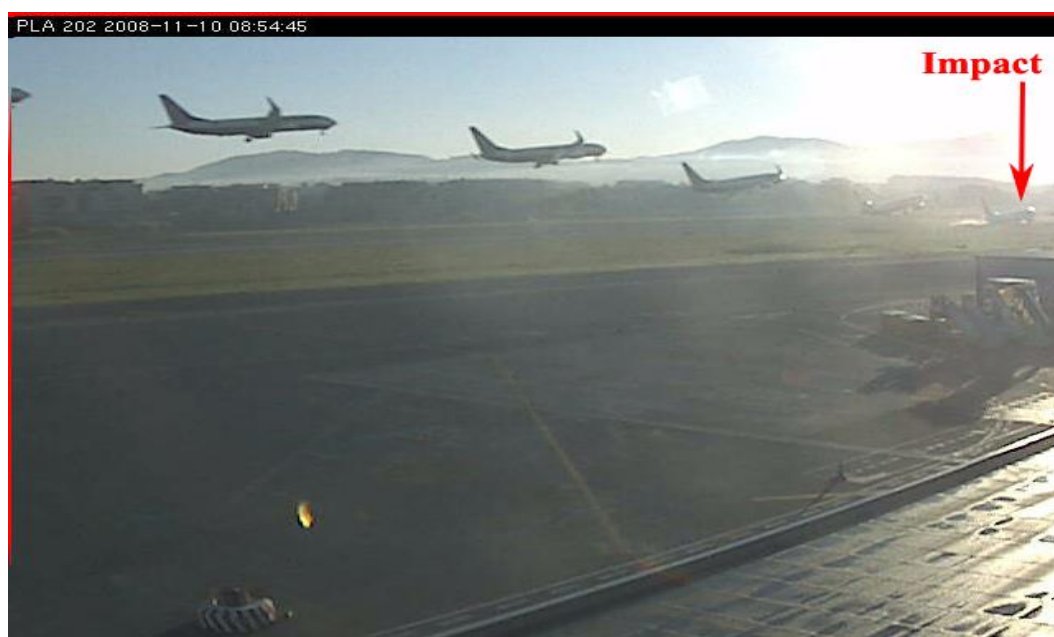
Photo 21: airport camera frames merge: final phase.

The left hand landing gear collapsed almost immediately after the first contact, causing the left hand engine nacelle to contact the runway.

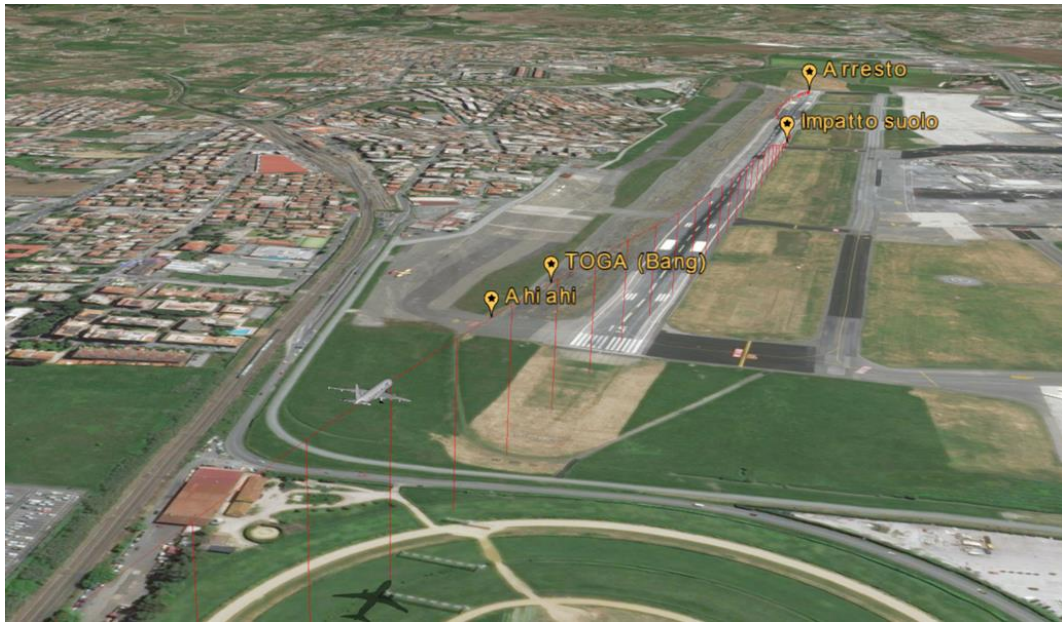
Figure 27: ANSV reconstruction of the final trajectory of EI-DYG.

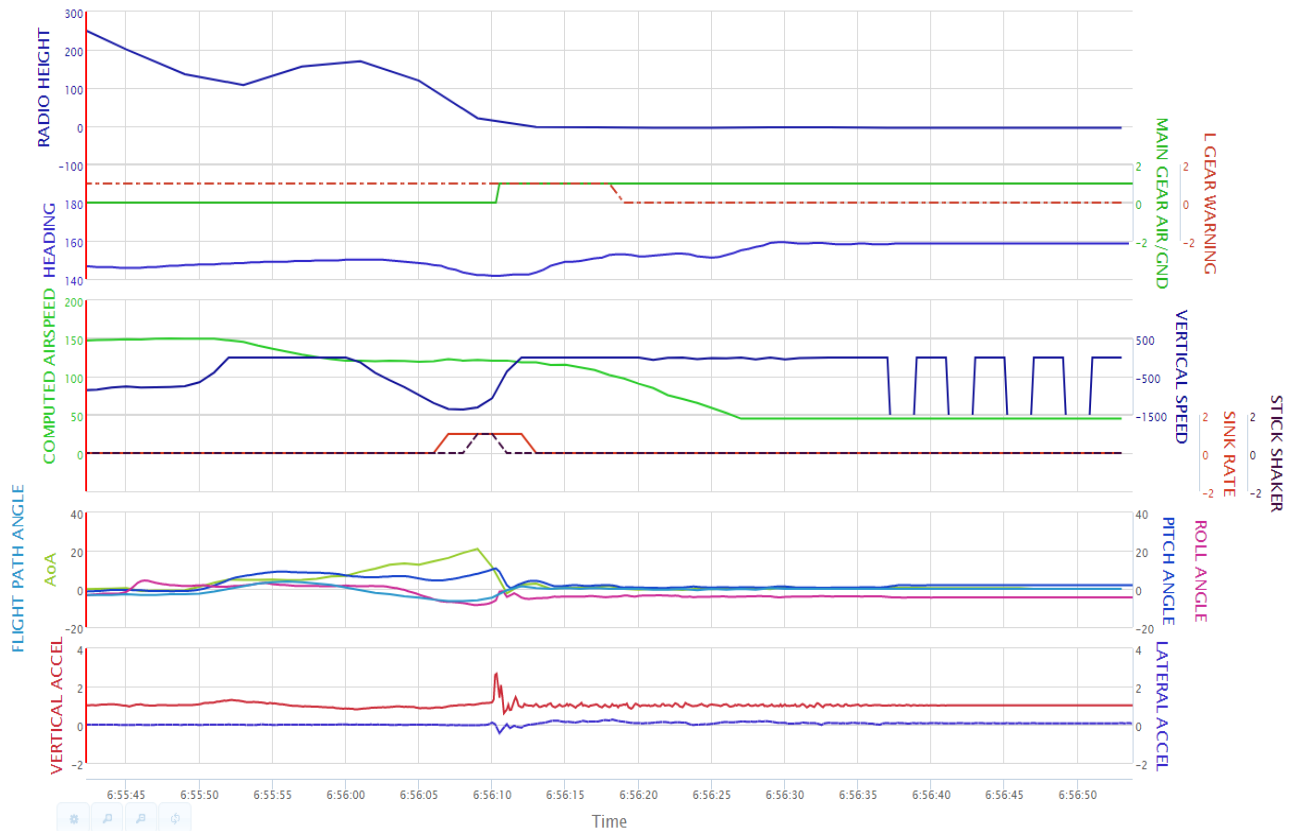
On contact with the ground, a vertical acceleration of 2.66 g and a lateral acceleration of -0.45 g were recorded.

Figure 28: aerodynamic parameters and accelerations on impact with the ground.

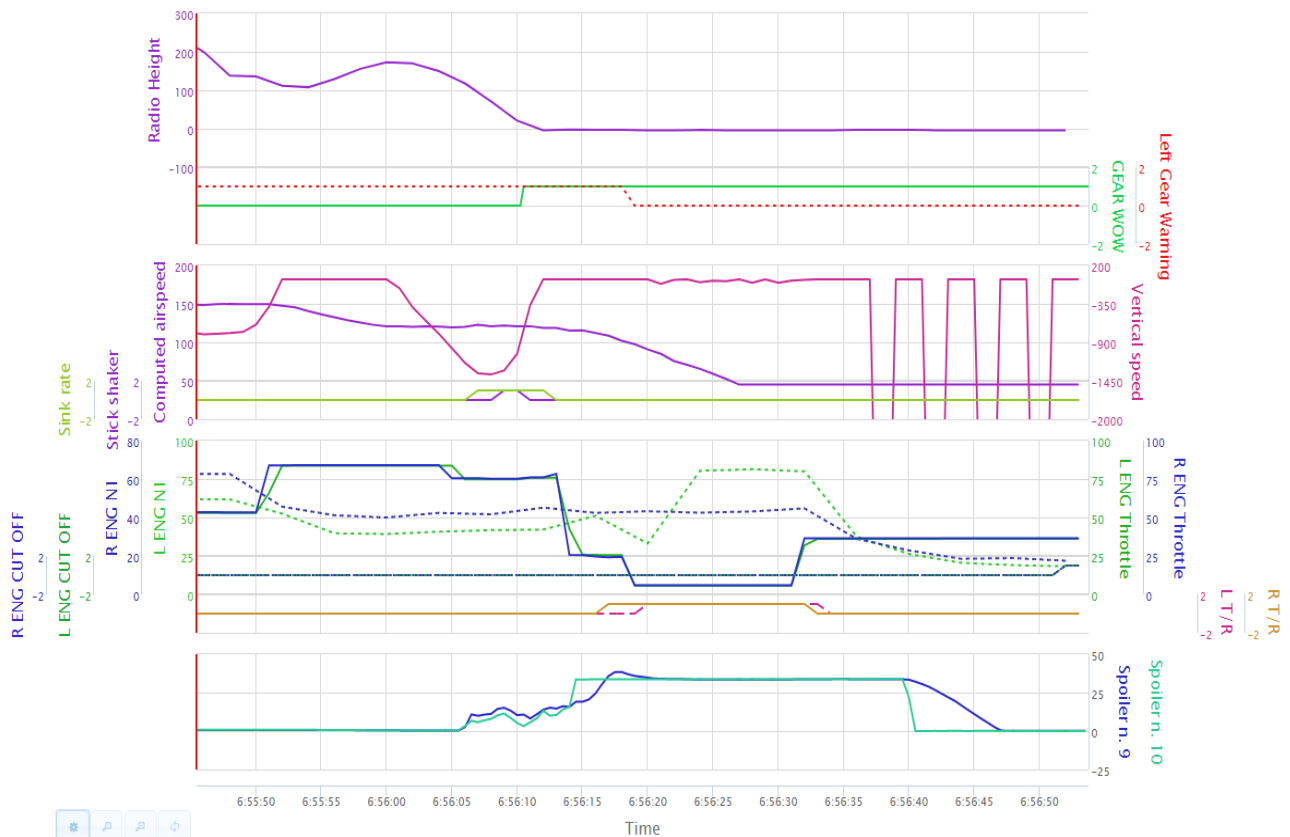
was a progressive reduction of speed and increase in angle of attack, which reached values of 120.75 kts and 21° of AoA at 06.56.10, when the aircraft was at a radalt height of 21 ft. 19 seconds elapsed from TOGA command to touch down.

Figure 29: engine response and thrust reversers activation.

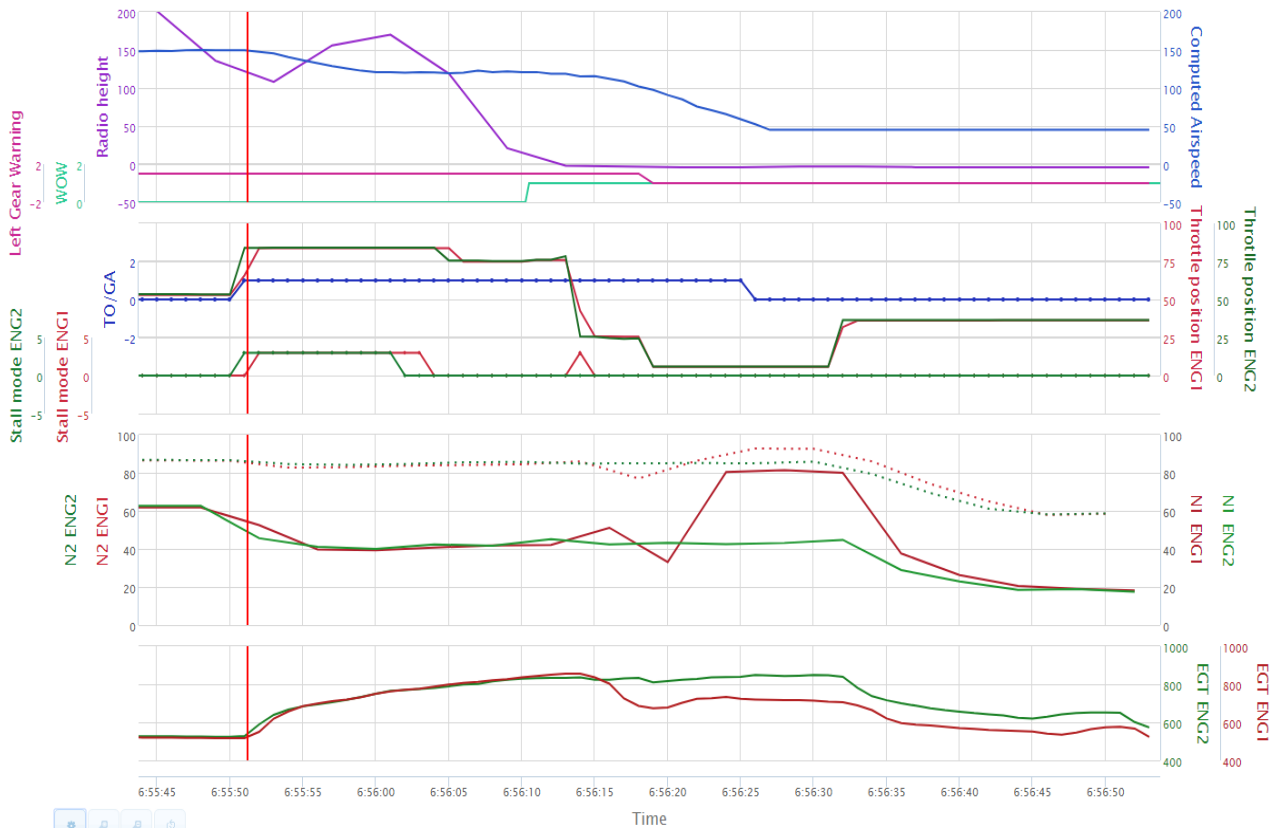
Immediately after the bird strike and application of the TO/GA command (corresponding to the vertical red line in the following plotting), both engines experienced a drop in N1 RPMs, from 62% to 52% and 46% for the left hand and right hand engine respectively. The N2 remained substantially stable at about 83% (a drop of about 3%), whilst the EGT temperature underwent a sudden increase of about 300°C in the next 24 seconds. The N1 drop and rise in the EGT took place at the same time as a series of “*surges*²“ experienced by both compressors and indicative of a severe aerodynamic disturbance of the air flow inside the HPC.

Figure 31: N1, N2, EGT behaviour, stall mode on throttles positions after TO/GA.

These repeated surges caused a fluctuation of the pressure values transmitted from the High Pressure Compressor Discharge Pressure (CDP), with a corresponding drop in the N1 (from 62% to about 40%) and N2 (stabilised on 83%) rpm and a sudden increase in the EGT values, due to a loss of air flow crossing the engine.

The low CDP values caused by the compressor surges led to fuel flow values that were too low to maintain the N1 level required by the crew.

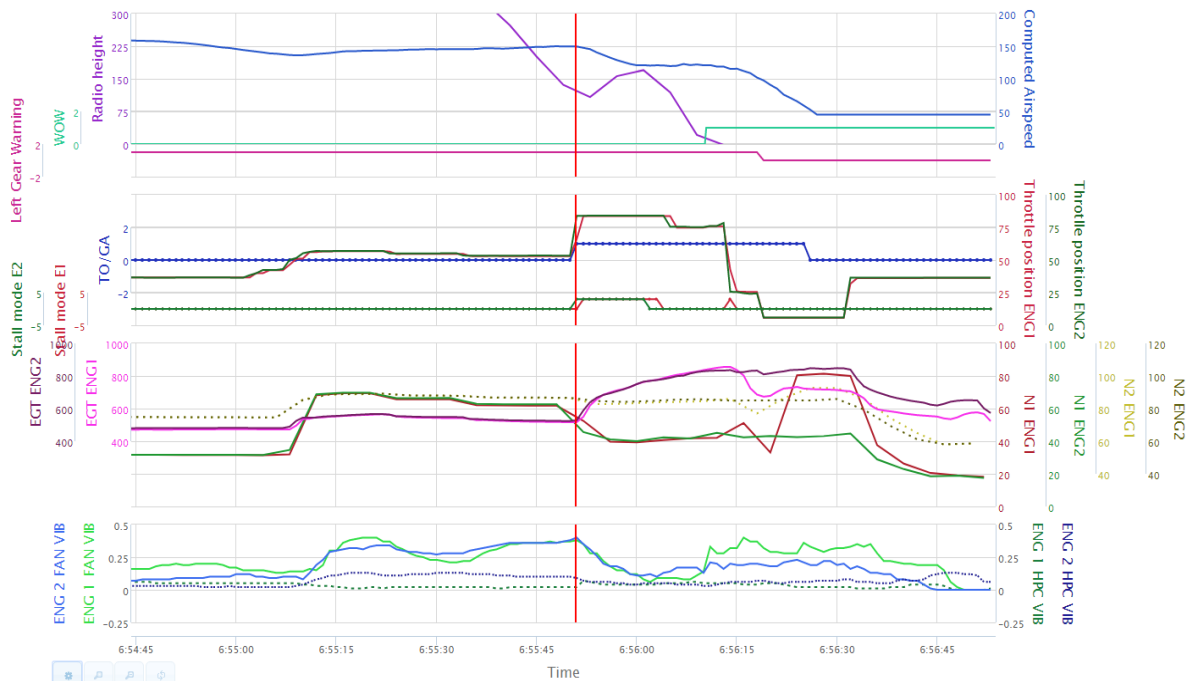
Figure 32: engine vibration level before birds acquisition and engines stall.

The vibration levels recorded for the FANS and HPC of both engines shown in the previous plotting do not indicate anomalous vibrations in the seconds prior to the TOGA command being activated, vibrations that may possibly be an indication of bird strikes.

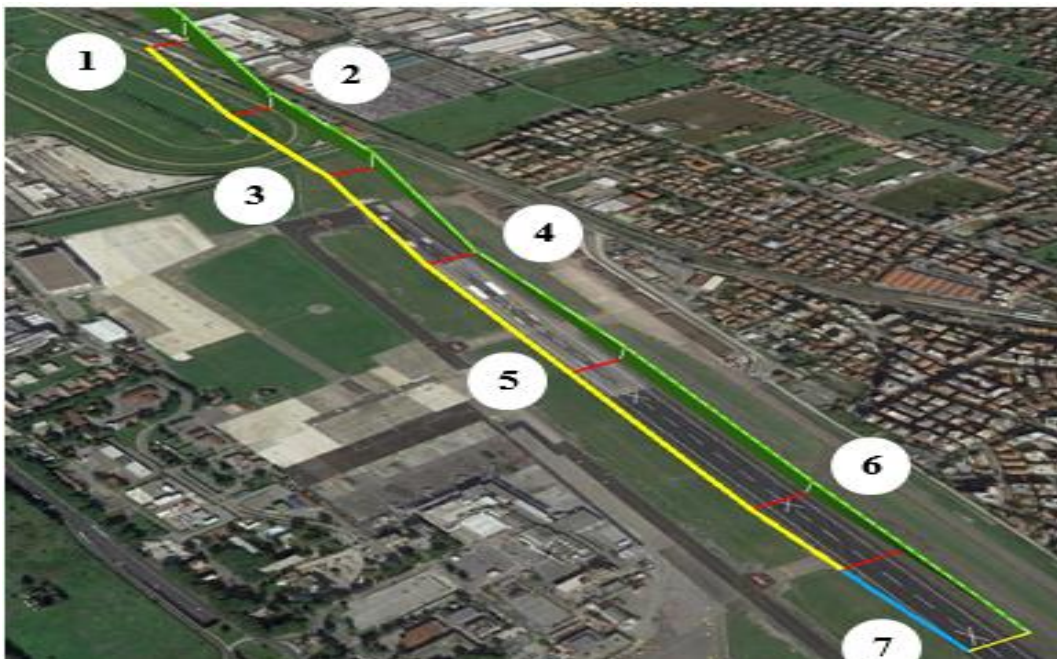
The figure represents the last 30 seconds of interception and processing of the radar tracking for flight RYR41CH shown graphically in green on Google Earth support between points 1 and 7, each with an interval of about 5 seconds, starting at 06.55.42 and ending at 06.56.12. Because of the effect of the geographical coordinates approximation of the radar plot recordings in order to enter such data in Google Earth, the representation of the longitudinal axis of the aircraft's route seems to be translated by about 80 m east and its possible real route has been artfully re-proposed, projected on the ground, through the yellow line with the last section in blue, consistent with the aircraft's route reconstructed from the FDR data, including the clear deviation to right, corresponding with point 3.

Figure 35: reconstruction using of final trajectory using the radar data (on Google Earth).

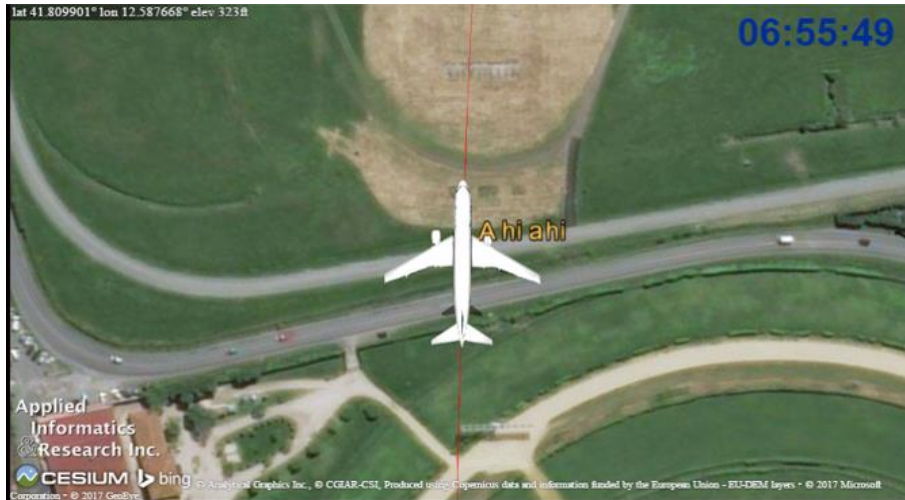
More particularly, thanks to the synchronisation of the CVR recording with the FDR, it is possible to locate the point when the Captain exclaimed «Ahi, ...!» (point corresponding to the time 06.55.49, substantially over the airport fencing).

Figure 36: point of birds visual acquisition.

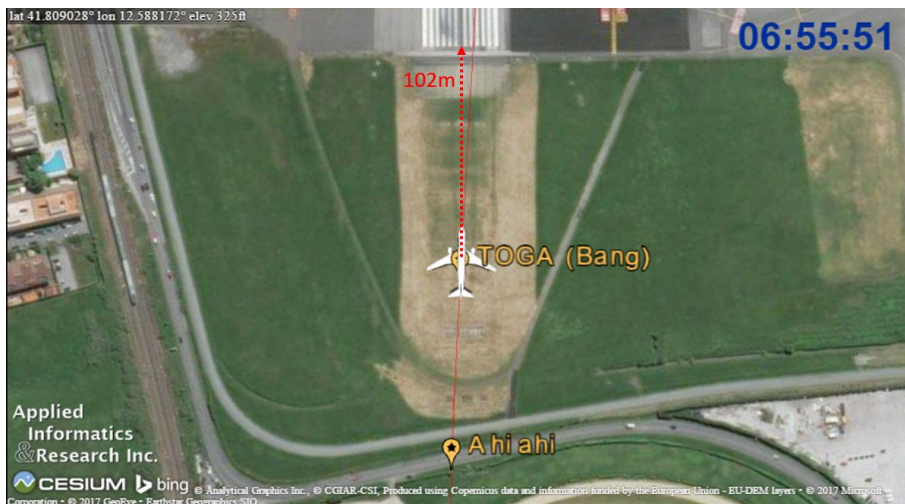
It is also possible to identify the point at which the TO/GA is applied and the “bang” is recorded, the latter corresponding to the engines stalls and to the aircraft impact with the flock of starlings (at 06.55.51, about 100 m from the runway threshold).

Figure 37: engine stalling point and bird strike.

This point of impact is corresponding to the area of maximum concentration of bird carcasses found on the ground.

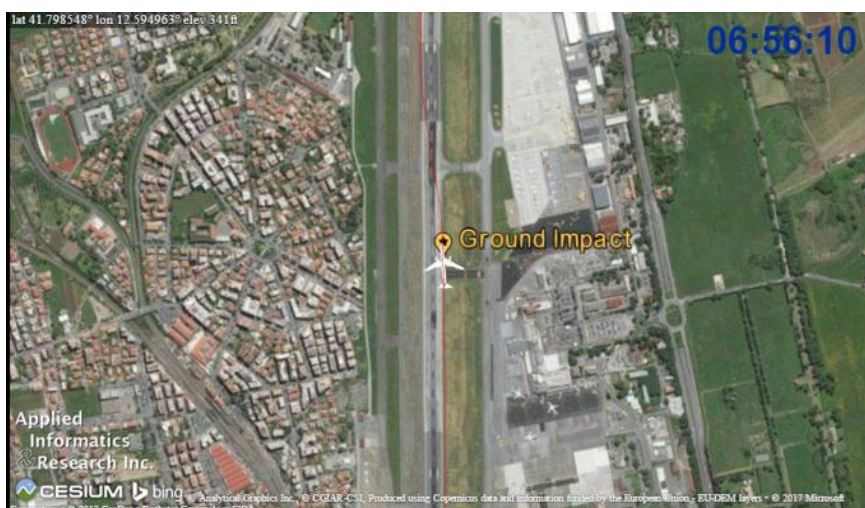
At 06.56.10, the aircraft touched ground (WOW commutation) with an attitude of about 10° pitch and -6° roll, an indicated speed of 120.75 knots, variometer of -1064 ft, vertical and lateral acceleration of 2.66 g and -0.45g respectively.

Figure 39: point of ground impact.

The aircraft had therefore lost height because of the aerodynamic stall, with the engine levers at maximum power position but without response from the engines and impacted the ground near taxiway “AC”, about half way along the total length of the runway, with a vertical acceleration of 2.66g.

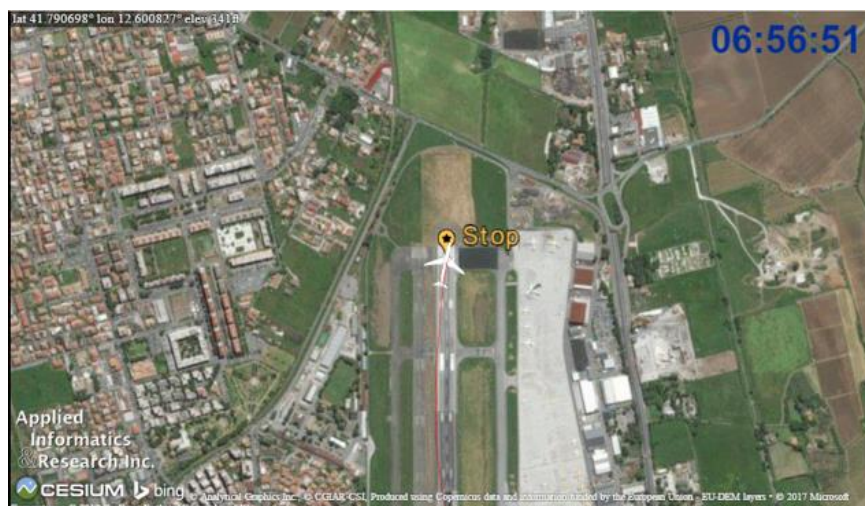
The aircraft came to a stop on the runway at 06.56.38, about 50 m from the end of the runway.

Figure 40: stop point on the runway.
