INTERSTATE AVIATION COMMITTEE
AIR ACCIDENT INVESTIGATION COMMISSION

FINAL REPORT
ON RESULTS OF INVESTIGATION OF ACCIDENT

Type of accident	Fatal accident
Type of aircraft	ATR72-201 aeroplane
Registration	VP-BYZ, Bermudas
Owner	BLF Limited
Operator	UTAir Aviation, JSC
Place of accident	1500 m from RWY 21 threshold; cross-track deviation about 400 m, Roschino aerodrome, Tyumen. Coordinates: N 57°09.440' E 065°16.000'
Date and time of accident	02.04.2012, 01:35 UTC (07:35 local time), day time

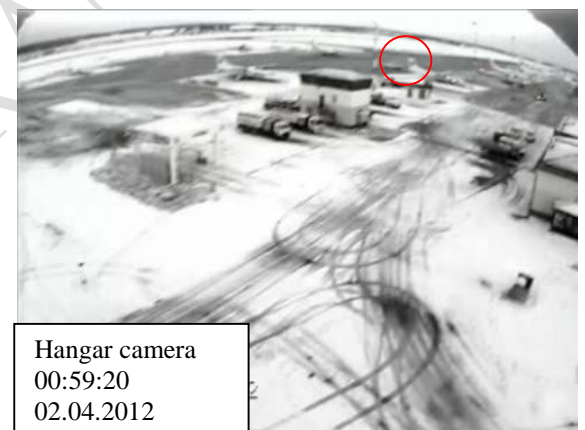
Figure 18. De-/anti-icing vehicle has arrived to the ATR 72 VP-BYZ A/C

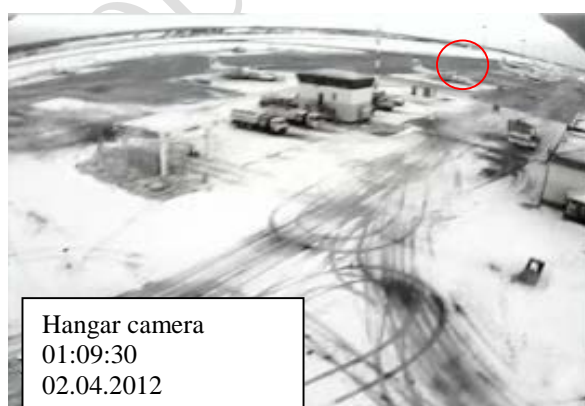
Figure 19. De-/anti-icing vehicle is leaving

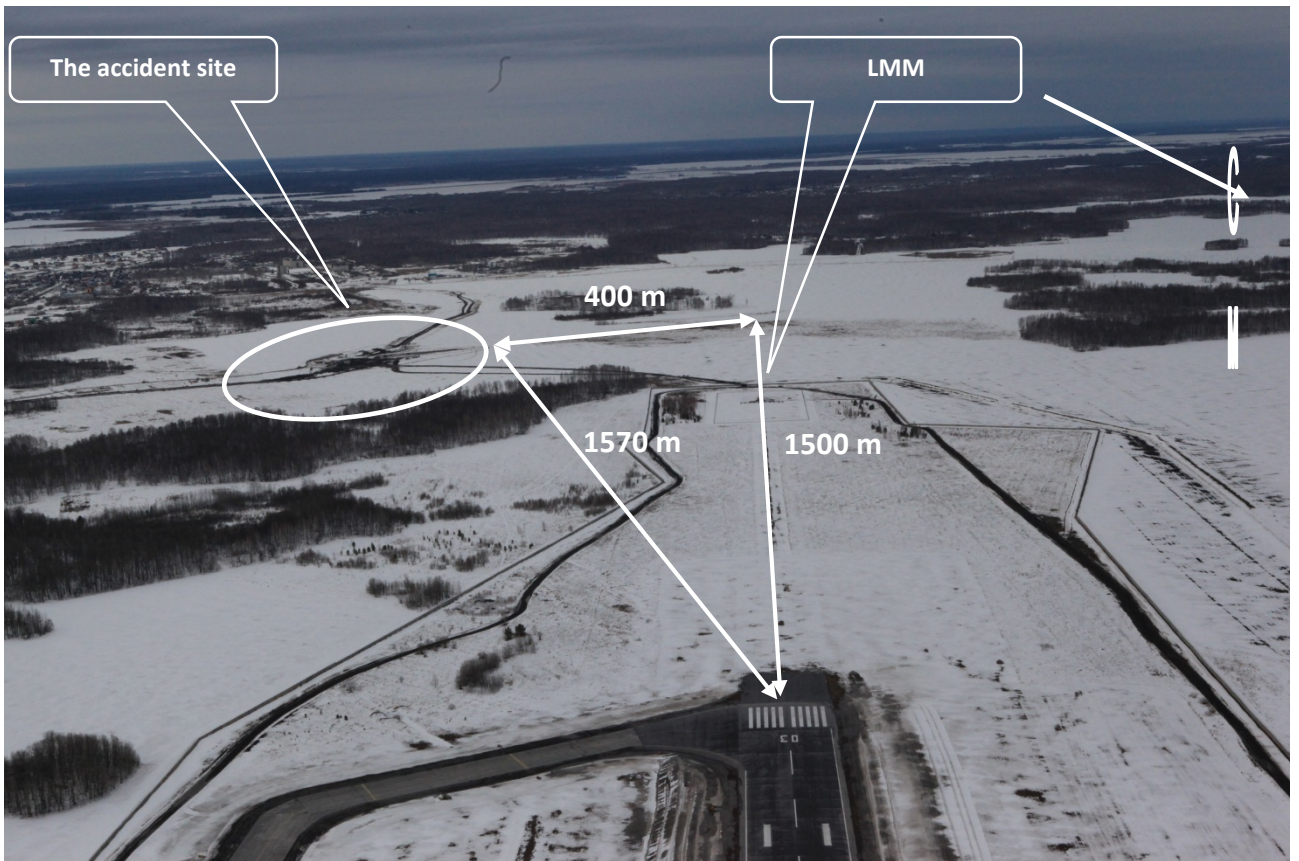
The accident site positioning with reference to the RWY is shown on Figure 30. The A/C center of mass's motion direction on impact was $MH \approx 90^\circ$. The A/C debris are located within about ≈ 190 m along the A/C motion direction and within about ≈ 50 m edgewise.

The A/C ground collision occurred at distance ≈ 1500 m from the RWY 03 threshold along the RWY centerline, with lateral deviation to the left ≈ 400 m of the RWY centerline. The point of initial impact coordinates are: N $57^\circ 09.440'$ E $65^\circ 16.000'$.

Figure 30. Airspace view of the accident site with reference to RWY with takeoff heading MH = 214°

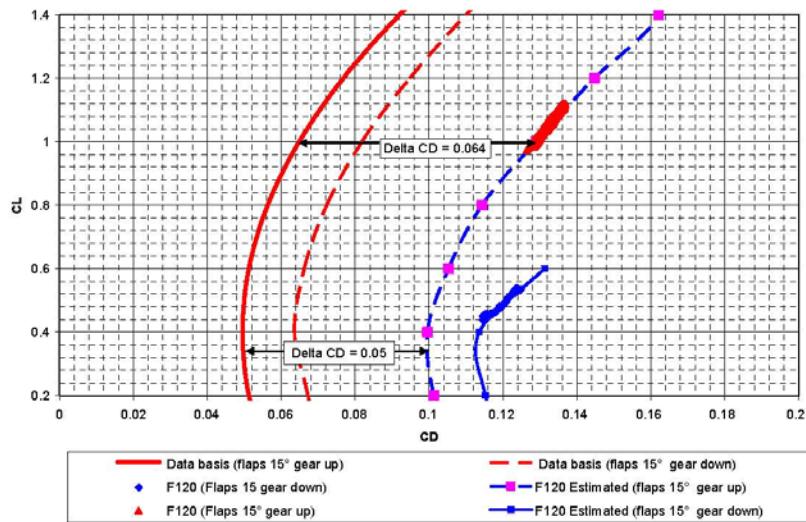
The simulation revealed that during the takeoff run at angle of attack near 0° , a loss of lift and an increase of drag were $\Delta CL_0 = -0.23$ and $\Delta CD_0 = 0.05$ (Figure 46). The graph analysis shows that at that phase of flight CL was reduced by approximately 25%, while drag was doubled. Further after the landing gear retraction the loss of lift remained more or less constant, while the drag increased with angle of attack, providing a $\Delta CD_0 = 0.064$ (Figure 46). After the flaps retraction the loss of lift still remained almost constant, while the drag increasing was $\Delta CD_0 = 0.05$ (Figure 47).

Figure 446. Takeoff simulation Flight UTA-120 (Flaps 15°)

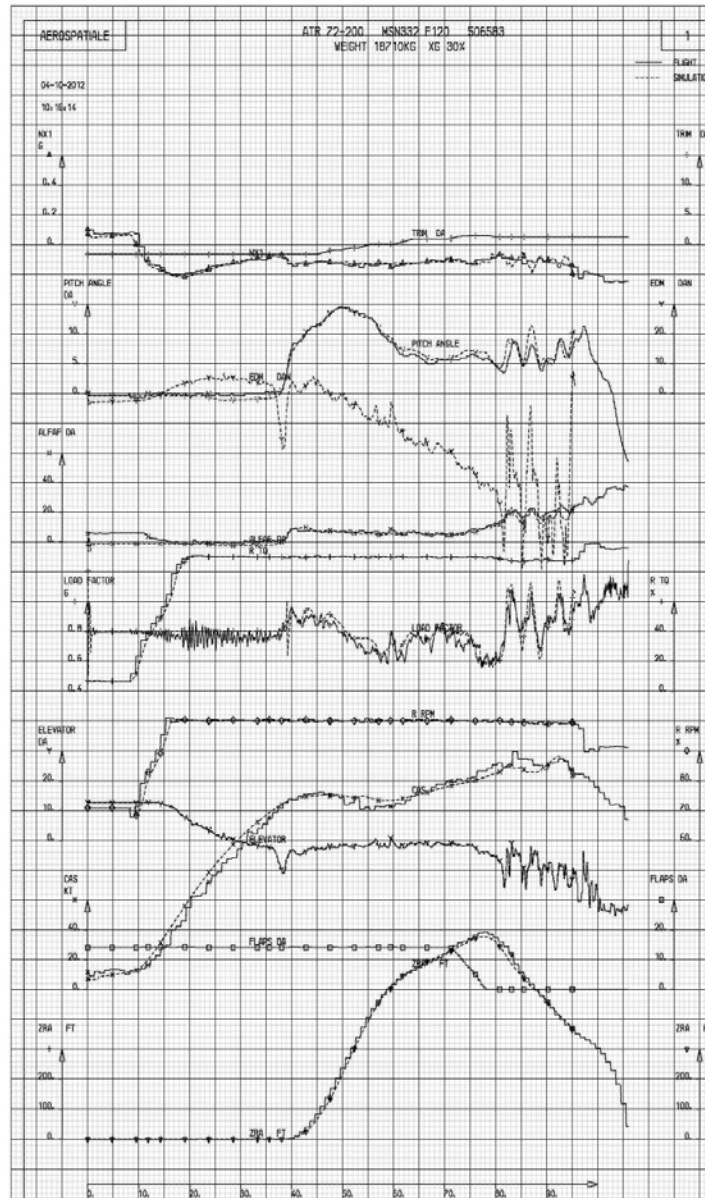
Figure 468. Simulation of Flight UTA-120 with basic hinge moment

According to the aircraft manufacturer's data, such incidents had occurred before. The plot below shows the simulated pilot's control column forces with basic hinge moment for a clean aircraft with DFDR elevator trim data. Figure 48 reveals that if the aircraft had been clean the crew would have experienced significant pitch up control column forces, while they actually trimmed the elevator for pitch down.

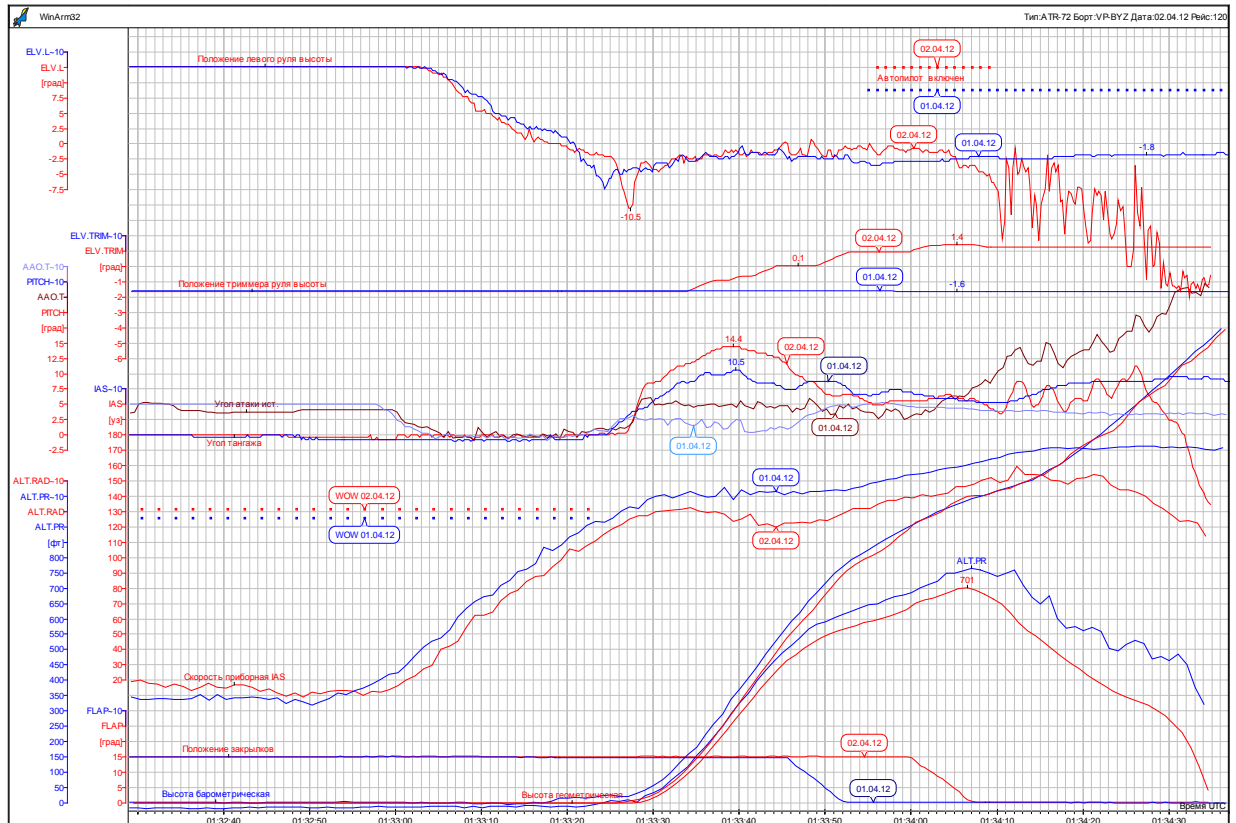
Figure 54. The comparison of the climb envelopes in a previous and accident flight

The comparison of the climb envelopes after takeoff (Figure 54) for the accident and the previous flight (TOW $\sim 19\,350$ kg, OAT $+6^\circ$) shows, that in the previous flight with greater TOW, with the same engine operating mode, a significantly smaller angle of attack value was necessary to climb with a greater vertical speed, meanwhile the speed in the previous flight also increased faster.

The aircraft takeoff run and liftoff occurred without particularities. After aircraft liftoff, due to significant degradation of the lift, to provide the “normal” climb speed (the angle of climb) a greater angle of attack was required ($\approx 4^\circ$) (Fig. 54). As there is no angle-of-attack indicator on the aircraft, this fact could not assist the crew to identify the change in the aircraft aerodynamic performance.

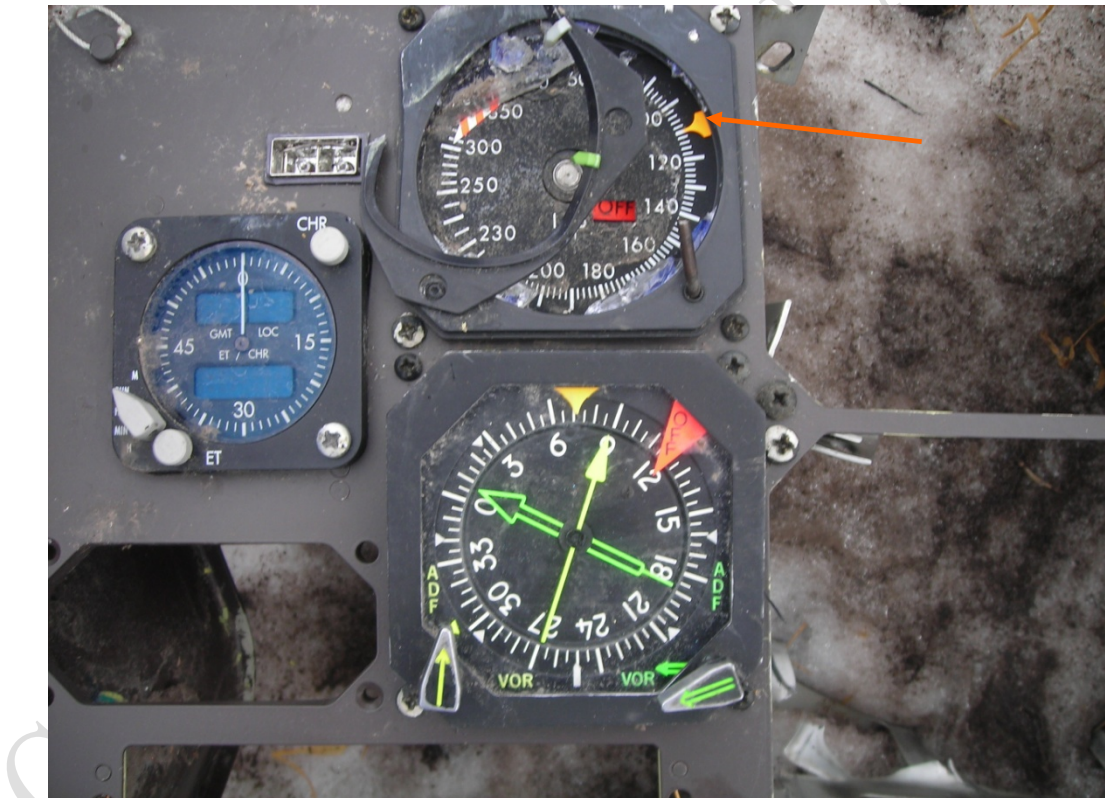
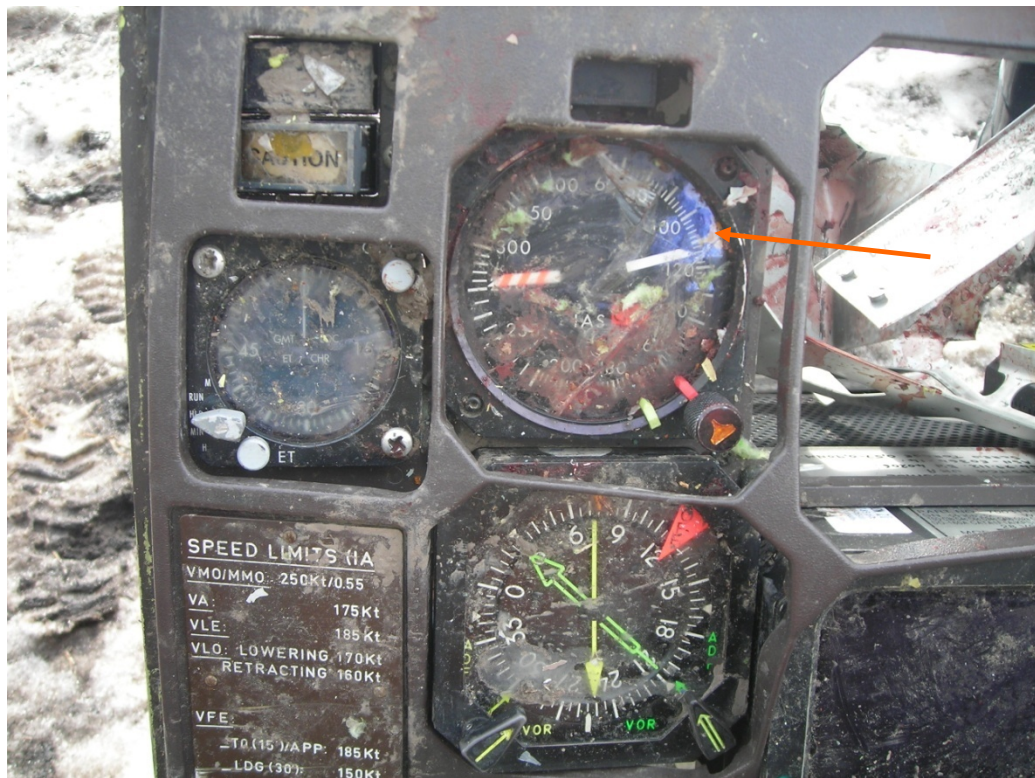
All the crew further actions also confirm that they were not aware of the danger of aircraft takeoff with non-removed ground icing. The value of takeoff safety speed (V_2) was set on the airspeed indicator for normal conditions but not for flight under the conditions of possible icing. During the inspection of the PIC's and F/O's instrument panels it was revealed that the V_2 bugs were set at 111 kt. According to FCOM this speed value corresponds to takeoff normal conditions for the actual weight. For takeoff under possible icing conditions this value would be equal to 115 kt.

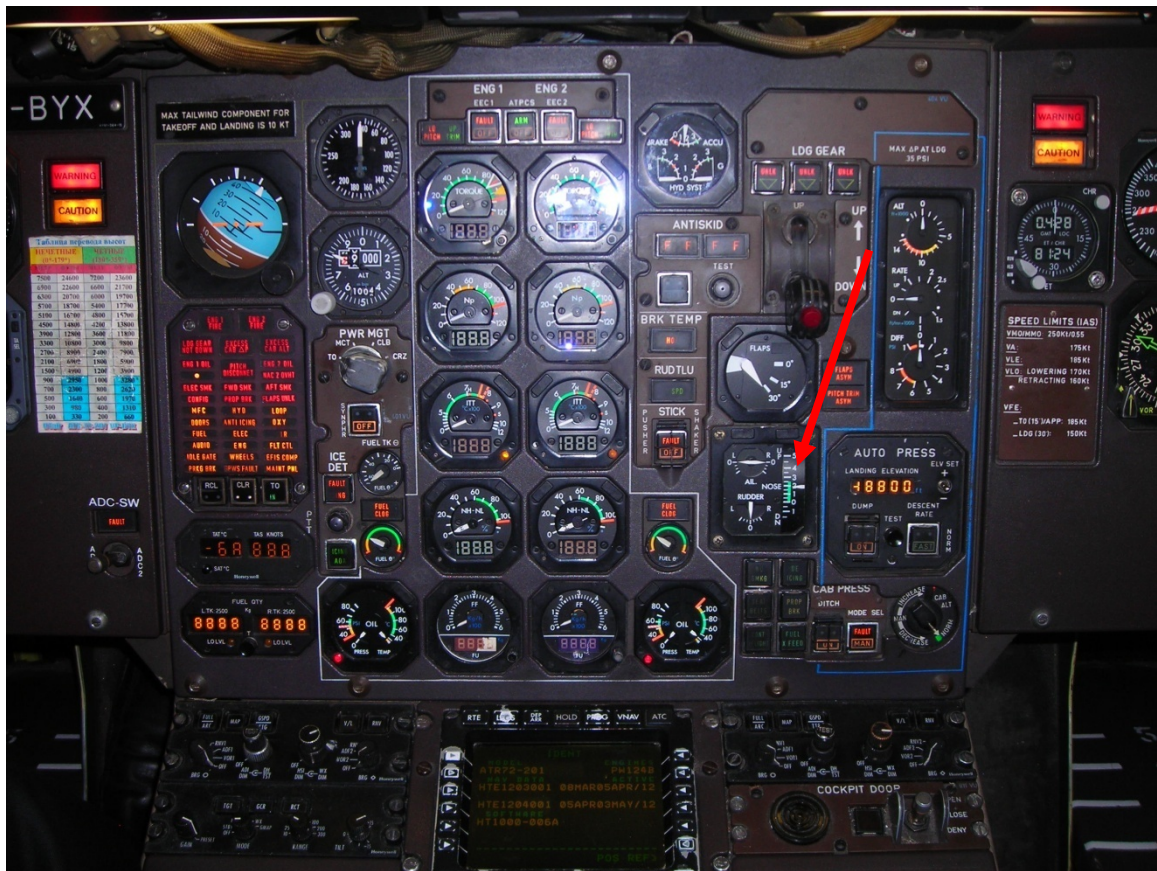
Figure 59. The instrument panel with the indication of the elevator trim position

Altogether, from the moment of the engines start-up and till the rise of the emergency the SOPs were fulfilled. It should be pointed as a shortcoming that before the flight the elevator trim was set by the crew incorrectly. The actual trim position (-1.65°, nose up) did not comply with the

estimated one for CG 30.72% MAC ($\approx -0.7^\circ$, nose up), however the trim position was in a green zone permitted for takeoff (Figure 59).
