An investigation into a dropped fuel element incident at Chapelcross Nuclear Power Station

A report by HM Nuclear Installations Inspectorate

*Published by the Health and Safety Executive
February 2002*

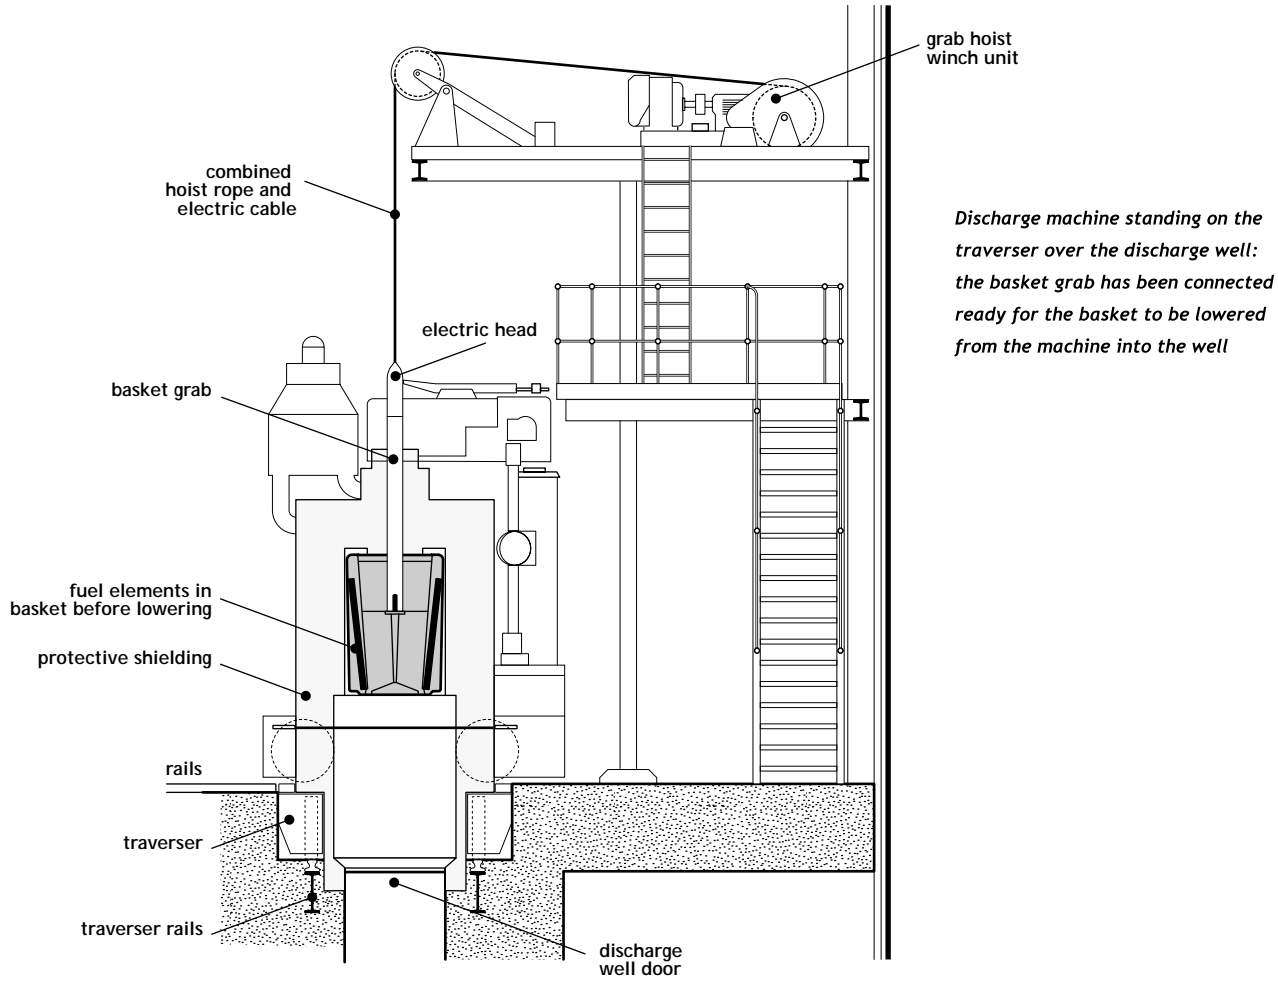
Figure 2: Fuel handling route from pile cap to discharge chamber

Discharge machine standing on the traverser over the discharge well: the basket grab has been connected ready for the basket to be lowered from the machine into the well

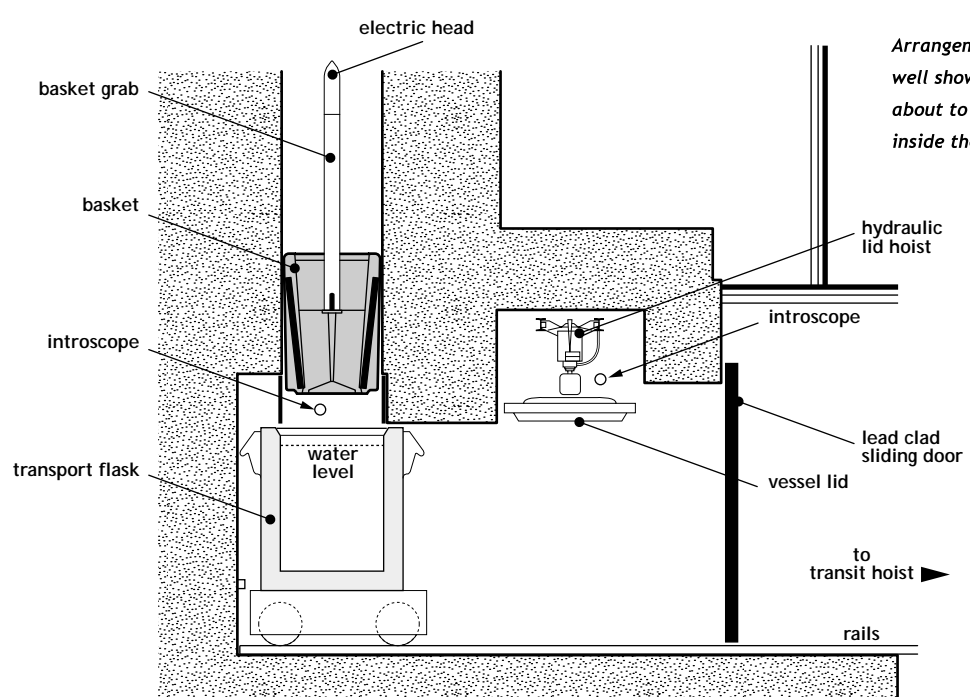
Arrangement at the bottom of the well showing the discharge basket about to enter the transport flask inside the shielded chamber
