PB91-910404  
NTSB/AAR-91/04

## AIRCRAFT ACCIDENT REPORT

AVIANCA, THE AIRLINE OF COLUMBIA  
BOEING 707-321B, HK 2016  
FUEL EXHAUSTION  
COVE NECK, NEW YORK  
JANUARY 25, 1990

**ADOPTED: APRIL 30, 1991  
NOTATION: 52558**

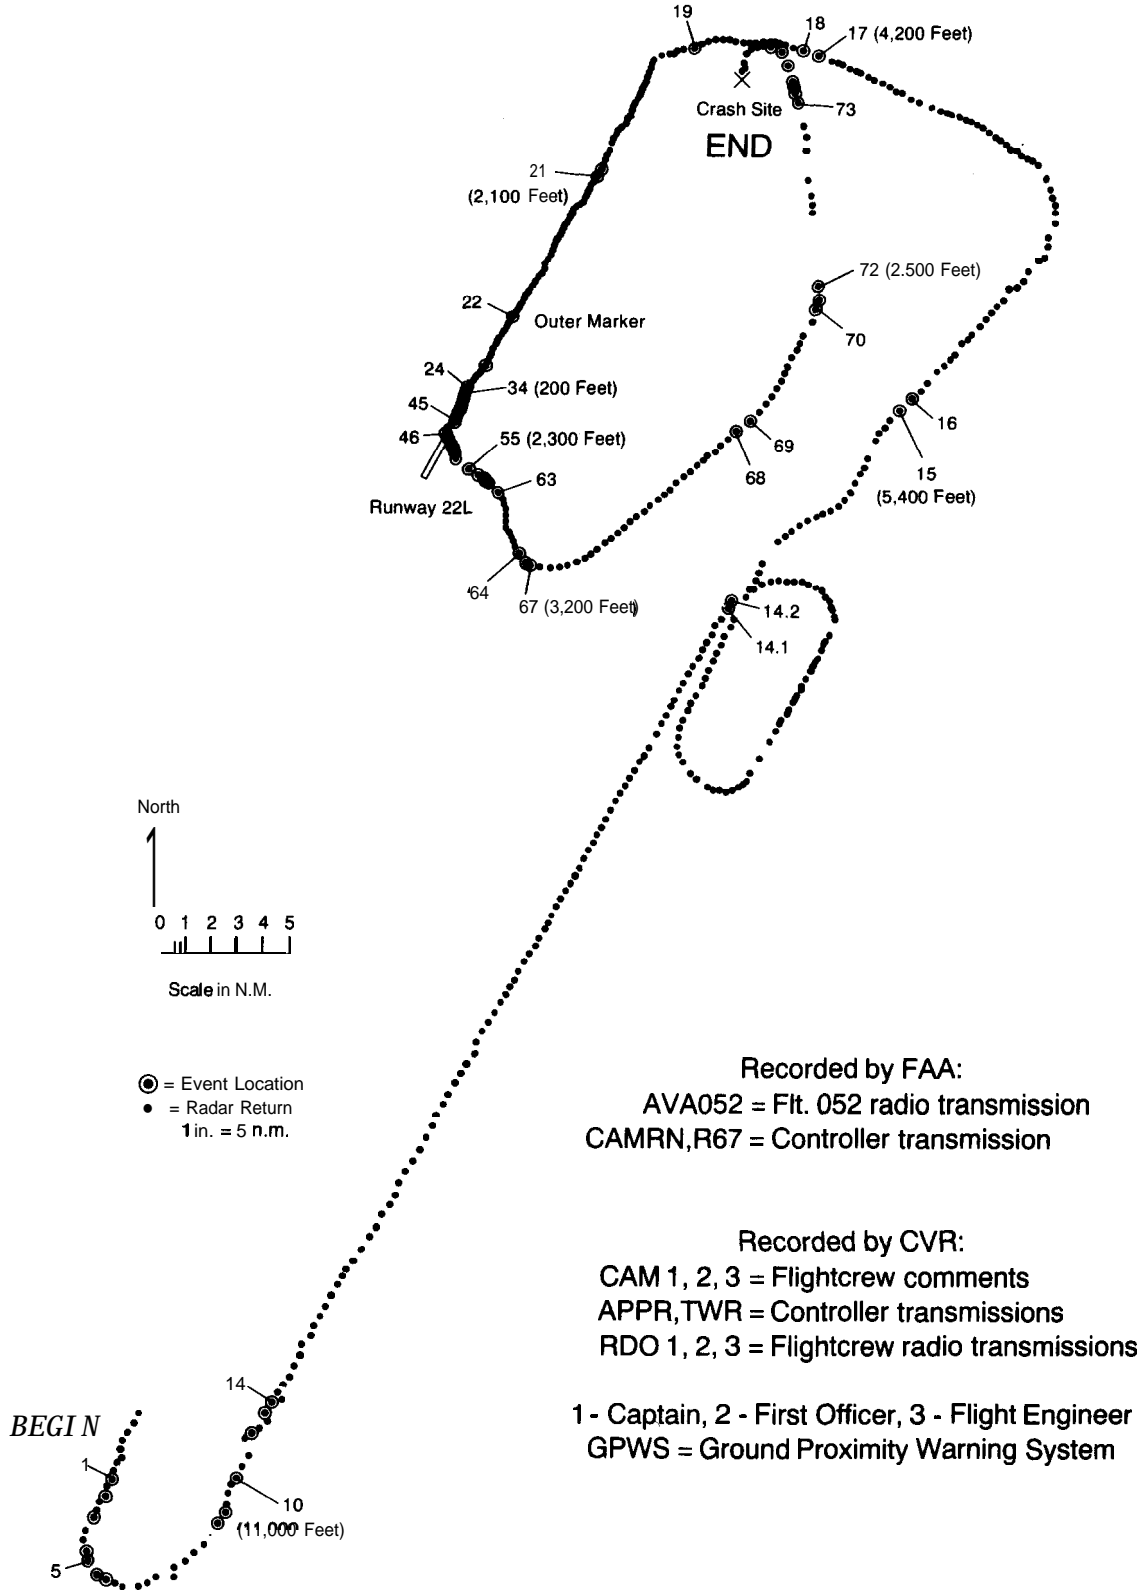
Figure 1. --AVA052 flight reconstruction based on CVR, ATC radar data, and ATC communications.

Between the **ORF** and **CAMRN** intersections, AVA052 was cleared to descend to several lower altitudes. The flight entered the holding pattern at **CAMRN**, at 14,000 feet mean sea level (msl). The flight was subsequently descended to 11,000 feet while in the holding pattern. Figure 1 depicts the track of AVA052 beginning at **2042:59**.

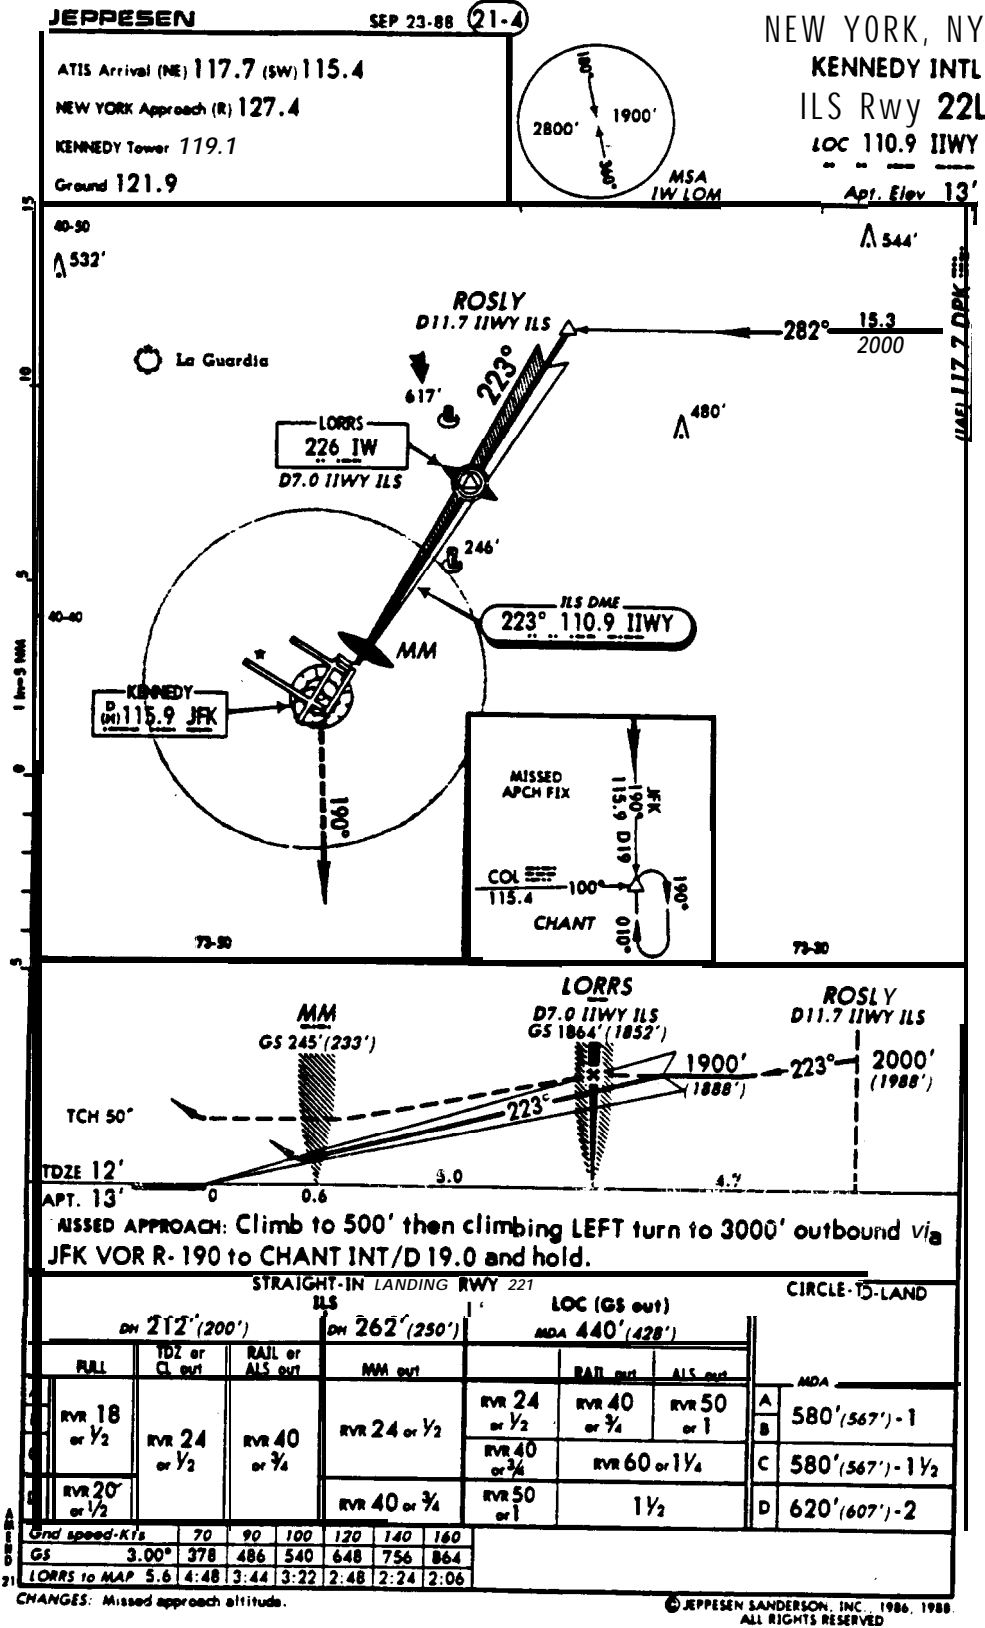
Figure 2. -- Jeppesen Approach Plate of ILS to runway 22 left at JFK.

At **2111:07**, the final controller stated, "...you are one five miles from the outer marker maintain two thousand until established on the localizer cleared ILS two two left." Figure 2 depicts the ILS runway 22L approach chart.

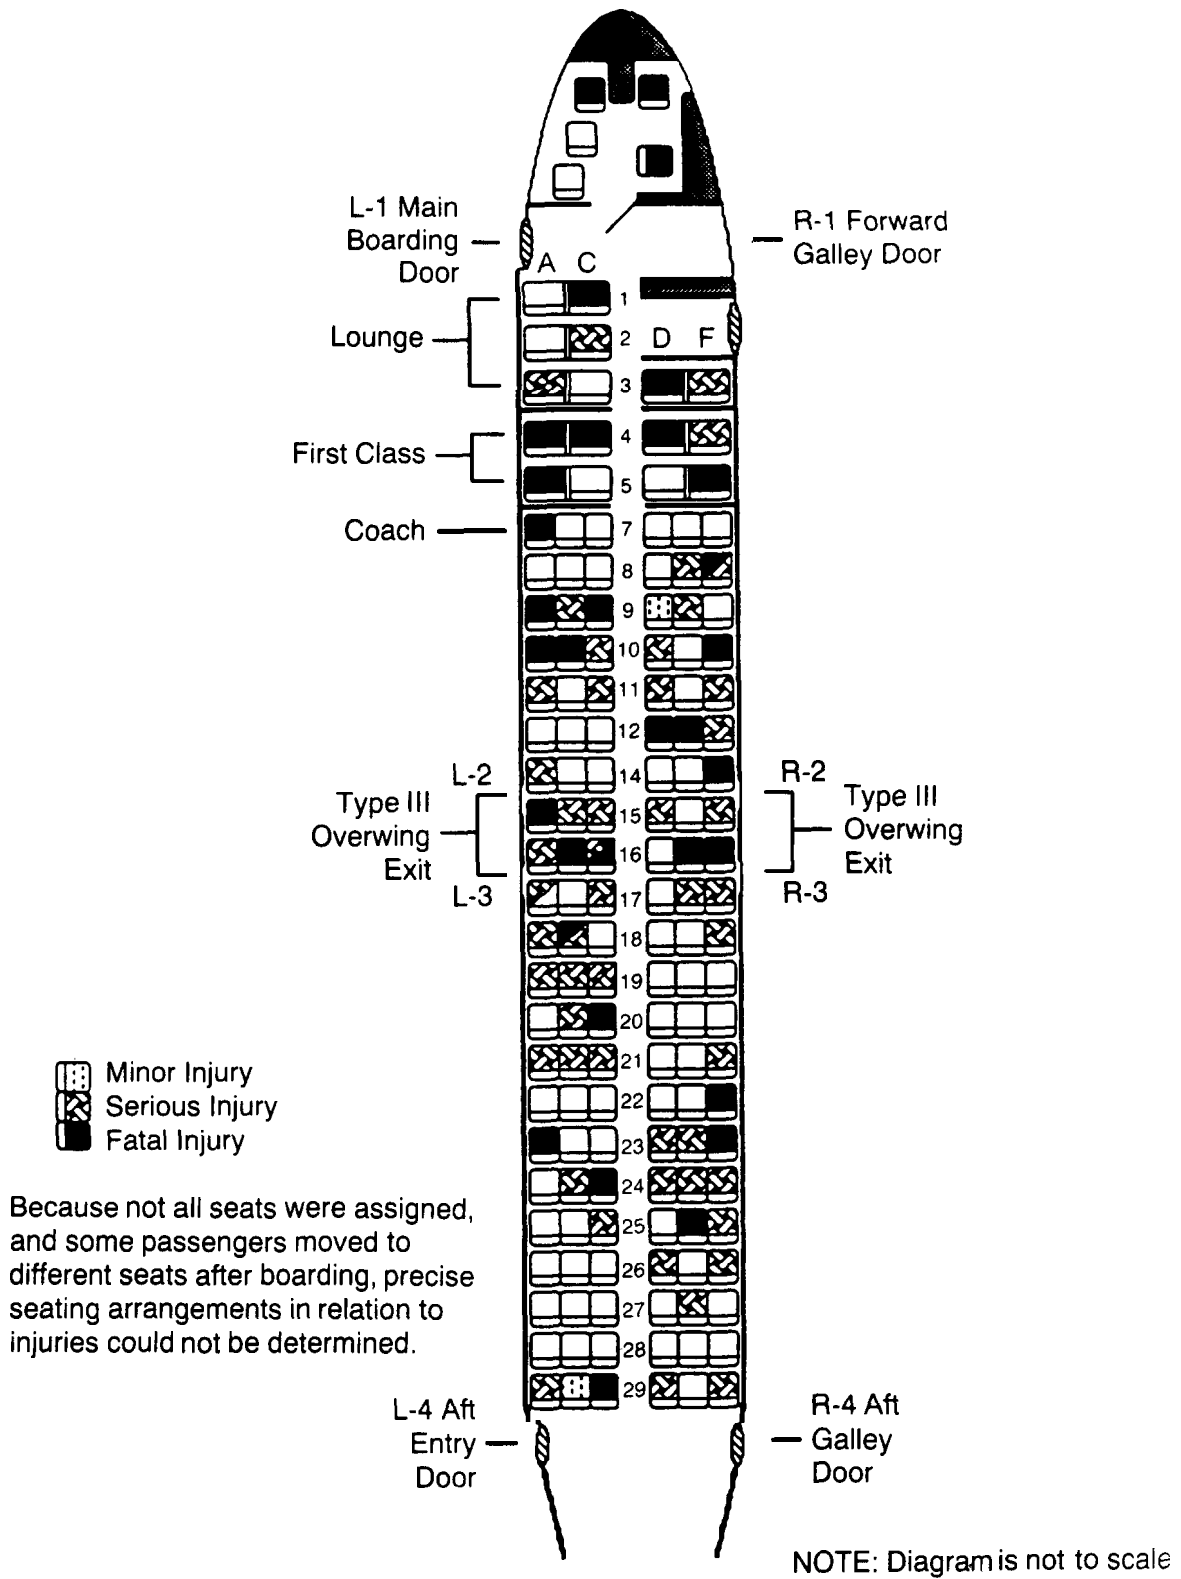
Figure 4. --AVA052 cabin seating diagram.

*An airplane Seating Diagram, showing the placement of occupants (flightcrew, attendants and passengers) and extent of injury of each person (minor, serious or fatal) is provided as figure 4.*
