Report

Accident on **9 August 2007**
off **the coast of Moorea (French Polynesia)**
to the **DHC6-300**
registered **F-OIQI**
operated by **Air Moorea**

BEA

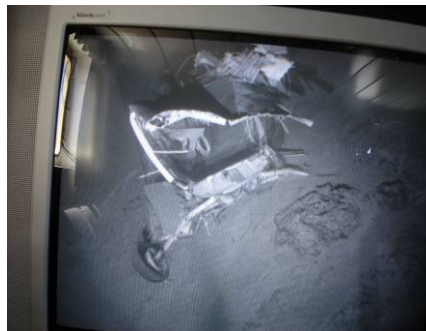
A part of the central fuselage (passenger cabin) with, underneath, the left landing gear, was found forty-five metres north-north-east of the rear part of the aeroplane, 670 metres deep. A detailed examination was made: no bodies were found, and there were no seats in the cabin.

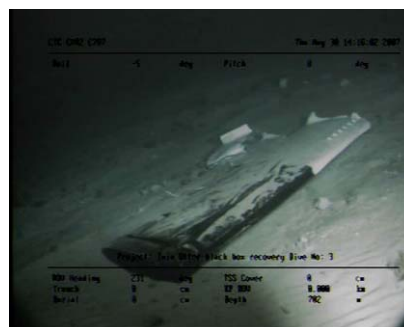
A part of right wing was found eleven metres southwest of the rear part of the aeroplane, 650 metres deep.

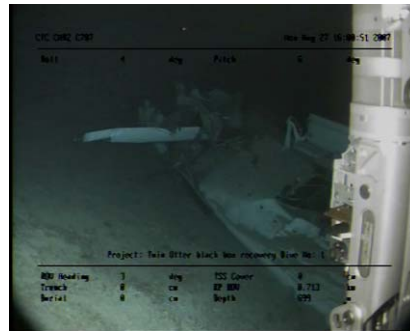
A part of left wing was found eleven metres to the south of the rear part of the aeroplane, 668 metres deep.

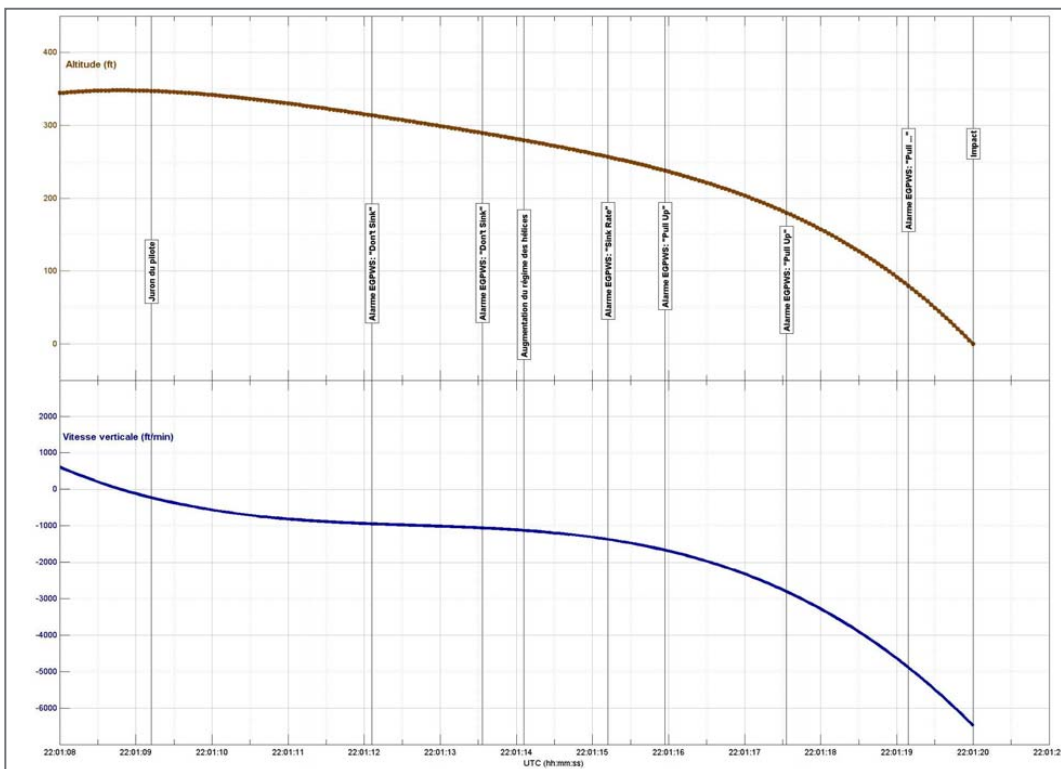
From these hypotheses, the establishment of model of the aeroplane's altitude enabled the following vertical profile for the end of the flight to be calculated:

Specifically, the maximum altitude reached at 22 h 01 min 08.8 was about 350 ft. The vertical speed at impact was – 6,500 ft/min.

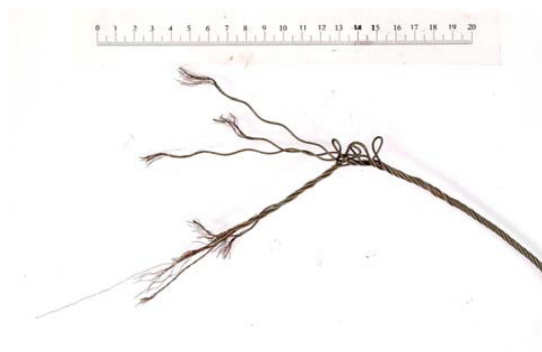
Tensile test on a slightly worn cable

On a slightly worn cable, the failure occurred in the worn area, located in the middle of the section between the attachments.

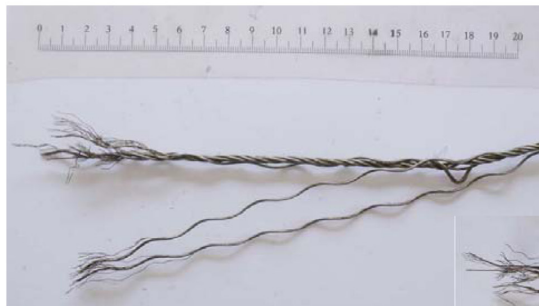
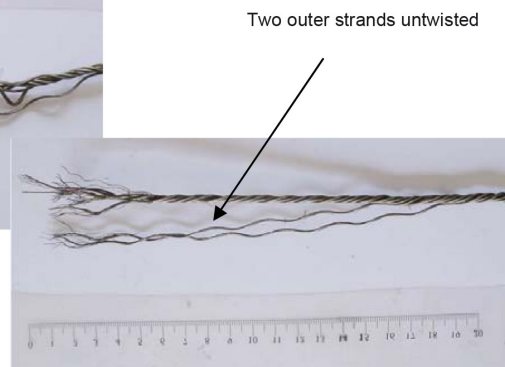
Tensile test on a cable showing similar wear to that of the F-OIQI's pitch-up cable with a system simulating the presence of the cable guide

In addition to the set-up for the previous test, a system with a diameter, thickness and rigidity all similar to those of the cable guide was placed in contact with the cable in its worn section. The failure occurred at this point.

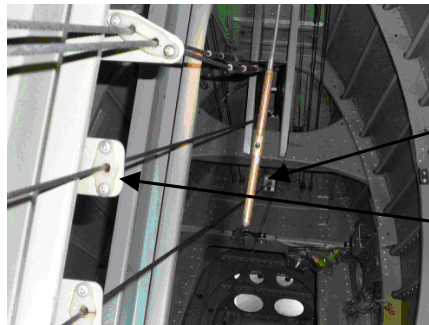
6. The fairlead at STA 486.34 if not relocated as per TAB 646/9 has been found to show signs of wear or found worn out and the elevator cable rubbing on P/N C6FS1714-3 (MOD 6/1458).

Fairlead at STA 486.34
