Turkish Airlines DC-10 TC-JAV
Report on the accident in the
Ermenonville Forest, France
on 3 March 1974

**ACCIDENT TO
TURKISH AIRLINES DC-10 TC-JAV
IN THE ERMENONVILLE FOREST
ON 3 MARCH 1974**

FINAL REPORT

February 1976

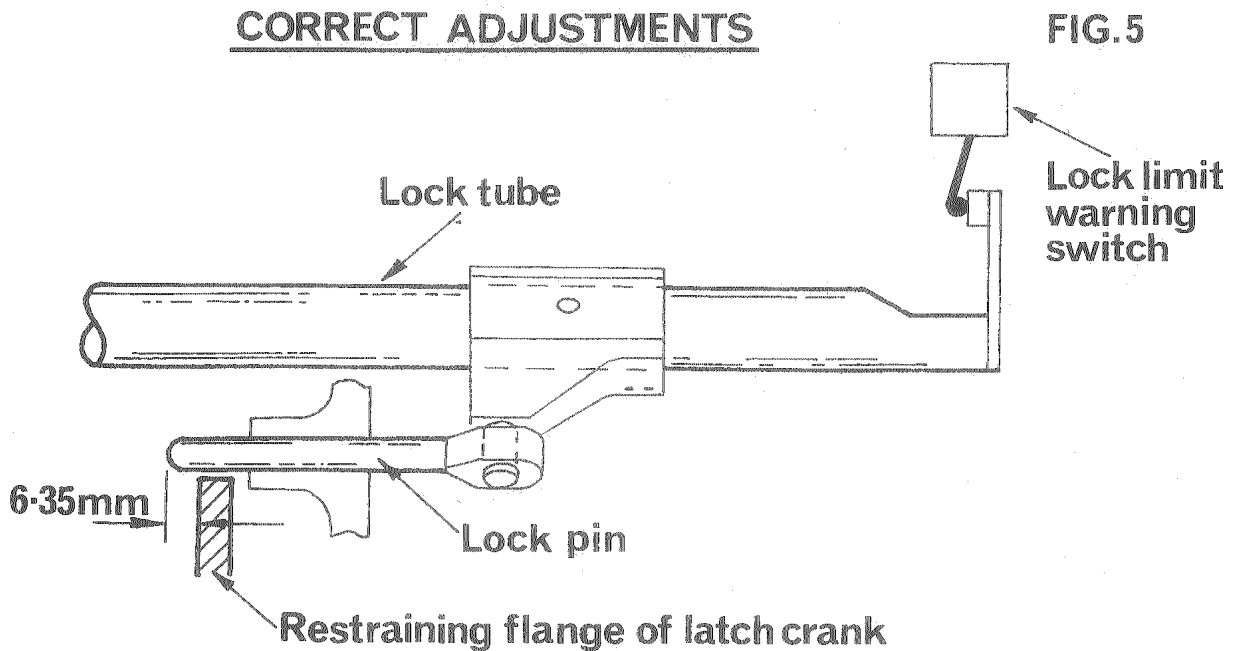
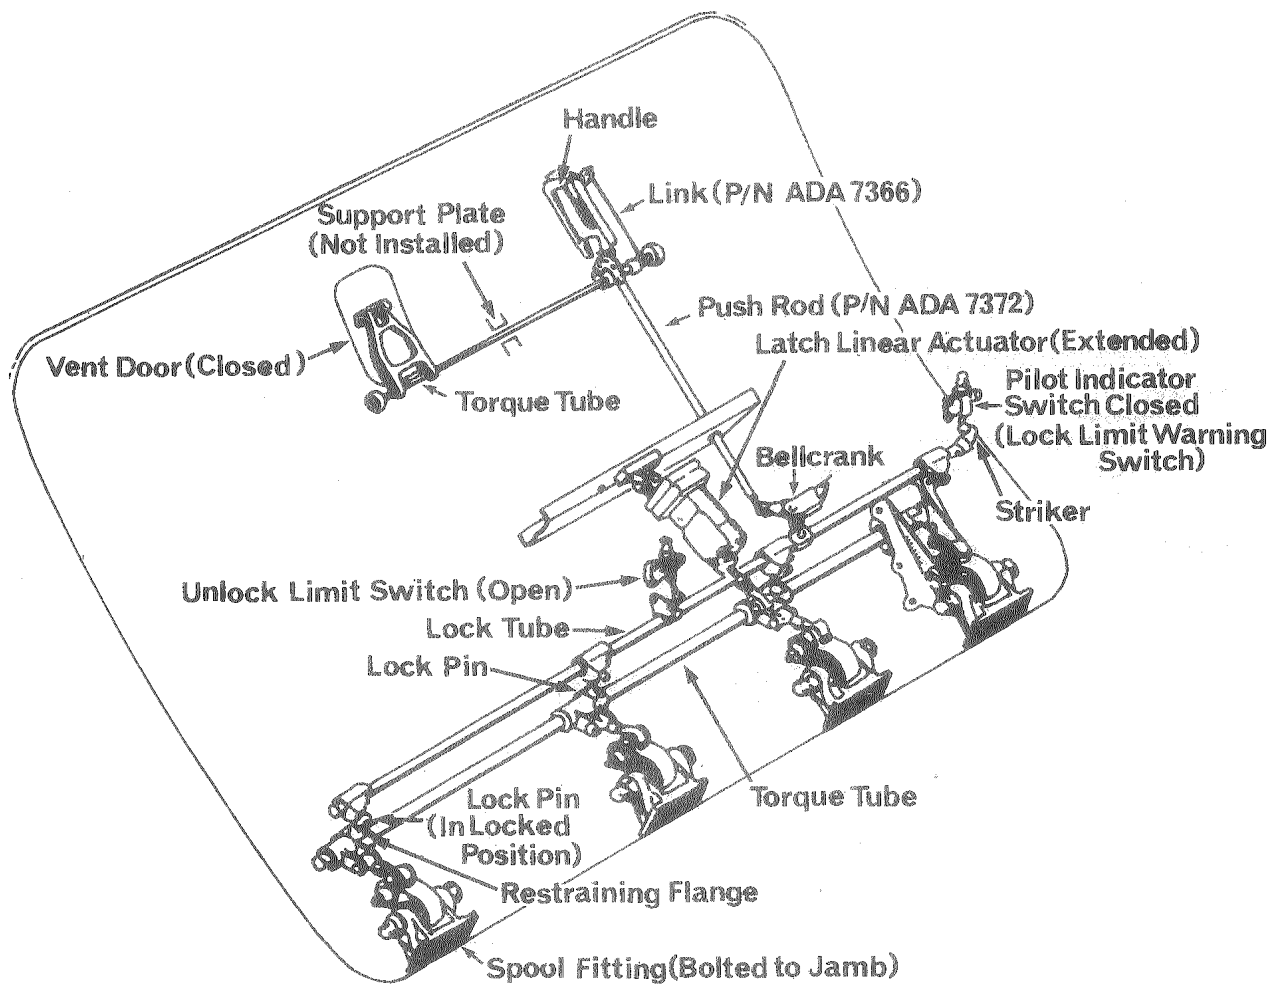
FIG. 6

This closure was possible only because of deformation of the mechanism providing control transmission for the operation of the lock tube. The principal deformation affected the vent door shaft. The additional support plate specified by SB 52-37 (fig 6) was designed precisely to prevent such deformation.

**CLOSING AND LOCKING MECHANISM
(CLOSED AND LOCKED POSITION)**
