Rail Accident Investigation Branch

Rail Accident Report

**Passenger door open on a moving train
near Desborough
10 June 2006**

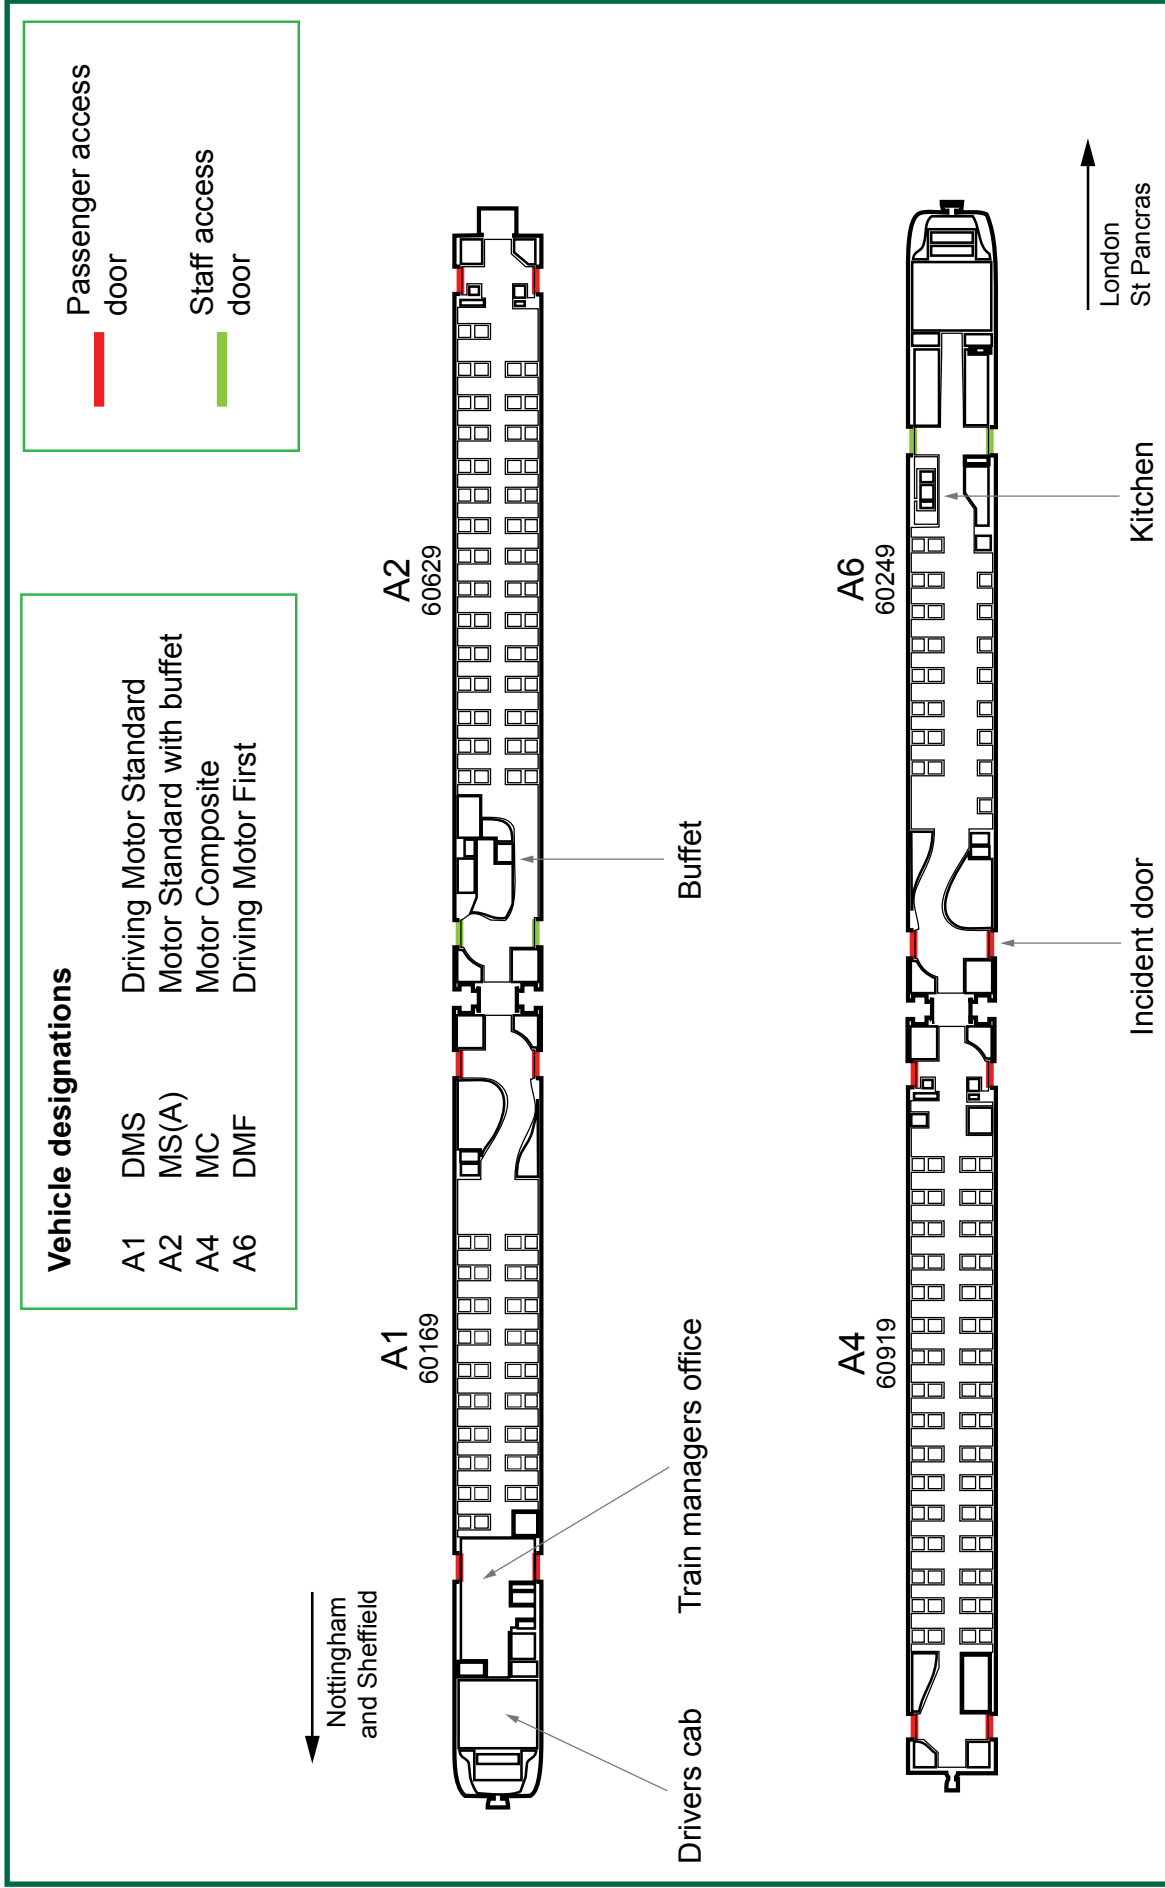
Figure 3: Train formation unit 222 009

- 31 The trains can be marshalled into a variety of car formations. Unit 222 009 is formed of four cars. Figure 3 shows the train formation, vehicle designations, numbers, and pertinent features.

- 32 The trains are fitted with electrically operated exterior doors, two on each vehicle side. On *intermediate vehicles*, they are located in the two *intermediate end vestibules*. On driving vehicles, they are located in the intermediate end vestibule and also toward the cab-end of the passenger area: in the kitchen area on the first class vehicle and next to the train manager's office on the standard class. The doors are a single leaf *slide-and-plug* design. Most of the doors are designated for passenger access use. However, some are for staff use only – these have different controls. The location of each door and type is shown in Figure 3. The door which opened (the incident door) was on the west side of the train; this is also identified on Figure 3.

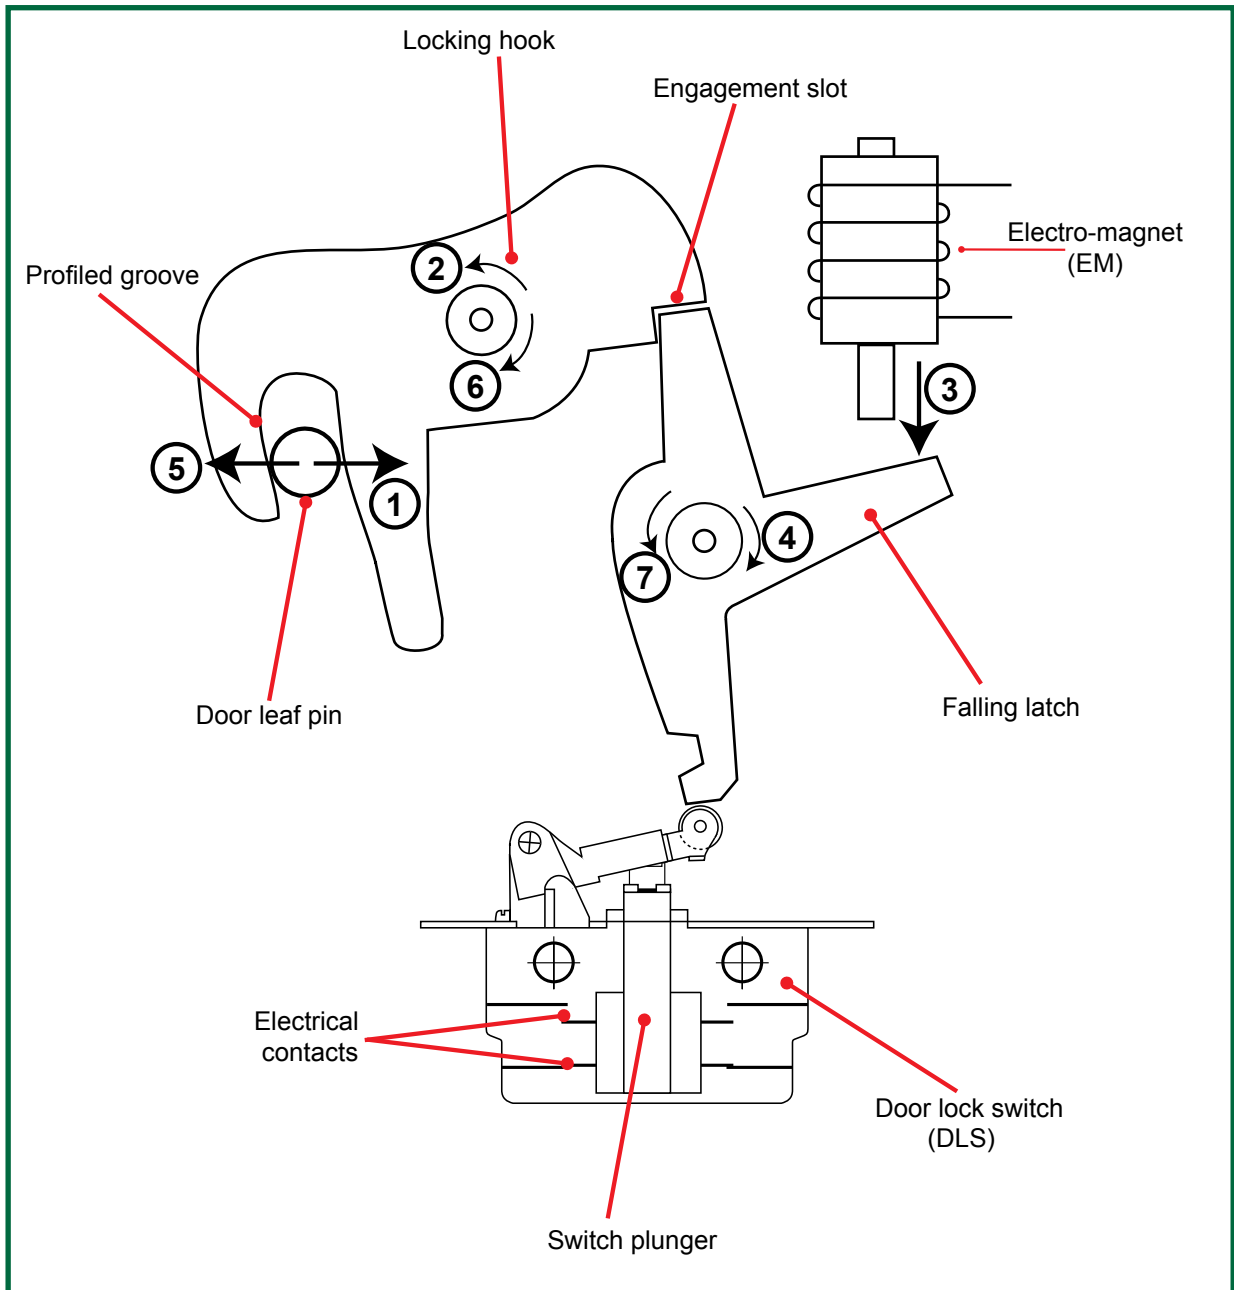
Figure 8: Door locking mechanism (shown in locked state) - annotation on diagram refers to description given in paragraphs 85 - 89

82 The door is in the locked state when the door leaf pin is held in place by the locking hook; see Figure 8. The locking hook can rotate, but when locked, it is held in place by the falling latch locating in the *engagement slot* (engagement). Locking detection is provided by the DLS. When deactivated (natural condition), an unlocked door state is indicated; the *switch plunger* (which opens and closes the electrical contacts) is raised. When the falling latch engages in the locking hook, the switch plunger is depressed and the opposing contacts made. The DLS is activated and a locked state is indicated. The door is unlocked by the *electro-magnet* (EM); when activated, it presses on the falling latch, rotating it out of the engagement slot.

- 85 When the passenger presses the ‘open’ push button, the EDCU initiates a further sequence of control commands. Referring to Figure 8, first a current is applied to the door motor to close the door; this pulls the door leaf pin to the right (1) – toward the portal – rotating the locking hook (2) and relieving any force on the top of the falling latch and the engagement slot. Unlocking is then initiated. The electro-magnet is energised (3), forcing the falling latch to rotate clockwise (4) and disengage from the locking hook; the locking hook is now only held in place by the door leaf pin.

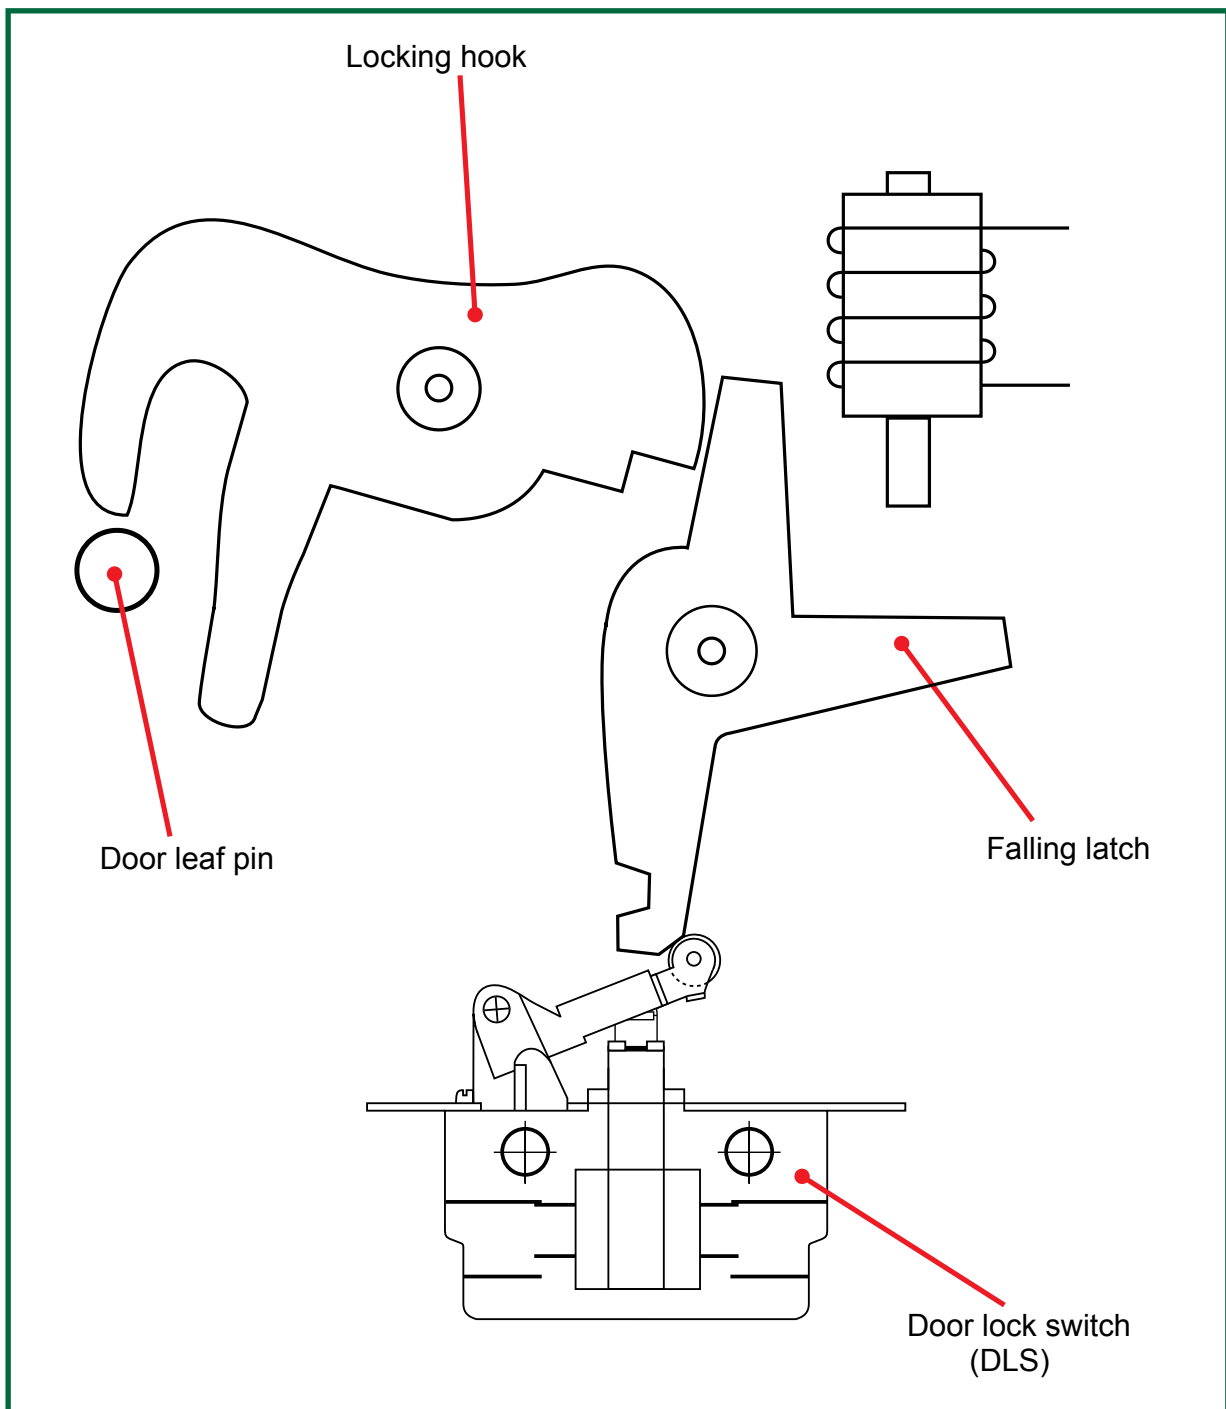
Figure 9: Door locking mechanism in unlocked state

- 87 As the door opens, the DCS (which acts on the door leaf) deactivates. The electro-magnet is de-energised after a fixed time period (configurable in the range 2-5 seconds) and the falling latch is released. This is also spring biased and it rotates anti-clockwise (7) to rest against the locking hook (it cannot enter the engagement slot because of the now clockwise orientated position of the hook). Figure 9 shows the door locking mechanism in this unlocked state with the door leaf pin free of the locking hook.
