Remedial works for the Iron Bridge

by J. A. WILLIAMS, FICE, FStructE, Sandford Fawcett, Wilton and Bell

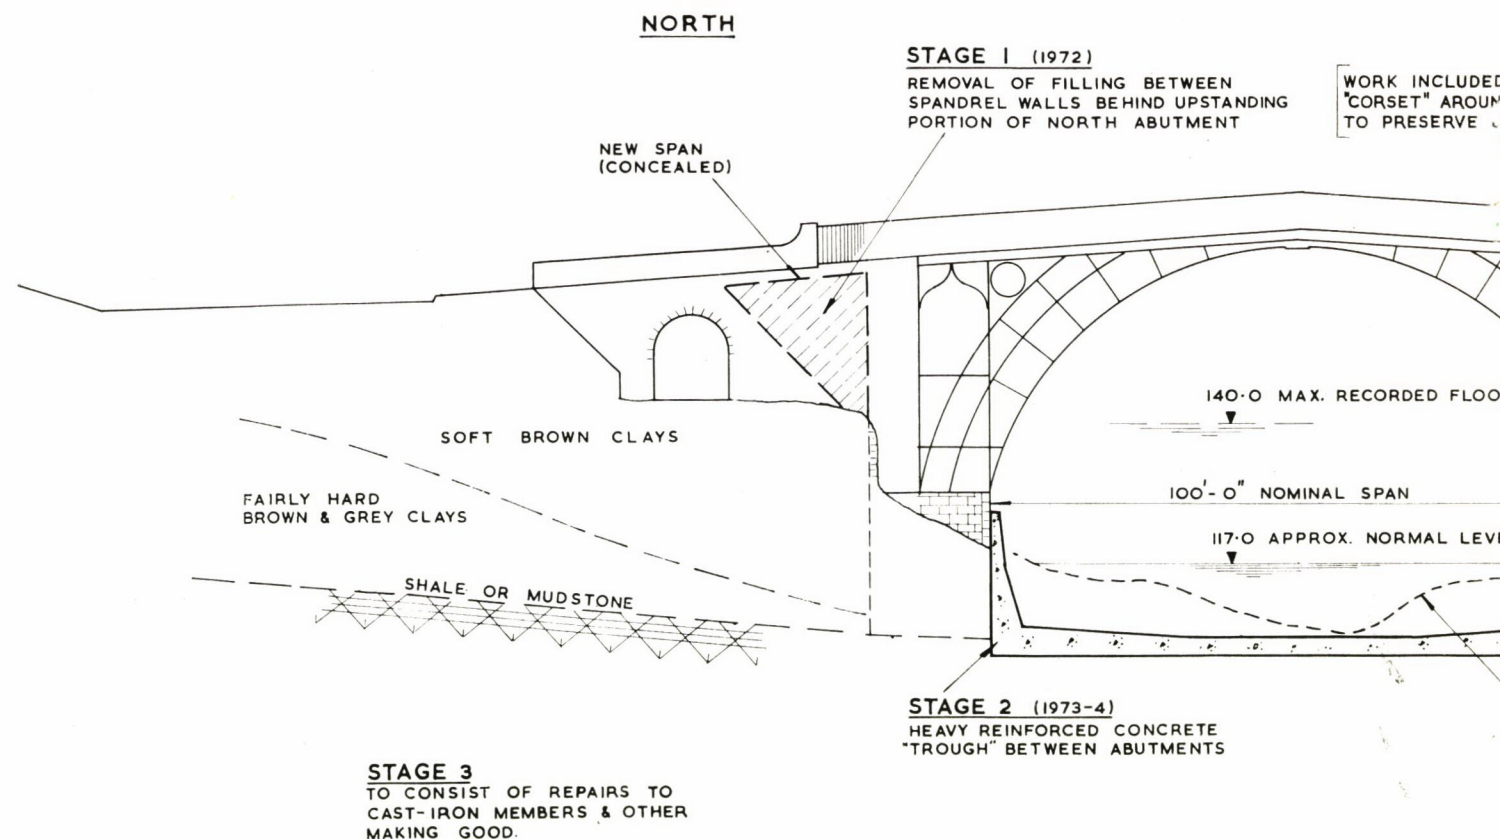
Below—General arrangement of the iron bridge remedial works showing stages of the work and the ground conditions

The scheme finally selected consisted of a heavy reinforced concrete invert slab at river bed level between, and over the full width of, the abutments together with heavy reinforced concrete facing walls to the abutments. The invert and facing walls together form a very substantial trough section, the function of the invert being, as a strut, to prevent further sliding at abutment toe level, while the monolithic facing walls resist any resulting tendency for the abutments to tilt forward above toe level.
