Bureau enquêtes accidents pour la sécurité de l'aéronautique d'État

Safety Investigation Report

I-2016-15-A

Date of event	24 October 2016
Place	Malta International Airport
Type of aircraft	SA227 AT - MERLIN IV C
Company	CAE Aviation

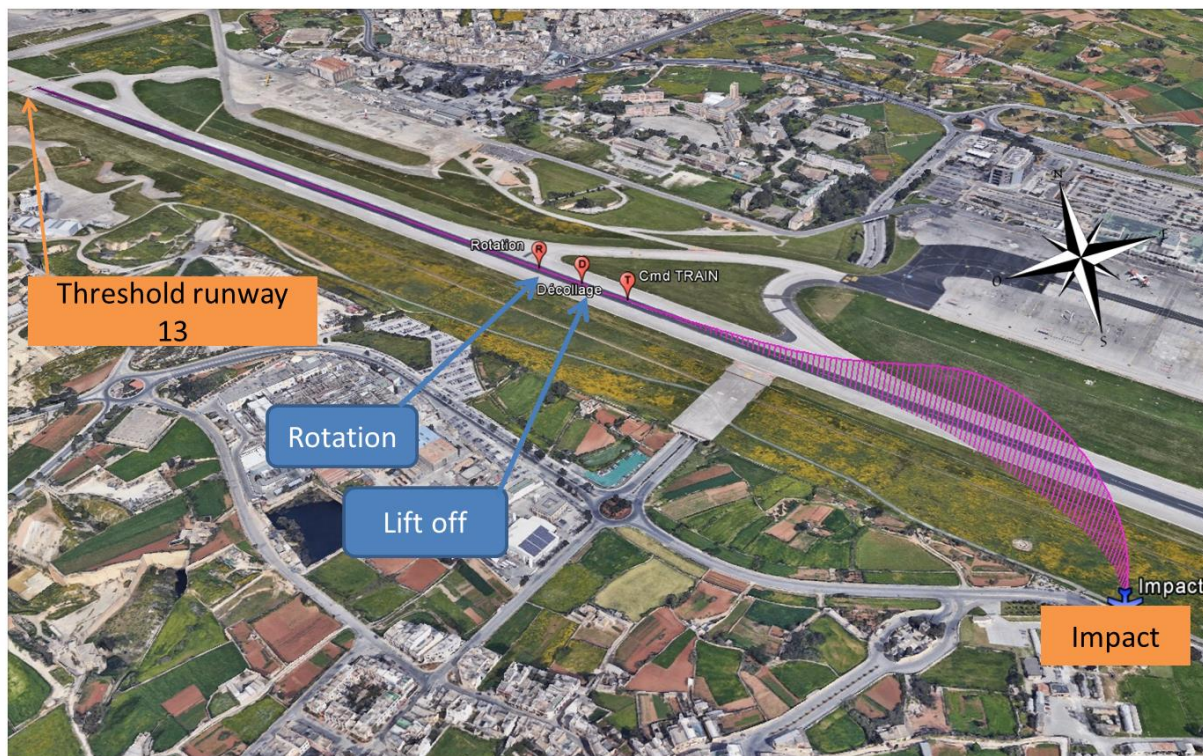
Figure 1: Reconstitution of the aircraft's trajectory

The plane was observed in a three-quarters inverted position at the apogee of its trajectory.

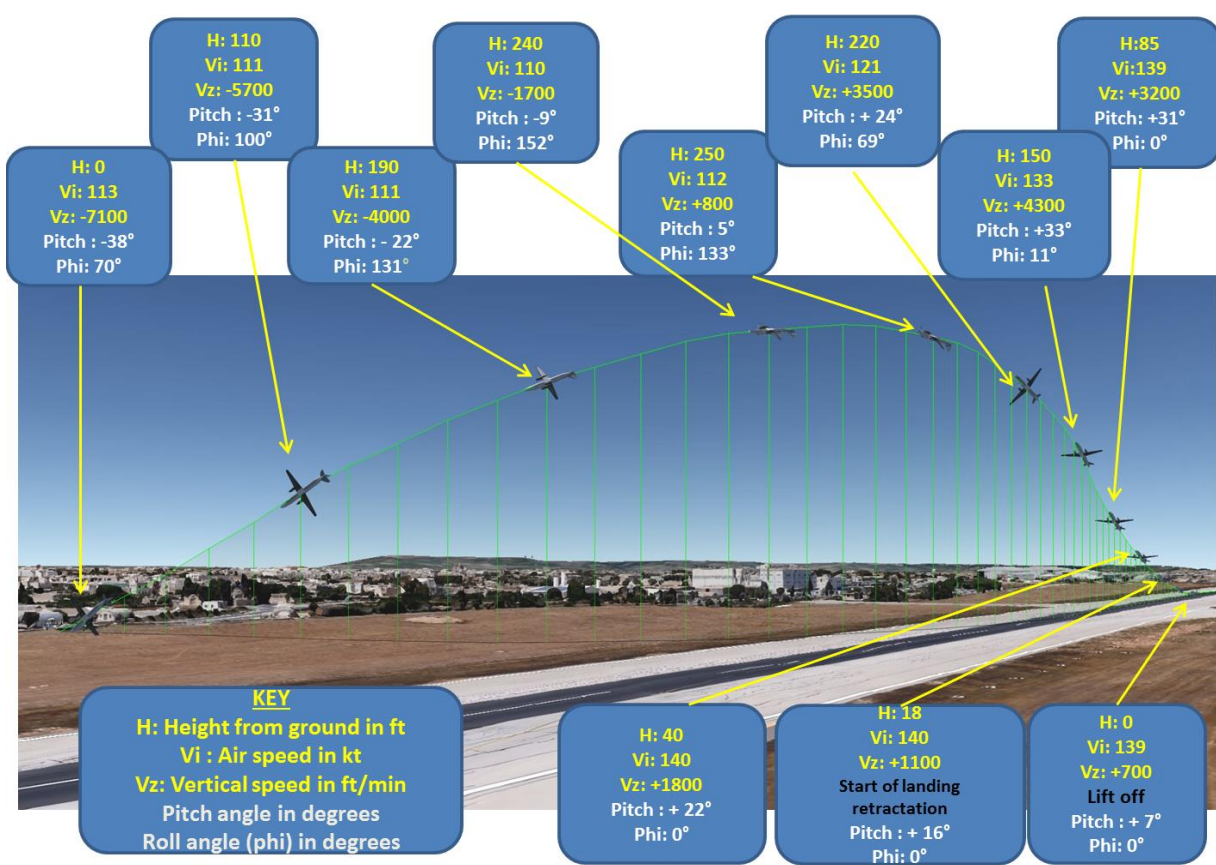
Figure 11: Final reconstituted trajectory

Analysis of the plane's attitude shows that the pitch angle increased continuously from the moment of rotation (see Figure 12). The pitch attitude before lift-off was normal, but then it continued to increase constantly until the start of the roll. A deviation can already be observed less than one second after lift-off, or soon after the pilot manoeuvred the elevator control to set the attitude.

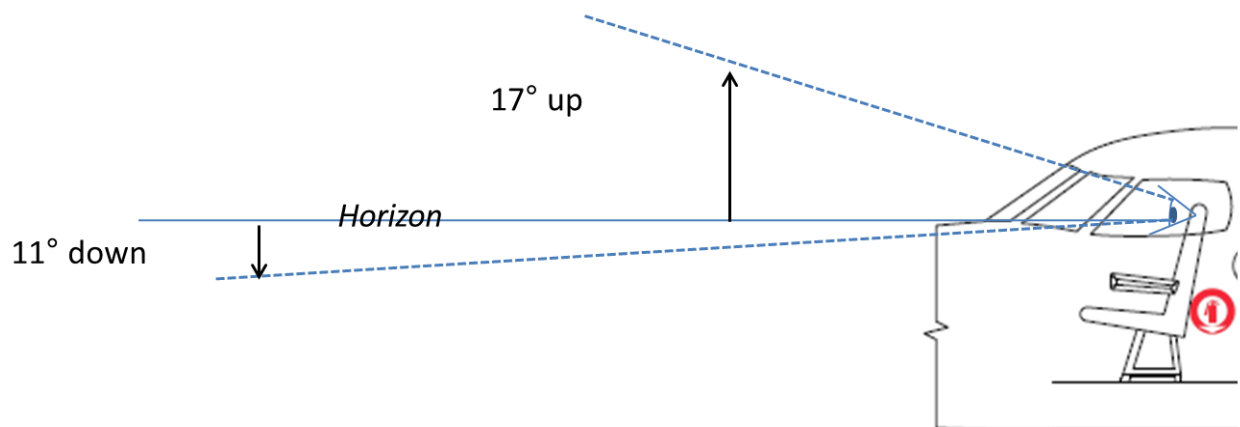
Figure 14: Field of vision of the pilot in the vertical plane

With a pitch attitude greater than 11°, the horizon is no longer visible to the pilot. The normal takeoff attitude is in the range from 5° to 7°.

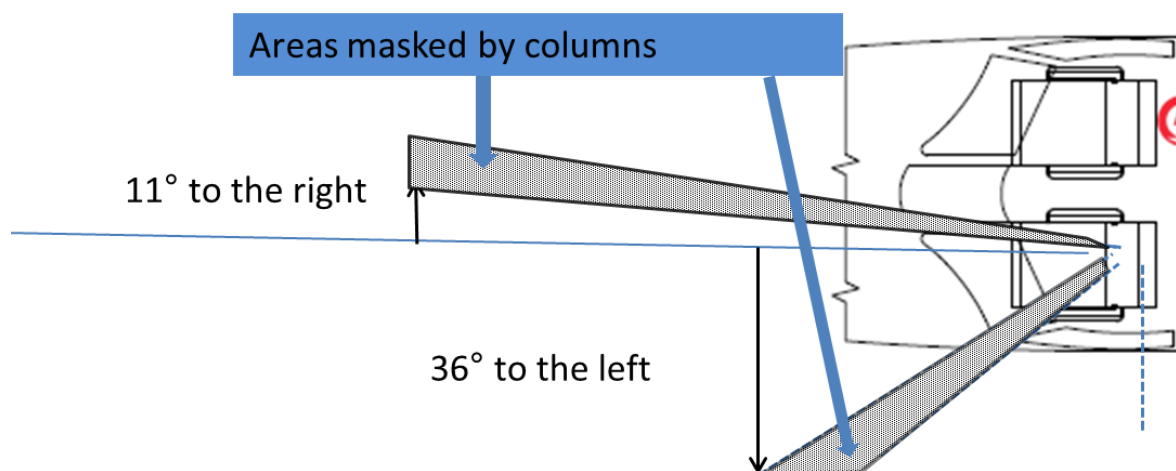
Figure 15: Field of vision of the pilot in the horizontal plane

The zones masked by the uprights do not impede to piloting the aircraft or to detecting obstacles on the takeoff trajectory.

The characteristics of the cockpit do not cause any visual obstruction for normal takeoff.

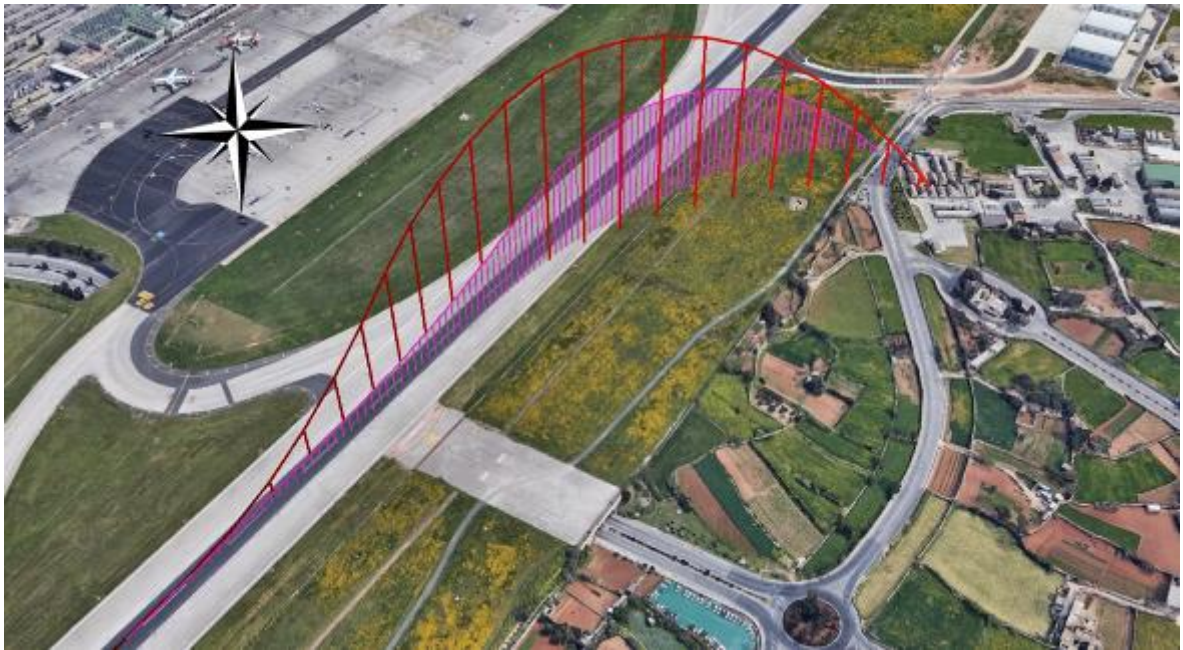
Figure 16: Comparison of the flight path of the PC7 (red) with that of the accident (magenta)

Analysis of the flight path of the SA227 AT shows that it recovered the effectiveness of the controls after reaching the three-quarter turned position, as revealed by an inversion of the rate of roll. The descent path reveals that the nose-up elevator control was maintained in the same position.

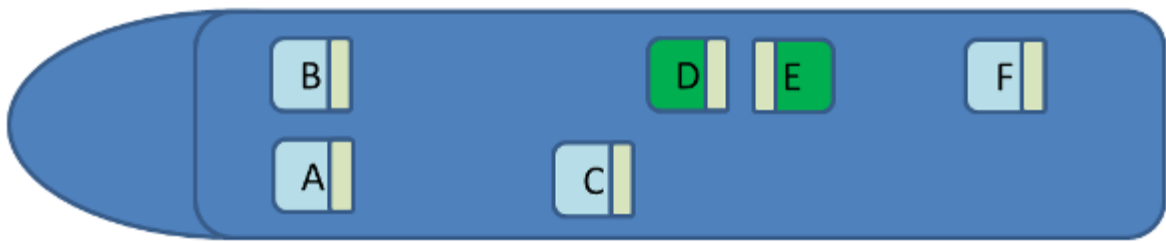
Figure 17: Arrangement of the seats in the aircraft

The conducted investigations established that on impact all the seats (especially the pilot's seat A and co-pilot's seat B) were locked in their two adjustment axis (longitudinal and height).

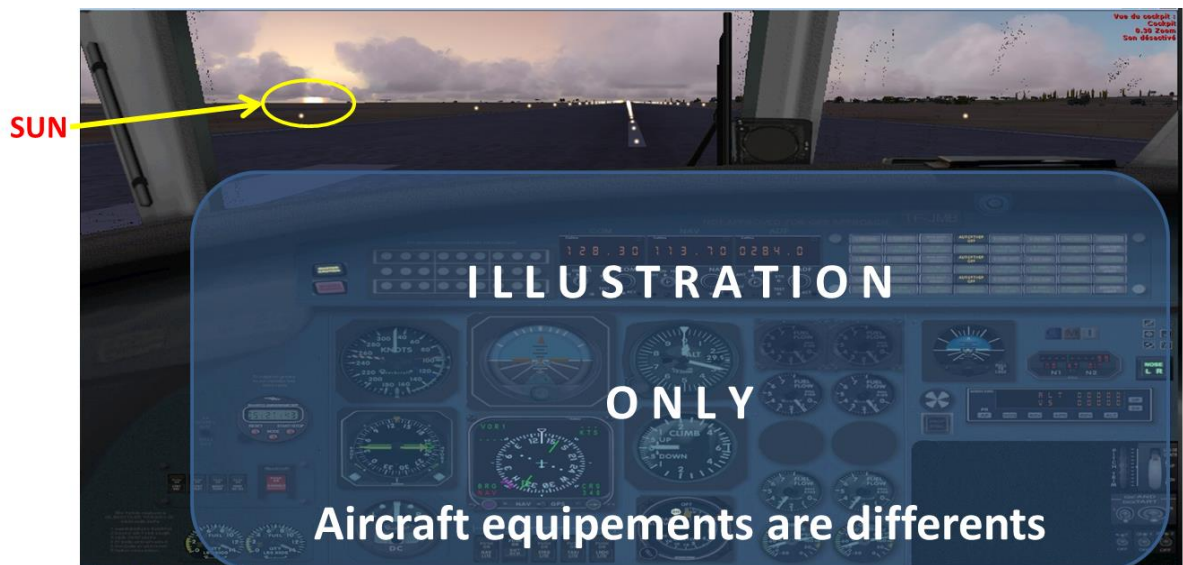
Figure 22: Position of the sun before rotation (on left seat)

The takeoff took place at dawn. Sunrise on the day of the accident was effective at 07:17. The azimuth at sunrise is 104 degrees. The position of the sun in the cockpit before rotation is represented in Figure 22. The representation of the meteorological conditions has been enhanced to show the sun.

The hypothesis that the position of the sun hampered the pilot is rejected.

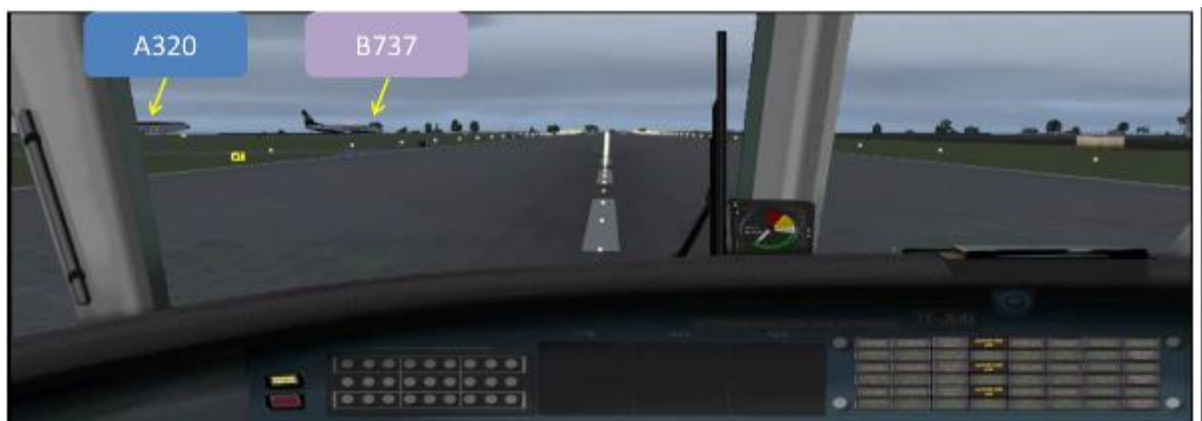
Figure 23: Relative position of the aircrafts at the moment of rotation

Also, the SANDEL Avionics control unit (see Annex 3) recorded the transmission of at least one traffic information message during the takeoff phase. The proximity of these aircraft could have triggered a visual and aural warning message generated by the TCAS of the aircraft involved in the accident.

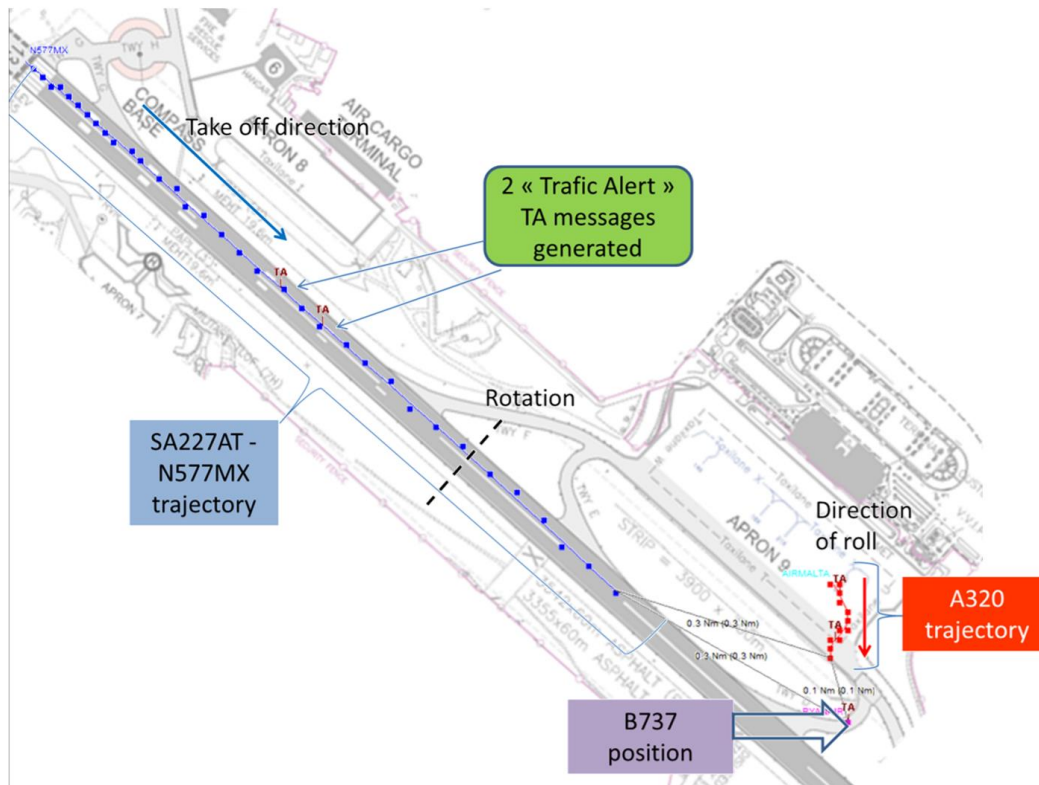
Figure 24: Positioning of the two TA messages generated by the TCAS of the B737 and A320
(source: Eurocontrol InCAS® software)

Simulation of the scenario indicates the possibility of two TA (Traffic Alert) messages in the SA227 AT on takeoff.

Unlike a RA message (“Resolution Advisory”), which requires the crew to take specific action by means of an aural announcement, the generation of a TA message only provides information to the crew.

The hypothesis that the accident was caused by a message generated by the TCAS is rejected.

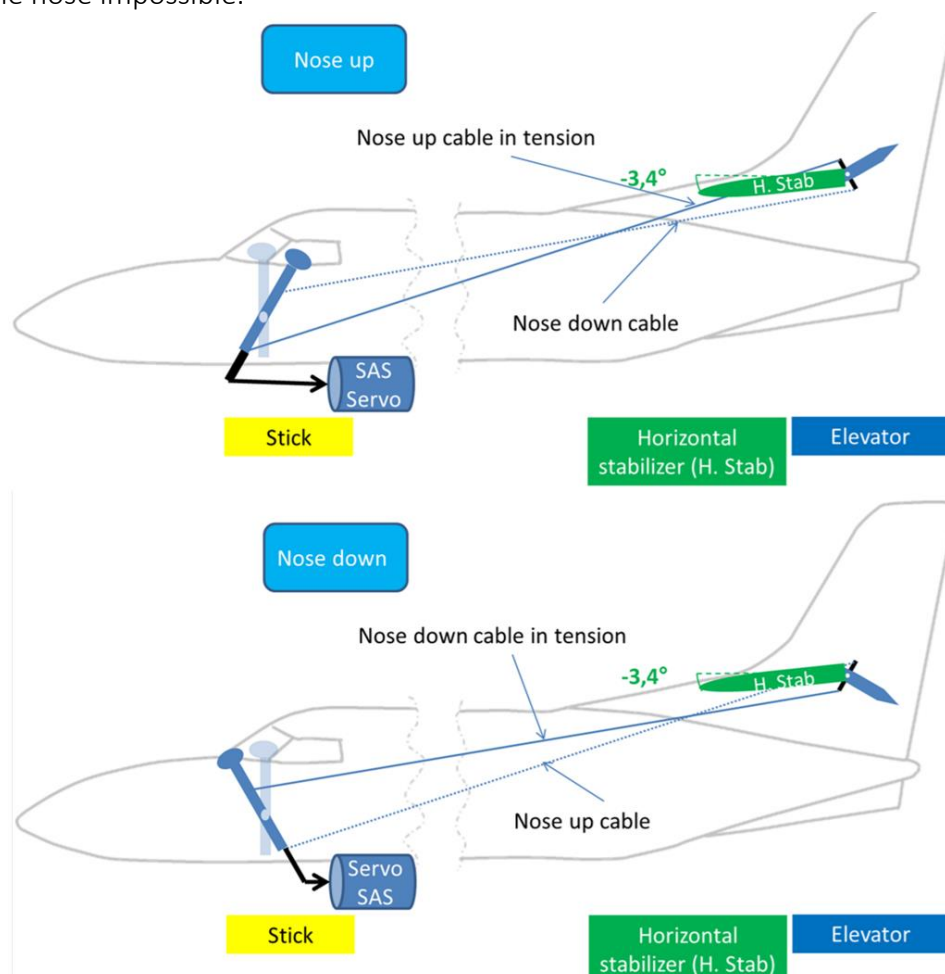
Figure 27: Diagram illustrating the cables actuated by moving the control stick

For a cable-operated flight control system, these actions are only possible if the system (cables, pulleys and bellcranks) is intact and the cables remain tensioned (see illustration below). Any loss of tension or jamming (blockage) of a cable makes the actions of raising or lowering the nose impossible.

According to this scenario, the elevator control surface remained in the “nose up” range due to jamming of a component of one of the flight controls.

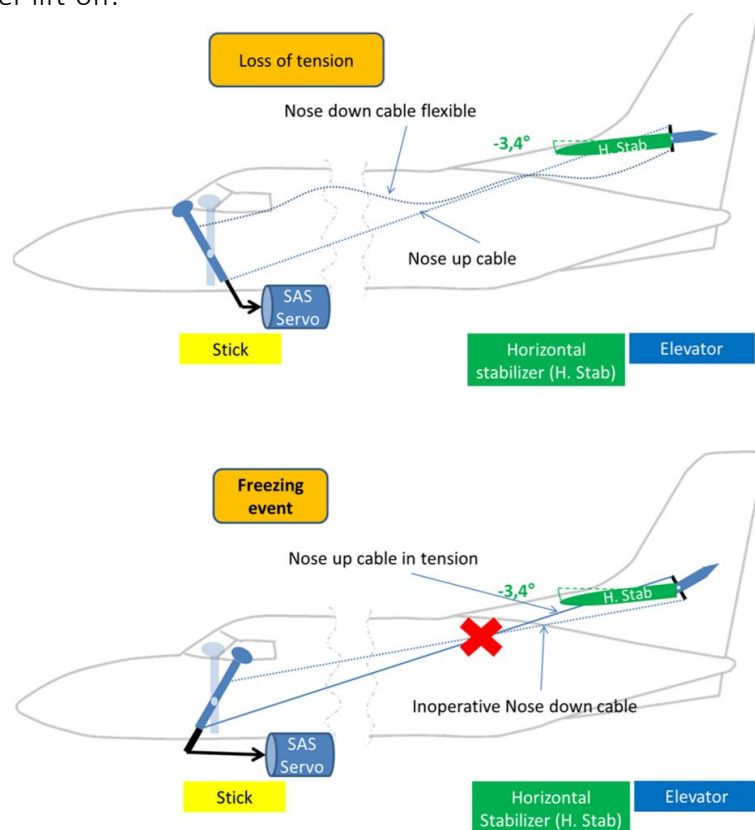
Figure 28: Diagram illustrating the two investigated fault scenarios

In this situation, one solution for recovering control of the aircraft would be to act rapidly on the elevator trim to set the horizontal stabilizer into the “nose down” sector. According to the data in the maintenance manual, the shortest time necessary to attain this trim range is approximately 8 seconds from position -3.4° .

However, control of the aircraft cannot be recovered once it has stalled, which means less than 4 seconds after lift-off.

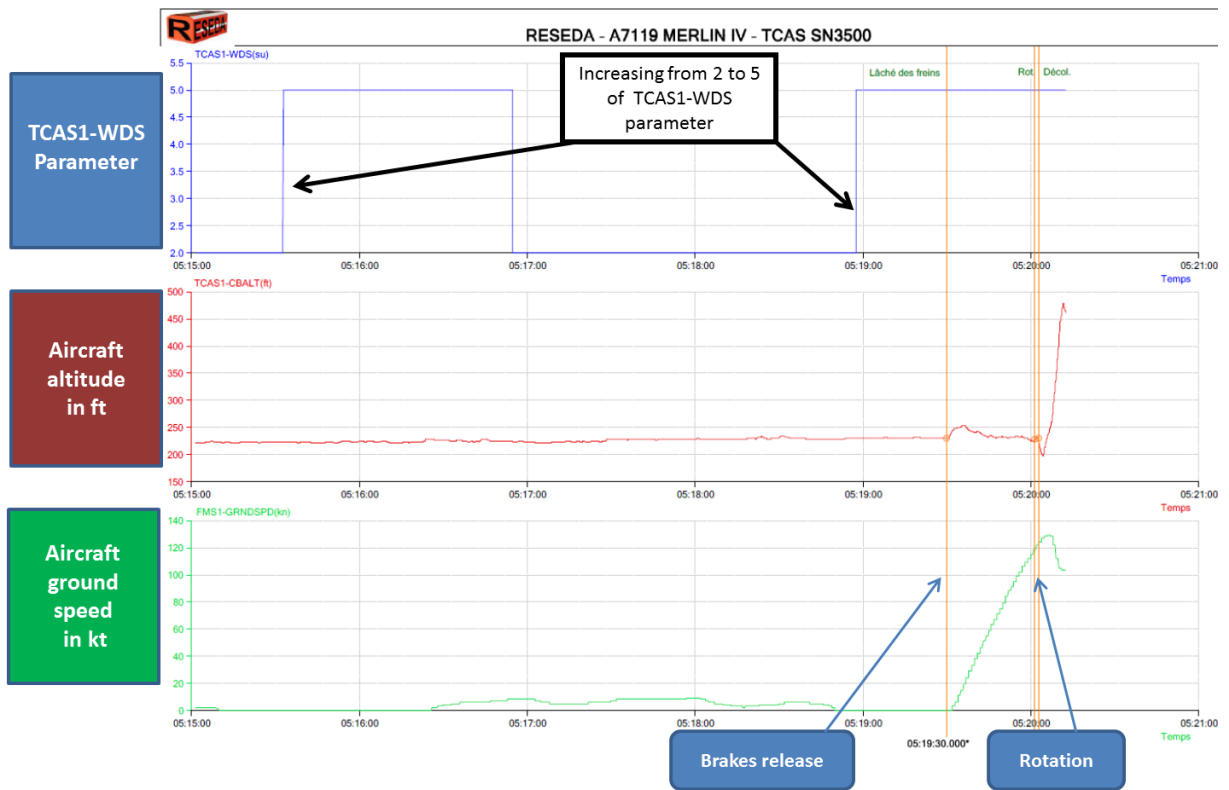
Figure 33: Identification of the two traffic alert signals (1st line) received by the SANDEL control unit

No DC or AC power failure of the control unit was observed up to the end of recording. The TCAS was in operation, because the control unit received two traffic alerts (parameter TCAS1-WDS switched from 2 to 5) via the TCAS control unit:

- one during the taxiing phase on the apron or taxiways;
- a second similar signal during the line-up/takeoff phase.

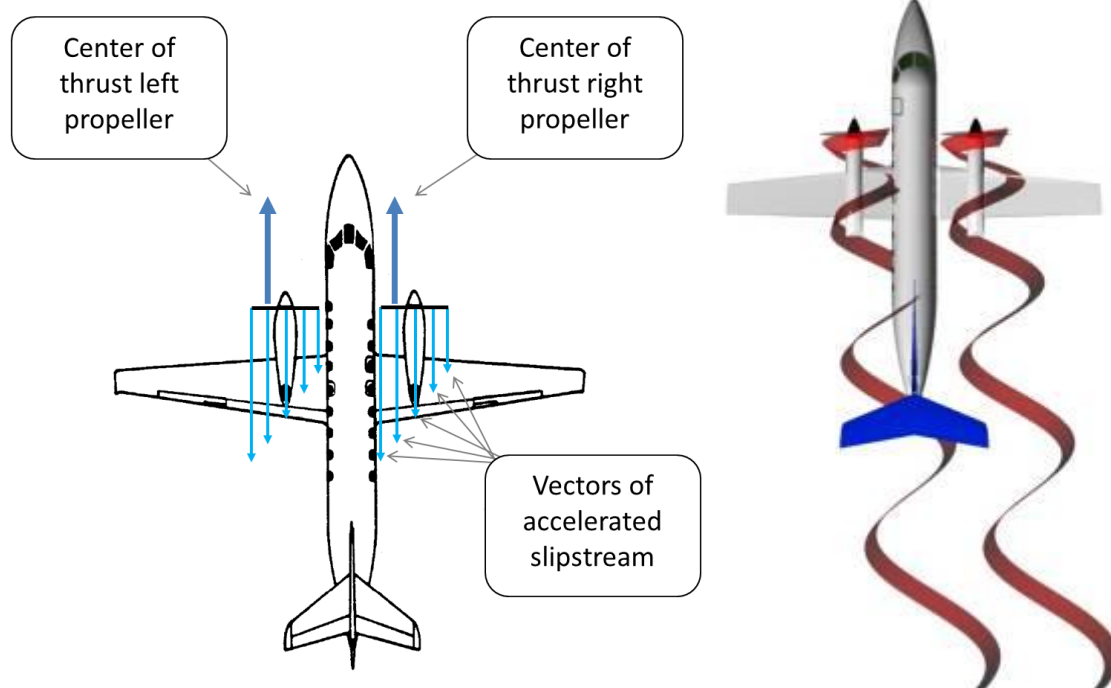
Figure 35: illustrations of the airflows and centers of thrust of the propellers on the SA227 AT

- asymmetrical distribution of lift, which is stronger on the descending blade side, so that the left-hand wing is better supplied than the right;
- local increase in the angle of attack of the right-hand wing, due to the helicoidal slipstream (descending on the left, ascending on the right).

The right-hand wing will therefore tend to stall first, accompanied by a sharp roll to the right.
