Aerodynamic Stall and Loss of Control During Approach
Embraer EMB-500, N100EQ
Gaithersburg, Maryland
December 8, 2014

NTSB/AAR-16/01
PB2016-103251

Aircraft Accident Report

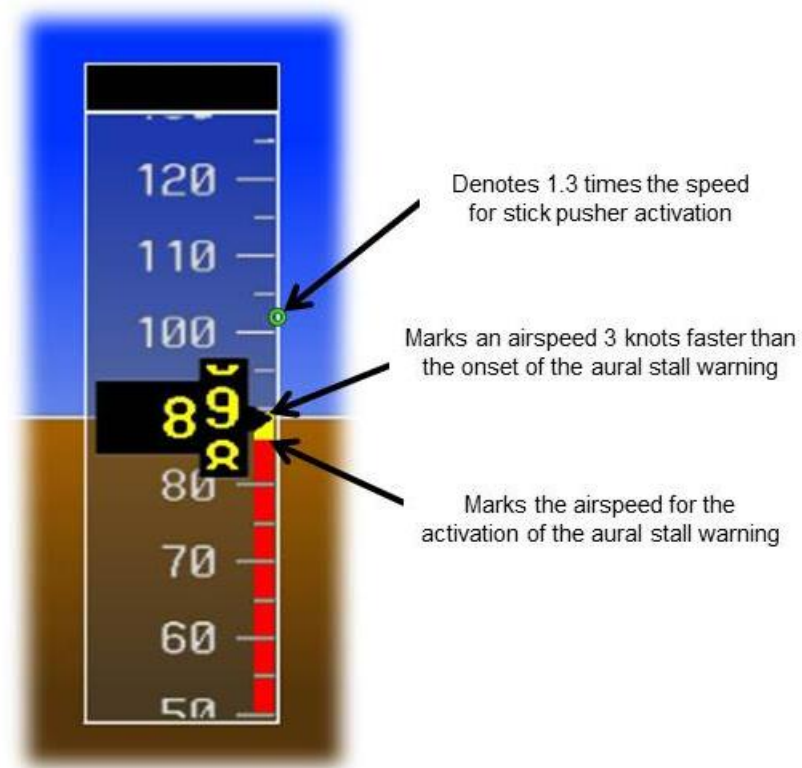
The airspeed tape on the PFD provides pilots with low-airspeed awareness indicators consisting of a short yellow band positioned above a longer red band and a green circle on the right edge of the tape (see figure 3). The top of the red band denotes the airspeed for the activation of the aural stall warning, the top of the yellow band marks an airspeed that is 3 knots faster than the onset of the aural stall warning, and the green circle denotes 1.3 times the speed at which the stick pusher would activate. Activating the airplane's wing and horizontal stabilizer

Figure 3. Simulated EMB-500 airspeed tape display (with ice protection deactivated).

The aircraft performance study also included simulations of the low-airspeed awareness cues on the airspeed tape. According to the simulations, because the pilot had not activated the wing and horizontal stabilizer deice system during the approach to GAI, the airspeed tape would have shown, just before the stall warning sounded, the top of the red band at 87 knots, the top of the yellow band at 90 knots, and the green circle at 102 knots (see figure 3). The simulations showed that, if the deice system had been activated, the airspeed tape would have displayed the top of the red band at 102 knots, the top of the yellow band at 105 knots, and the green circle at 121 knots (see figure 4).

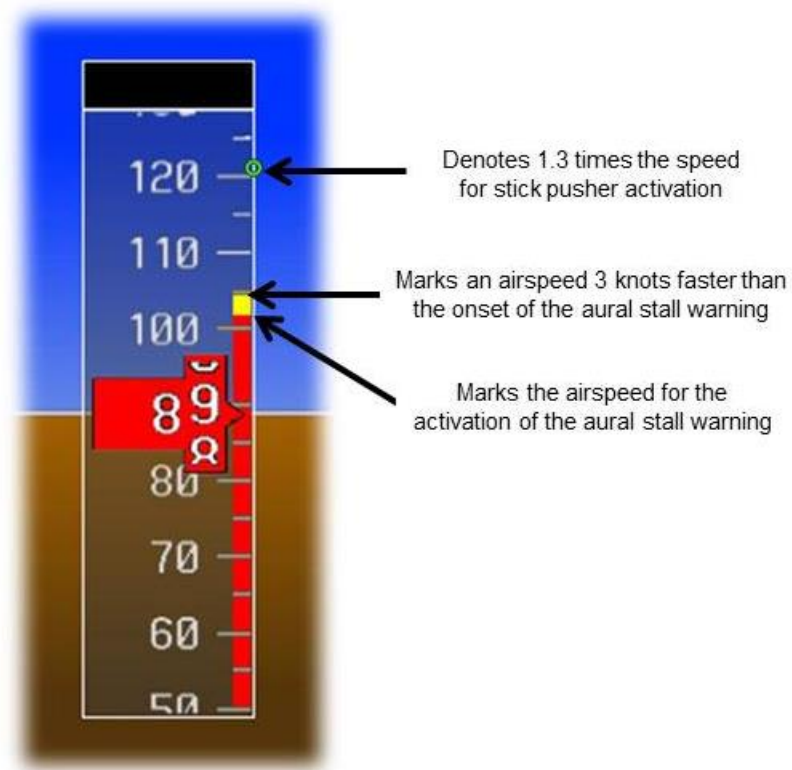
deice system results in a lower AOA threshold to trigger the SWPS and, therefore, higher indicated airspeeds for the warning bands on the airspeed tape display (see figure 4).

Figure 4. Simulated EMB-500 airspeed tape display (with ice protection activated).

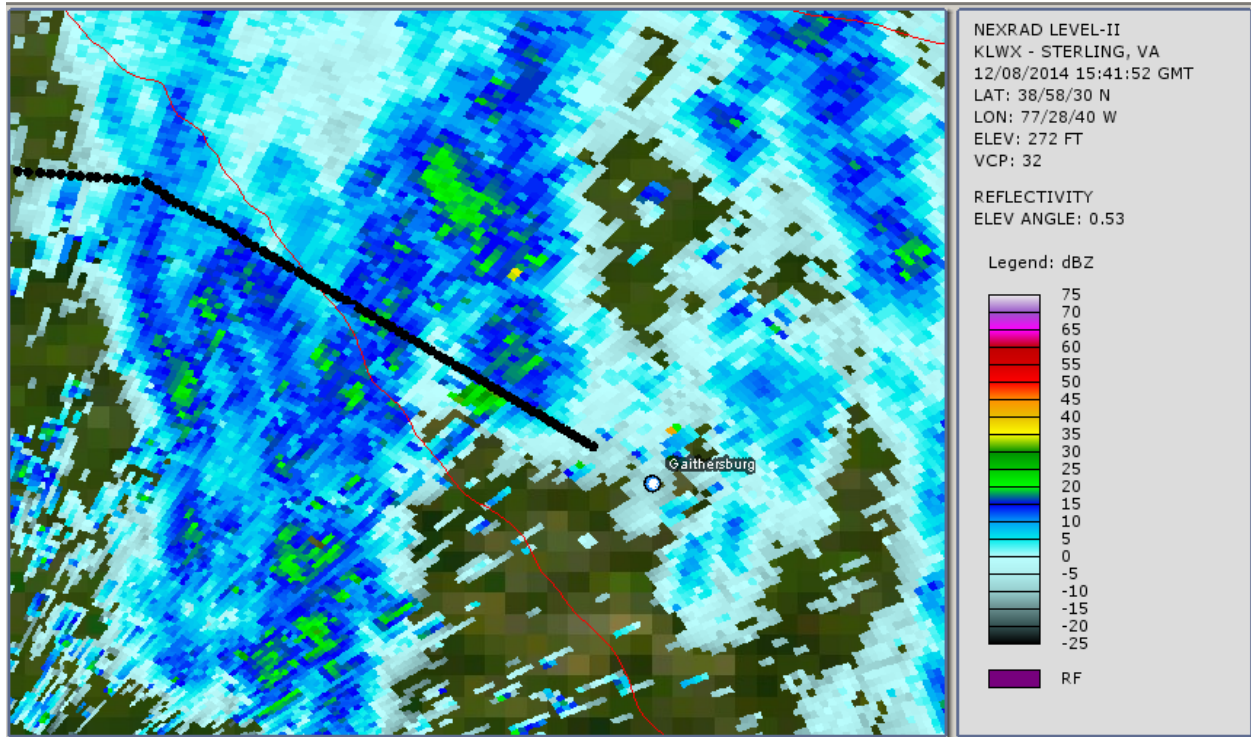
GAI's AWOS, the closest official National Weather Service (NWS) reporting location to the accident site, is privately owned and operated. The AWOS, located near midfield and immediately east of runway 14, issues observations from the ground every 20 minutes and broadcasts current conditions that are updated at least once per minute. The AWOS weather observation at 1035 (about 6 minutes before the accident) indicated the following: wind from 040° at 6 knots, visibility 10 statute miles, a few clouds at 2,100 ft agl, ceiling overcast at 3,200 ft agl, temperature -1° C, dew point temperature -7° C, altimeter 30.61 inches of mercury. The AWOS did not have a precipitation discriminator and therefore could not report types of precipitation. An NWS national radar mosaic for 1040 depicted several bands of very light intensity echoes over the area, likely associated with snow showers and/or snow squalls. A base reflectivity elevation scan completed at 1041:52 also depicted several bands of very light intensity echoes associated with light precipitation or snow that extended over the airplane's flight track during the descent and approach to GAI (shown as a black line in figure 5).

Figure 5. A Weather Surveillance Radar 88 Doppler base reflectivity scan with the accident airplane's flight track in black overlaid.
