# NATIONAL TRANSPORTATION SAFETY BOARD

## AIRCRAFT ACCIDENT REPORT

**CHINA AIRLINES BOEING 747-SP, N4522V  
300 NAUTICAL MILES NORTHWEST OF  
SAN FRANCISCO, CALIFORNIA  
FEBRUARY 19, 1985**

NTSB/AAR-86/03

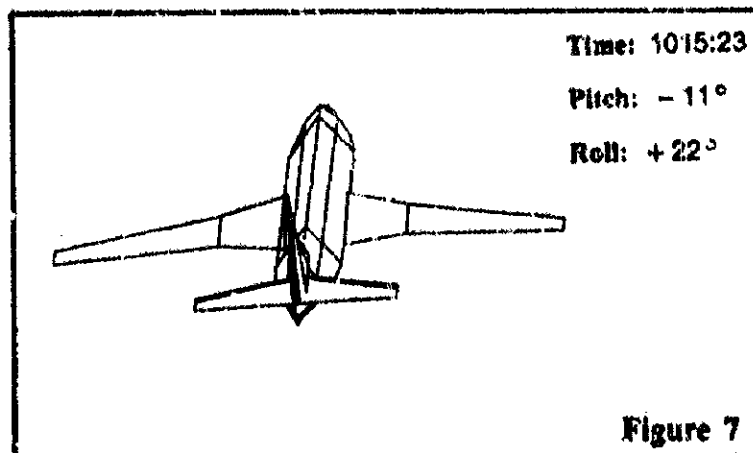
Figures 1.--Excerpts from Computer Animation.

Between 1013:10 and 1015:06, the Nos. 1, 2, and 3 engines remained at about 1.5 EPR while the No. 4 engine remained at about 1.1 to 1.2 EPR. The airplane continued level at 40,900 feet, but the airspeed continued to decrease at a rate of about 0.25 KIAS/sec. Although the roll angle of the airplane remained fairly constant at about  $2.6^\circ$  to  $3.5^\circ$  left-wing-down, the left-wing-down deflection of the control wheel continued to increase as the indicated airspeed decreased, and, by 1013:43 the deflection had increased to  $22.9^\circ$ , the maximum available input from the autopilot. As the airspeed continued to decrease and with the control wheel deflected to, and remaining essentially at, the  $22.9^\circ$  left-wing-down deflection, the airplane began rolling slowly to the right, reaching a wings-level attitude by 1013:58 and then continuing on into a right-wing-down attitude. (See figure 1.)
